**Proposed Development of  
Asda Home Shopping  
Purbrook Way, Havant**

**BS5837:2012  
Tree Survey and Implications Assessment**

**Prepared by EBS on behalf of SEP Ltd**

**Feb 2014**

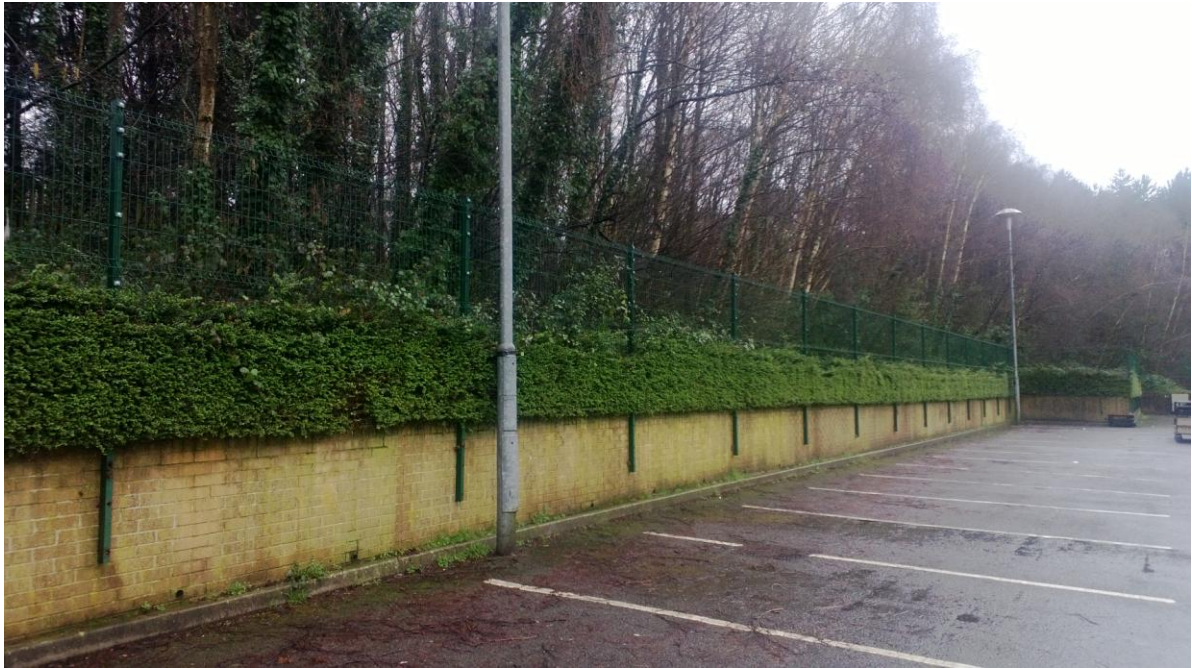
Photo 1. Showing area of retaining wall affected by development

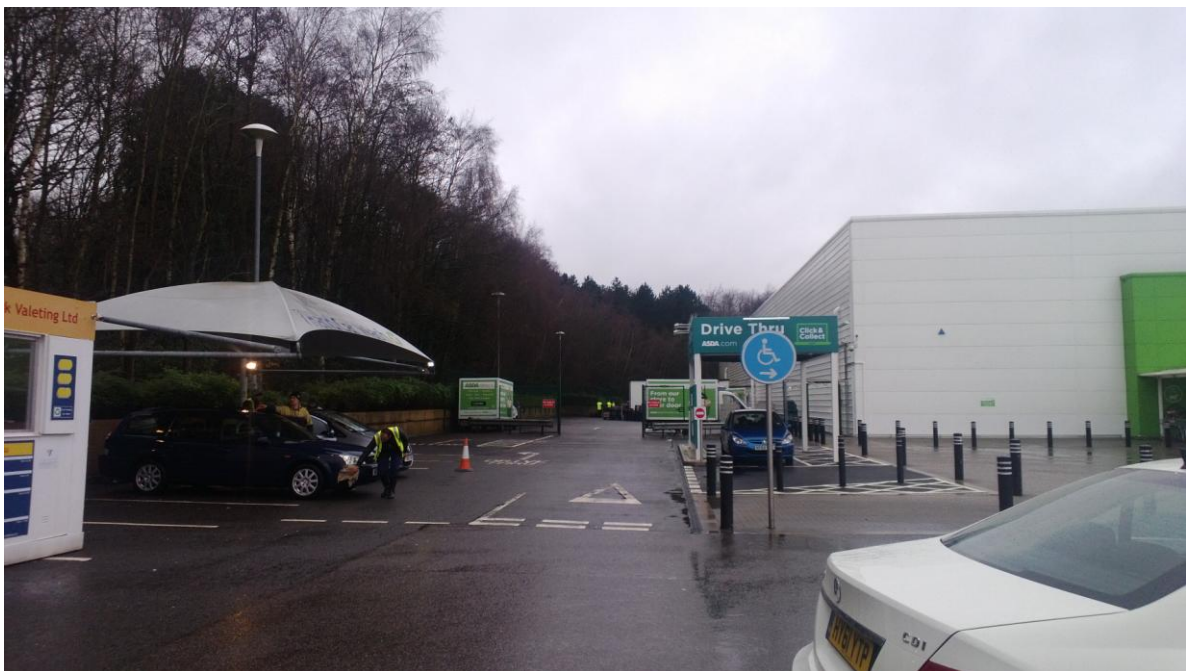
Photo 2. Showing screening of site
