# ARBORICULTURAL REPORT

**7 Broadmeadows Lane, Waterlooville, Hampshire**

Report Prepared by  
**PAUL COLLIS FICF, F.Arbor.A**  
Arboricultural Consultant & Chartered Forester

**October 2010**

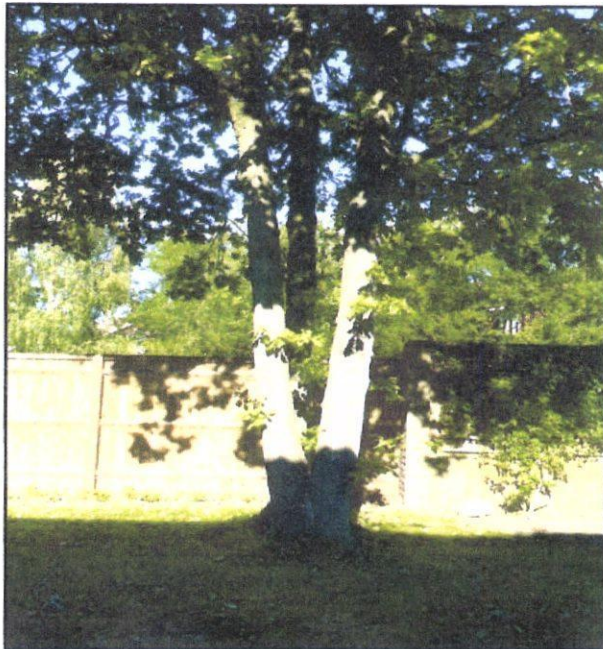
| CLIENT: Mr. & Mrs. David MacWilliams | | | | | | | Crown Radius | | | | Inspectors: P. Collis | Date: |
|---|---|---|---|---|---|---|---|---|---|---|---|---|
| A | √ | English oak | M/A | B | 10.5 | 27 | 5.0 | 4.7 | 4.8 | 5.0 | now, a small remnant, comprising four stems, of a very old tree (remaining stump diameter is approximately 1.5m diameter). | |
| | | | | | | 23 | | | | | The four small stems are in reasonable condition and appear to | |
| | | | | | | 25 | | | | | be stable. However, these are capable of growing much larger. | |

Tree A (N) from house & boundary fence beyond

| CLIENT: Mr. & Mrs. David MacWilliams | | | | | | | Crown Radius | | | | Inspectors: P. Collis | Date: |
|---|---|---|---|---|---|---|---|---|---|---|---|---|
| | | | | | | 12 | | | | | It would be sensible to keep the overall crown(s) at the present | |
| | | | | | | | | | | | size which must inevitably involve regular crown pruning as: | |
| | | | | | | | | | | | reduction and shaping and a limited thinning every 3-4 years. | |

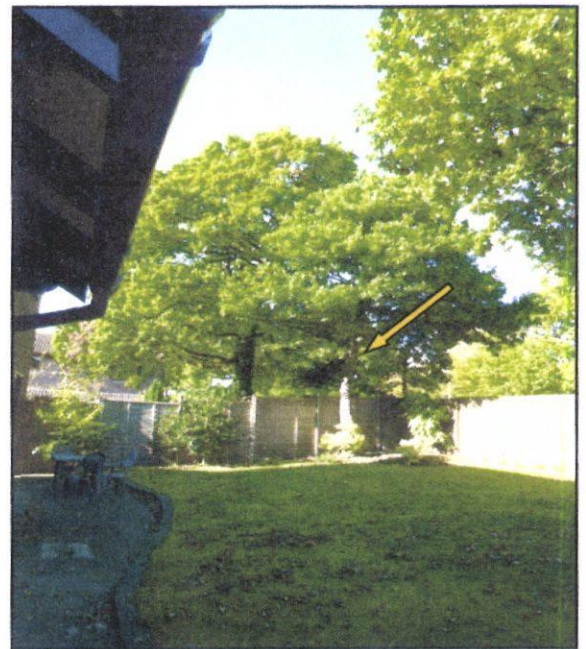
| CLIENT: Mr. & Mrs. David MacWilliams | | | | | | | Crown Radius | | | | Inspectors: P. Collis | Date: |
|---|---|---|---|---|---|---|---|---|---|---|---|---|
| B | √ | English oak | M/A | R | 10(e) | 45(e) | 5.3 | 4.6 | 4.1 | 2.0 | This mid-sized tree is subordinate to the larger tree 'X' in the | |
| | | | | | | | | | | | neighbouring garden; it is completely overtopped by that tree | |
| | | | | | | | | | | | and its crown reduced completely on that one (W) side and is | |
| | | | | | | | | | | | now lop-sided. In addition a small roadside tree, a Norway | |
| | | | | | | | | | | | maple has been planted against its N side. | |

Tree B from house—showing boundary fences

| CLIENT: Mr. & Mrs. David MacWilliams | | | | | | | Crown Radius | | | | Inspectors: P. Collis | Date: |
|---|---|---|---|---|---|---|---|---|---|---|---|---|
| | | | | | | | | | | | It would be reasonable to remove it completely and there now is | |
| | | | | | | | | | | | no sensible room for a replacement. | |

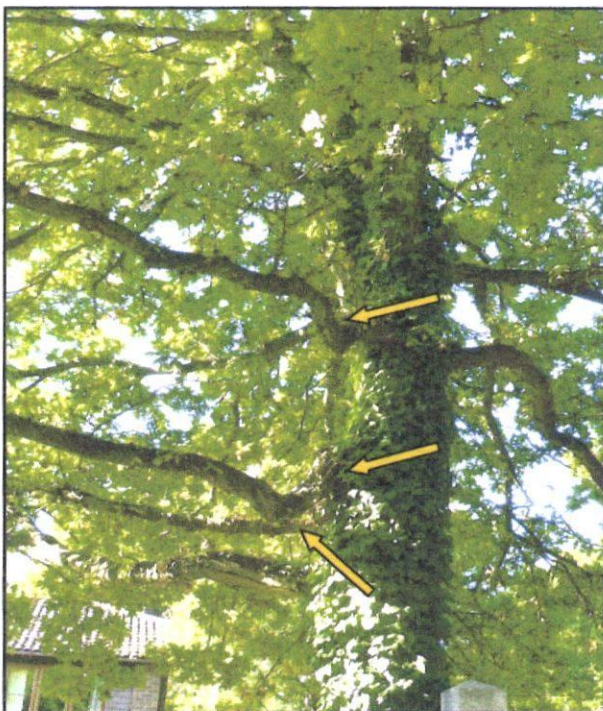
| CLIENT: Mr. & Mrs. David MacWilliams | | | | | | | Crown Radius | | | | Inspectors: P. Collis | Date: |
|---|---|---|---|---|---|---|---|---|---|---|---|---|
| X | √ | English oak | M | A | 13(e) | 70(e) | 6.0 | 6.0 | 6.0 | 6.0 | The larger tree of two linked crowns and a good landscape | |
| | | | | | | | | | | | feature. Has a symmetrical crown and is, luckily, far enough | |
| | | | | | | | | | | | removed from the house (No.6). However, crown casts heavy | |
| | | | | | | | | | | | shade in the afternoon on the garden of No.7. This shading | |

Detail of stem 'X'  
showing branches (arrowed) for removal

| CLIENT: Mr. & Mrs. David MacWilliams | | | | | | | Crown Radius | | | | Inspectors: P. Collis | Date: |
|---|---|---|---|---|---|---|---|---|---|---|---|---|
| | | | | | | | | | | | could be alleviated by a small crown thinning operation: | |
| | | | | | | | | | | | - removing just three lower branches on the South side. | |

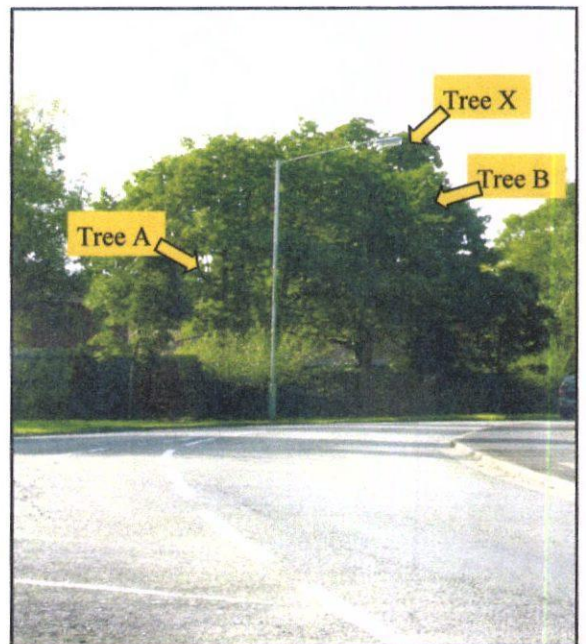
View (SW) from Tempest Avenue showing  
crowns (arrowed) of 7 Broadmeadows Lane trees

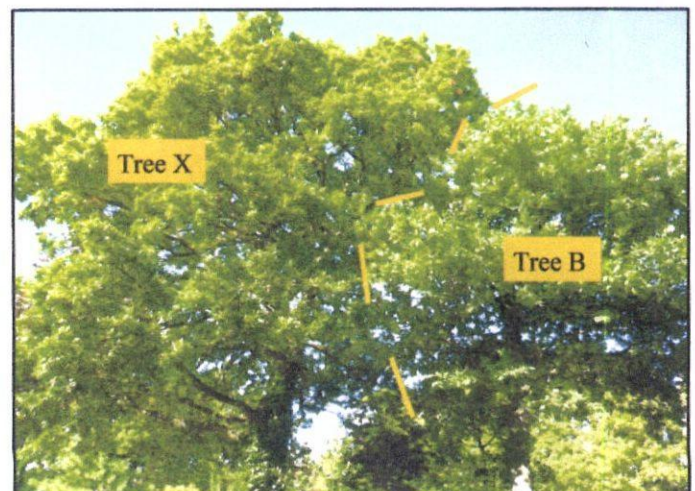
View (NW) from frontage  
of Broadmeadows Lane—  
showing relative sizes of  
crowns 'B' & 'X'
