# Arboricultural Consultancy for HBOS

| <b>Insured</b> | Mrs C Watson | <b>Address</b> | 31 Hollybank Road, Emsworth, West Sussex, PO10 7UE | | |
| <b>Client</b> | Lloyds Banking Group | <b>Contact</b> | David Elliot | <b>Claim No.</b> | 101431391 |

**31 Hollybank Road, W. Sussex, PO10 7UE**

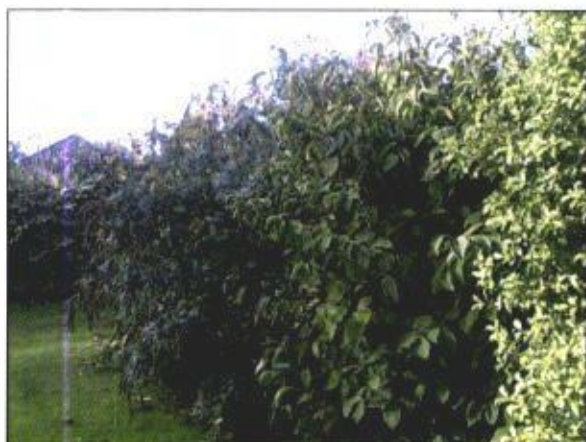
SG1 Mixed

In order to mitigate the current damage and allow soils beneath the property to recover to a position such that an effective engineering repair solution can be implemented we recommended that T2 (Oak) and TG1 (Oak) are removed. Shrubs within 4m of the rear conservatory within SG1 should be removed to eliminate them as a causal factor.

| Tree No. | Species | Age Cat | Approx. Height (m) | Distance to Building (m) | Ownership | Action | Requirement |
|---|---|---|---|---|---|---|---|
| SG1 | Mixed species shrubs including; Dogwood, Acer | 1 | 2.6 | 3.4 | C - Insured | Maintain as detailed | Remove to ensure 4m clearance to the rear conservatory. Do not allow remainder to exceed current dimensions. |

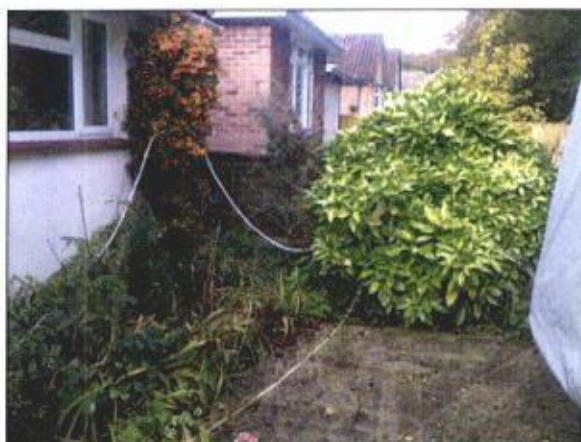
SG2 Mixed

| Tree No. | Species | Age Cat | Approx. Height (m) | Distance to Building (m) | Ownership | Action | Requirement |
|---|---|---|---|---|---|---|---|
| SG2 | Mixed species shrubs Group including; Laurel and Pyracantha. | 1 | 2.3 | 3.4 | C - Insured | Action to avoid future risk | Do not allow to exceed current dimensions. |

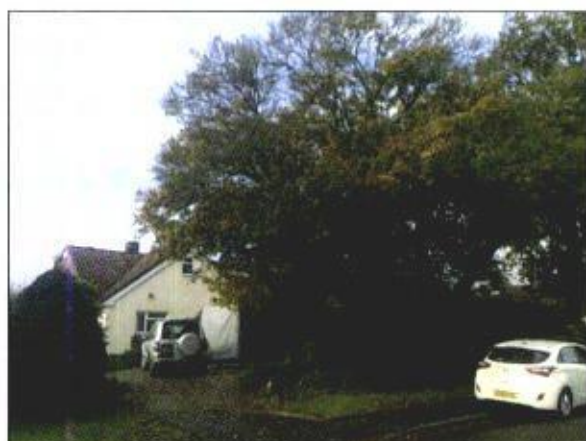
T1 Field Maple

| Tree No. | Species | Age Cat | Approx. Height (m) | Distance to Building (m) | Ownership | Action | Requirement |
|---|---|---|---|---|---|---|---|
| T1 | Maple (Field) | 3 | 10.5 | 16.5 | E - Boundary Veg (ownership to be confirmed) | Action to avoid future risk | Remove and treat stump to inhibit regrowth subject to heave assessment. |

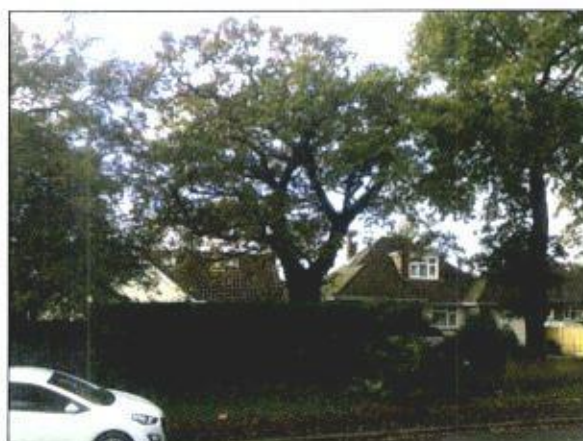
T2 Oak

In assessing the potential drying influence of the vegetation on site, T2 (Oak) and TG1 (Oak) are considered the dominant feature and accordingly we have identified them as the principal cause of subsidence.

| Tree No. | Species | Age Cat | Approx. Height (m) | Distance to Building (m) | Ownership | Action | Requirement |
|---|---|---|---|---|---|---|---|
| T2 | Oak | 3 | 10 | 13.8 | C - Insured | Remove | Remove subject to heave assessment. |

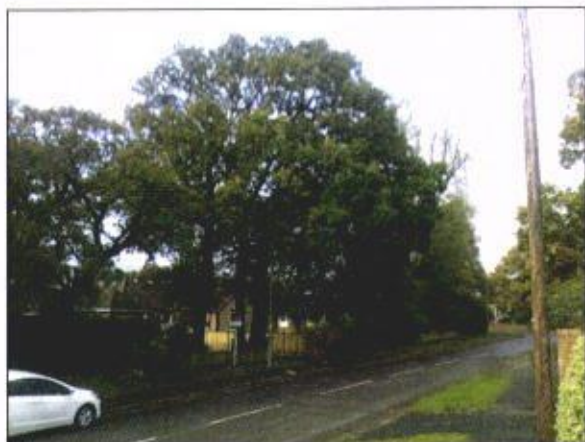
TG1 Oak x2

| Tree No. | Species | Age Cat | Approx. Height (m) | Distance to Building (m) | Ownership | Action | Requirement |
|---|---|---|---|---|---|---|---|
| TG1 | Oak | 3 | 16.8 | 15.1 | A - Third Party<br>33 Hollybank Road,<br>Emsworth, West<br>Sussex, PO10 7UE | Remove | Remove the closest Oak subject to heave assessment. Do not allow remainder to exceed current dimensions. |

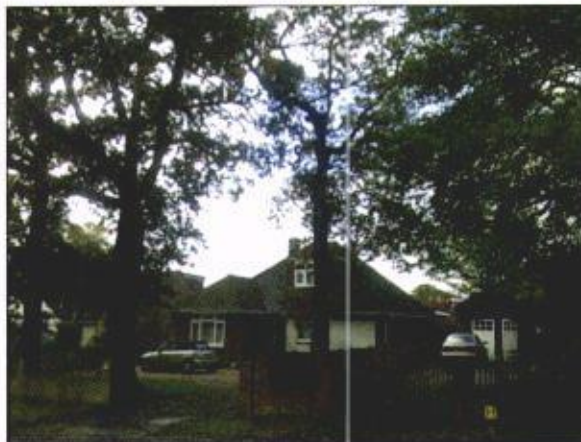
T3 Oak

| Tree No. | Species | Age Cat | Approx. Height (m) | Distance to Building (m) | Ownership | Action | Requirement |
|---|---|---|---|---|---|---|---|
| T3 | Oak | 2 | 11.5 | 17.5 | E - Boundary Veg (ownership to be confirmed) | Action to avoid future risk | Do not allow to exceed current dimensions. |

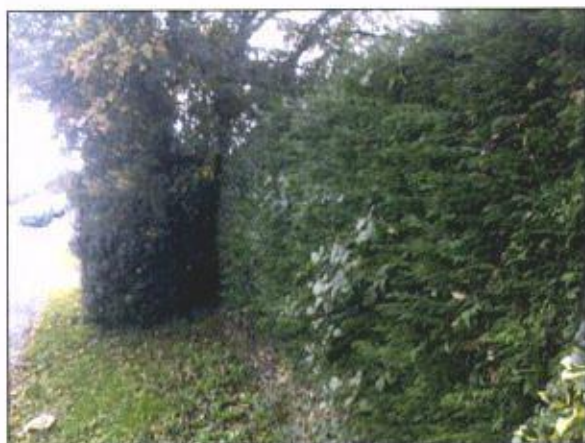
H1 Cypress

| Tree No. | Species | Age Cat | Approx. Height (m) | Distance to Building (m) | Ownership | Action | Requirement |
|---|---|---|---|---|---|---|---|
| H1 | Cypress | 1 | 2.4 | 12.4 | E - Boundary Veg (ownership to be confirmed) | Action to avoid future risk | Do not allow to exceed current dimensions. |

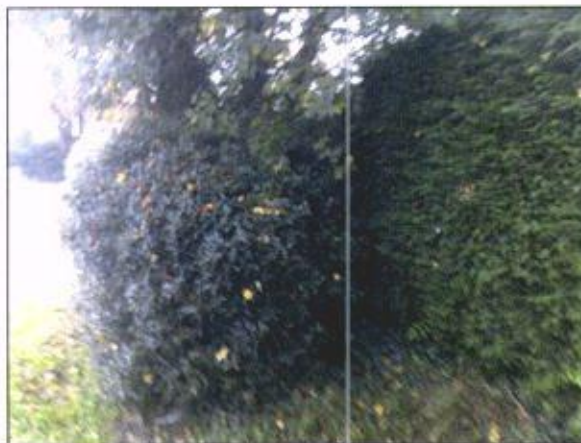
S1 Holly

| Tree No. | Species | Age Cat | Approx. Height (m) | Distance to Building (m) | Ownership | Action | Requirement |
|---|---|---|---|---|---|---|---|
| S1 | Holly | 1 | 2 | 13.6 | E - Boundary Veg (ownership to be confirmed) | No Action | No works. |
