# Arboricultural Consultancy for Groupama

| <b>Insured</b> | Mr & Mrs Gruchy | <b>Address</b> | 5 Hitherwood Close, Waterloooville, PO7 8SA | | |
| <b>Report Date</b> | 09/05/2011 | | | | |

**Scope of Report:** To survey the property and determine significant vegetation contributing to subsidence damage, make recommendation for remedial action, initiate mitigation action and assess recovery prospects. The survey does not make an assessment for decay or hazard evaluation.

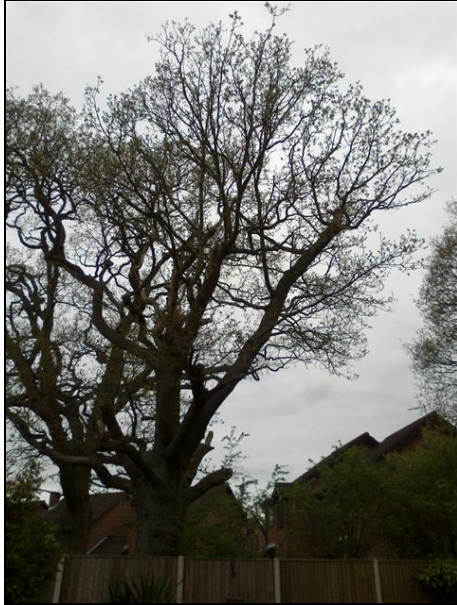
T9 - Oak

Based on our site inspection and investigations undertaken by engineers, and taking account of vegetation location, relative to the focal area of damage, it is our opinion that T11 (Oak) will be exerting the principal vegetative influence to the rear extension. It is also our opinion that T9 (Oak), T12 (Willow (Contorted)) and TG2 (Mixed Species Group) are considered to be contributory factors in the damage.

| T9 | Oak | 3 | 10 | 9.5 | D - Unknown | Remove | Remove subject to heave assessment. |
