## Rehydration Channel Feasibility Check Sheet

Address: 22 Oakmont Drive, Waterlooville, Hampshire, PO8 8TH

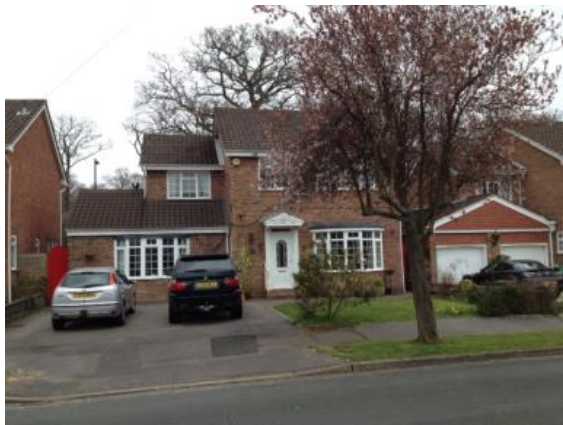
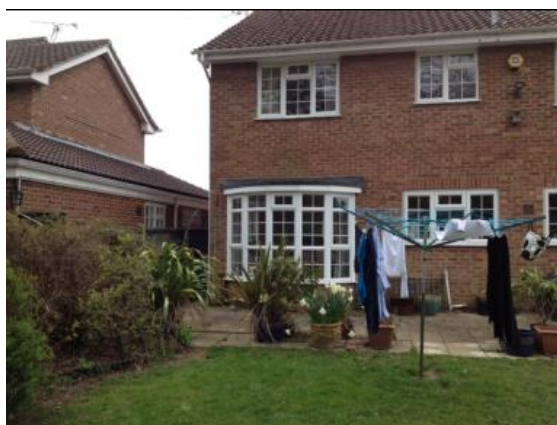
In August 2011 InFront-Innovation were instructed by Direct Line Group to take over the running of any existing claim which had been managed from inception by previous engineers who on this occasion were Riley Larkin Ltd Consulting Engineers and Surveyors. Various investigations have been undertaken and the cause identified as tree root induced clay shrinkage from the Oak Tree (T1) to the rear of the property currently protected by a tree preservation order.

An application (APP/12/00460 November 2012) and appeal (APP/TPO/X1735/3008) to remove the oak tree have been refused. The tree continues to cause differential movement to the foundations of the property.

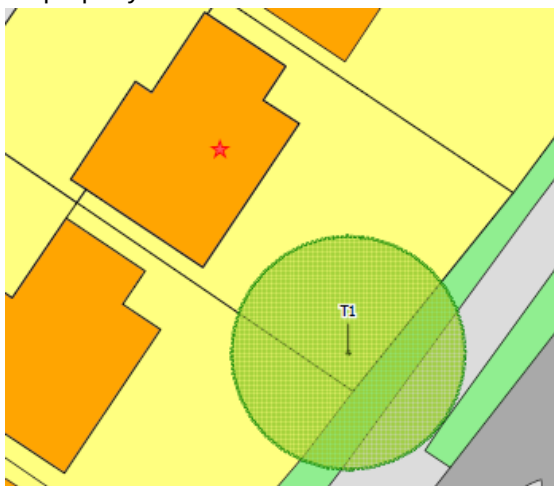
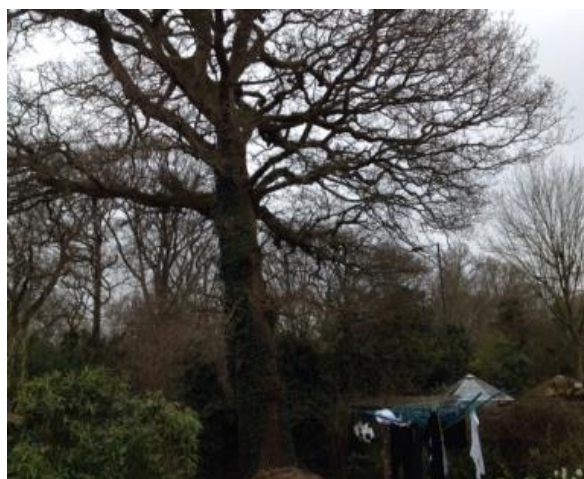
Category of damage Cat 1-5 **2**  
(in accordance with table 1 BRE digest 251)

Cracking around windows and wall junctions internally to the kitchen and left hand dining room area. Cracking and separation external of ground floor bay window and surrounding brickwork
