Tree Report  
29<sup>th</sup> August 2013

12 Bacon Lane  
Hayling Island  
PO11 0DN

- 1.1 **Brief:** to inspect two Mature Sycamore trees in the front left hand side of 12 Bacon Lane for Mr Andy Henderson.
- 1.2 Trees inspected by Mr. Kim Gifford Arboricultural Consultant on 22<sup>nd</sup> August 2013 in good weather conditions.

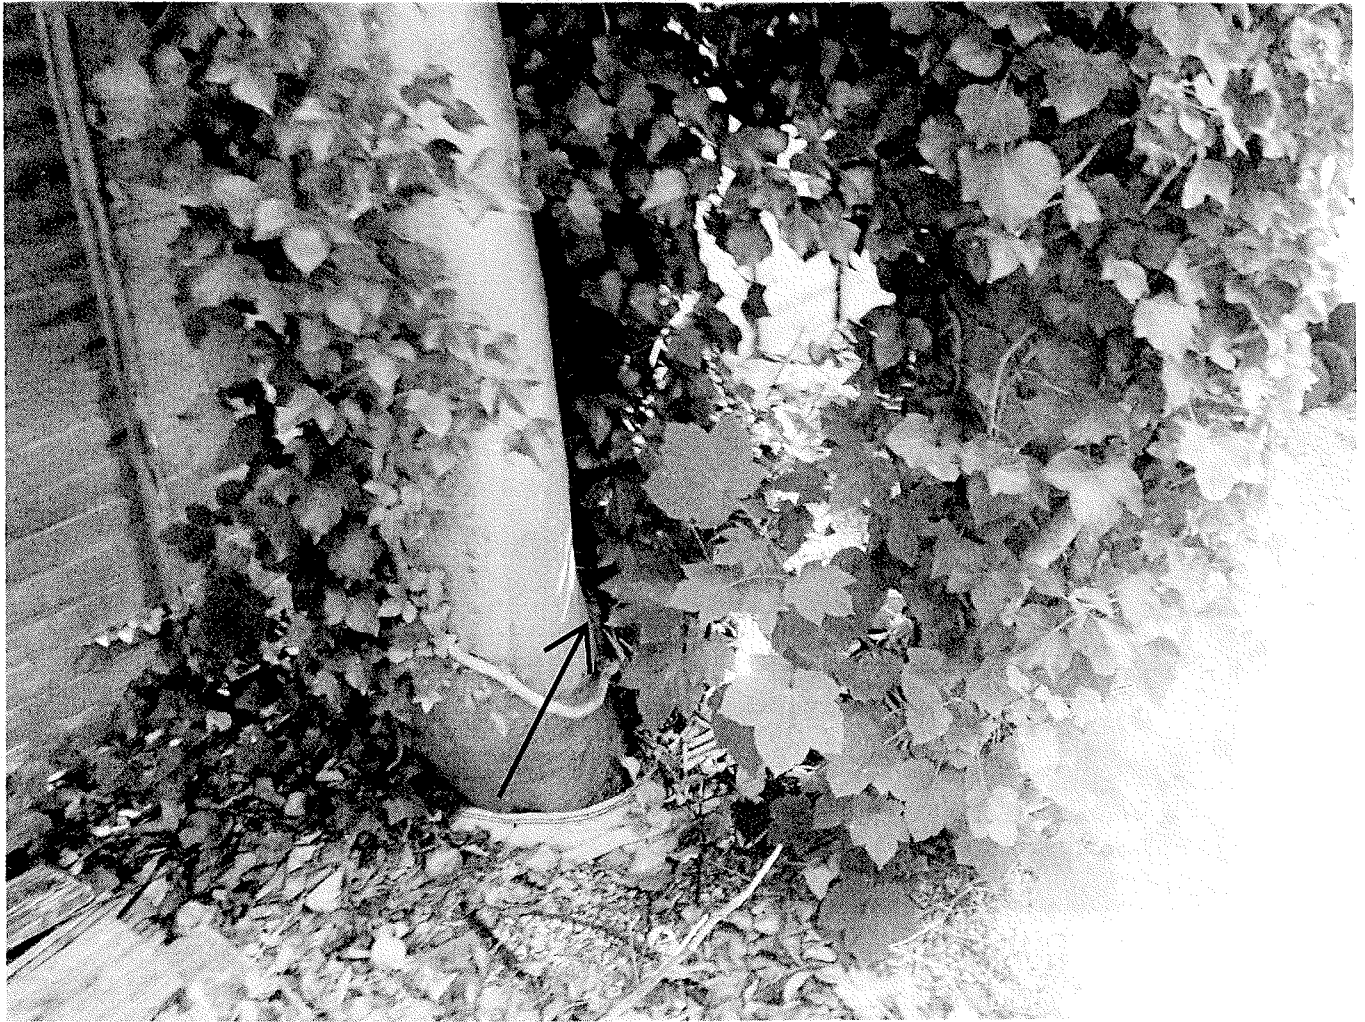
- 1.7 Both Sycamores T1 and T2 main stems have grown with tight forks, included bark these features are a recognised structural Arboricultural inherent defects (see photographs below)

T1 Sycamore tree 3 stems. One separate stem and one twin stem by fence with tight fork and included bark.

- 1.9 **Recommendation: Remove both Sycamores T1 and T2.**

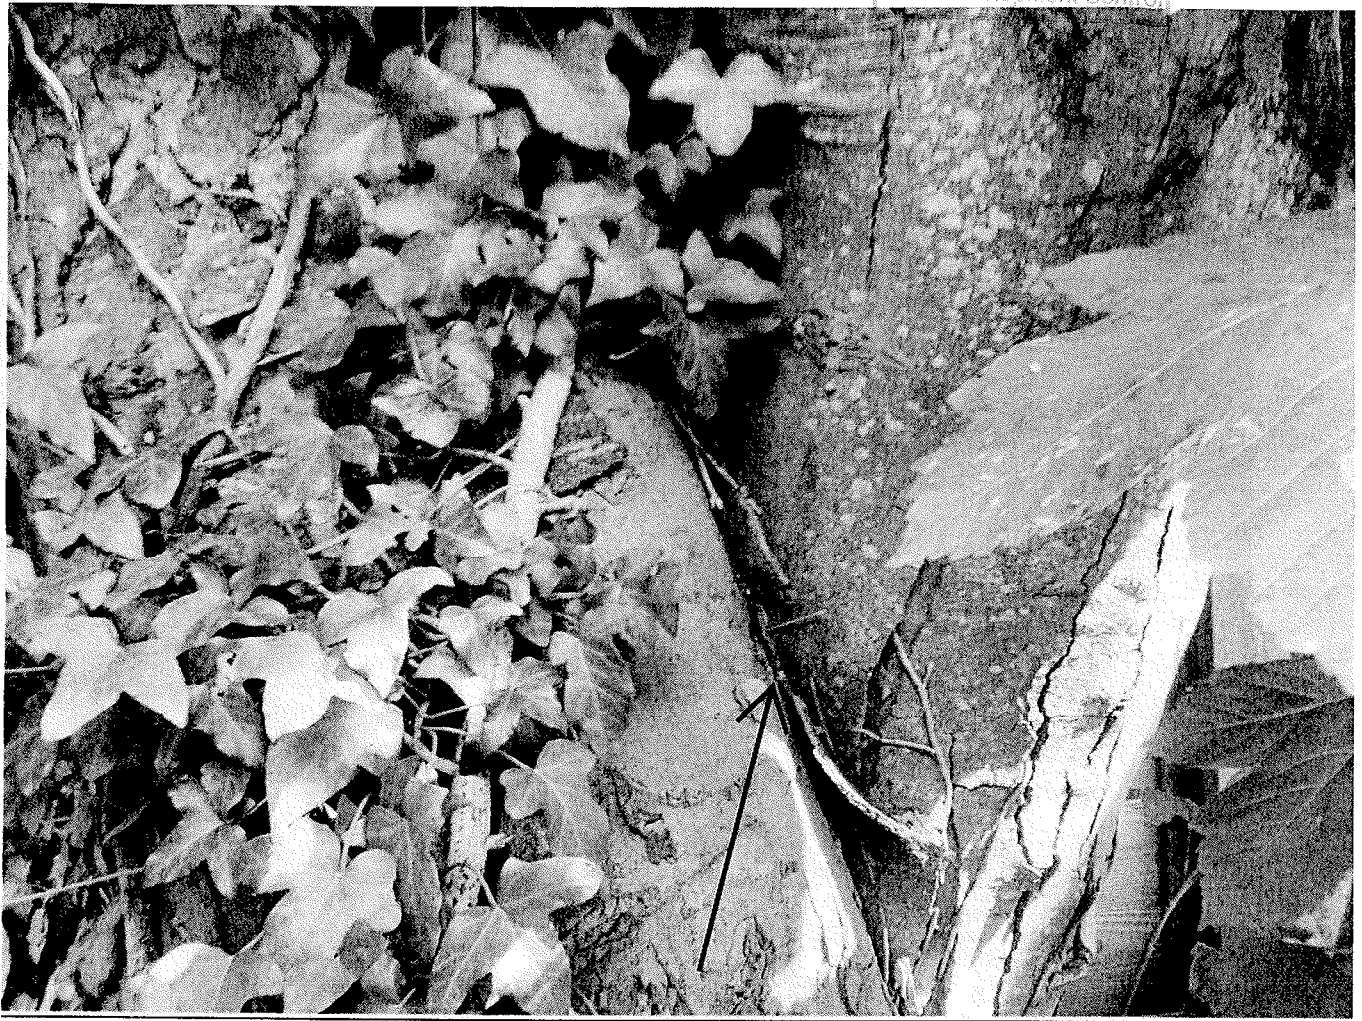
T2 Sycamore with tight fork and included bark defect.

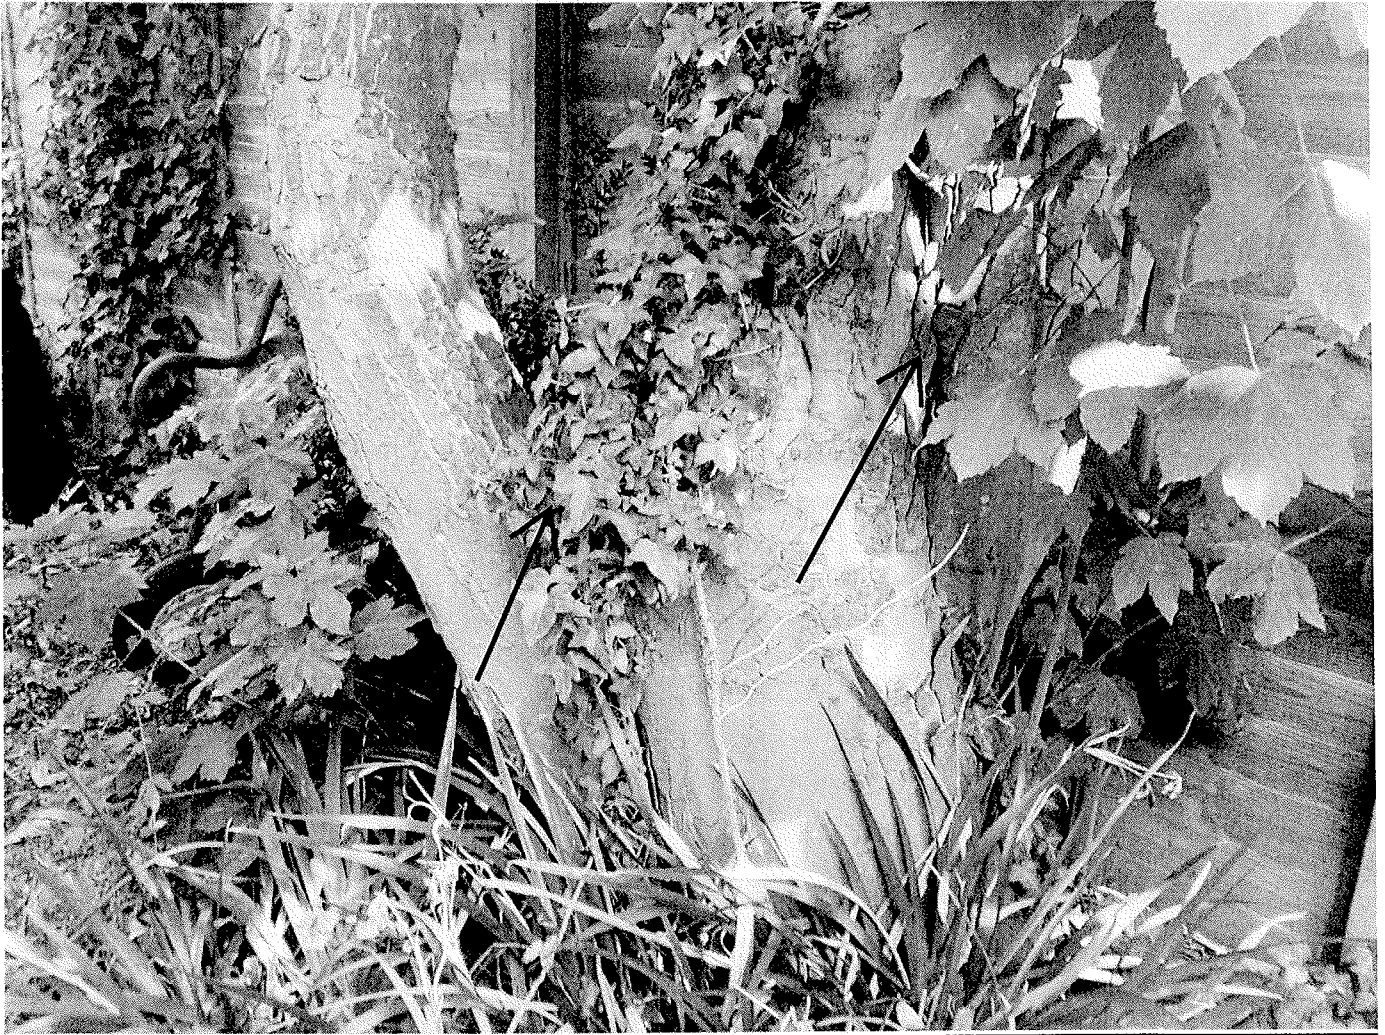
T2 Sycamore stems close the fence with tight forks and included bark.
