# Arboricultural Consultancy for HBOS

| <b>Insured</b> | Mrs C Watson | <b>Address</b> | 31 Hollybank Road, Emsworth, West Sussex, PO10 7UE | | |
| <b>Client</b> | Lloyds Banking Group | <b>Contact</b> | David Elliot | <b>Claim No.</b> | 101431391 |
| <b>Report Date</b> | 22/11/2013 | | | | |

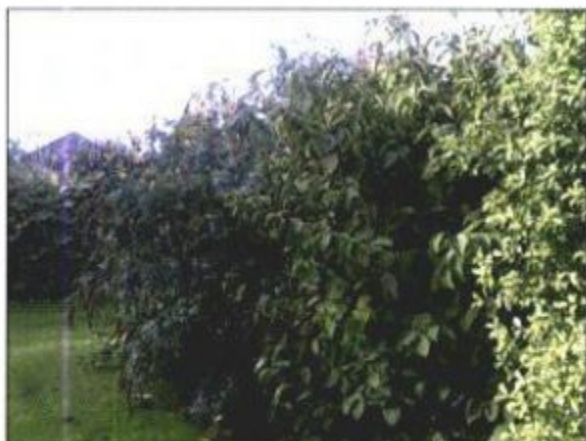
SG1 Mixed

| Tree No. | Species | Age Cat | Approx. Height (m) | Distance to Building (m) | Ownership | Action | Requirement |
|---|---|---|---|---|---|---|---|
| SG1 | Mixed species shrubs including; Dogwood, Acer | 1 | 2.6 | 3.4 | C - Insured | Maintain as detailed | Remove to ensure 4m clearance to the rear conservatory. Do not allow remainder to exceed current dimensions. |

In order to mitigate the current damage and allow soils beneath the property to recover to a position such that an effective engineering repair solution can be implemented we recommended that T2 (Oak) and TG1 (Oak) are removed. Shrubs within 4m of the rear conservatory within SG1 should be removed to eliminate them as a causal factor.

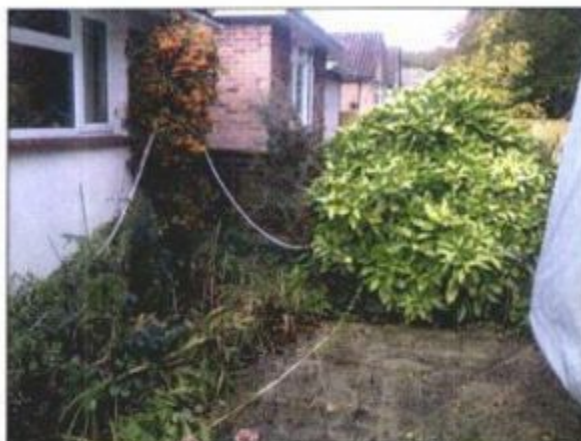
SG2 Mixed

| Tree No. | Species | Age Cat | Approx. Height (m) | Distance to Building (m) | Ownership | Action | Requirement |
|---|---|---|---|---|---|---|---|
| SG2 | Mixed species shrubs Group including; Laurel and Pyracantha | 1 | 2.3 | 3.4 | C - Insured | Action to avoid future risk | Do not allow to exceed current dimensions. |

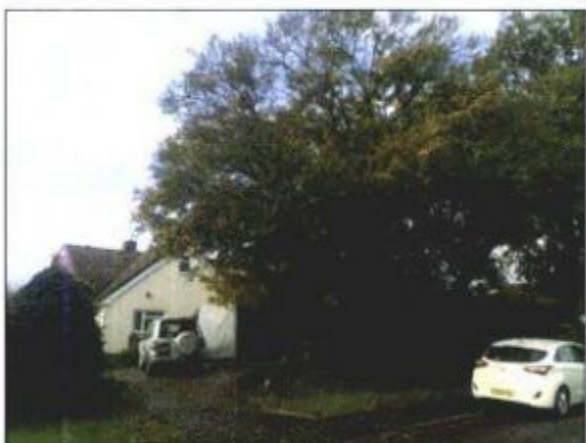
T1 Field Maple

| Tree No. | Species | Age Cat | Approx. Height (m) | Distance to Building (m) | Ownership | Action | Requirement |
|---|---|---|---|---|---|---|---|
| T1 | Maple (Field) | 3 | 10.5 | 16.5 | E - Boundary Veg (ownership to be confirmed) | Action to avoid future risk | Remove and treat stump to inhibit regrowth subject to heave assessment. |

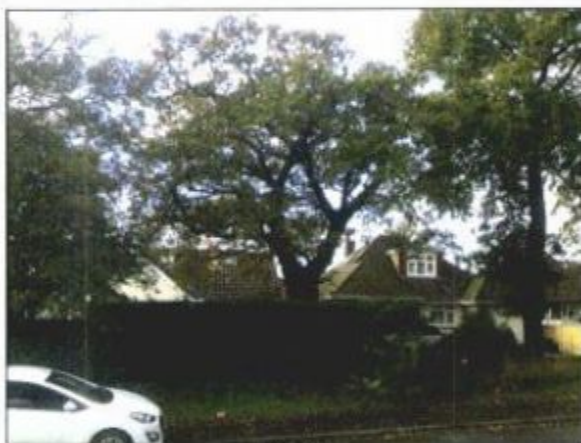
T2 Oak

In assessing the potential drying influence of the vegetation on site, T2 (Oak) and TG1 (Oak) are considered the dominant feature and accordingly we have identified them as the principal cause of subsidence.

| Tree No. | Species | Age Cat | Approx. Height (m) | Distance to Building (m) | Ownership | Action | Requirement |
|---|---|---|---|---|---|---|---|
| T2 | Oak | 3 | 10 | 13.8 | C - Insured | Remove | Remove subject to heave assessment. |

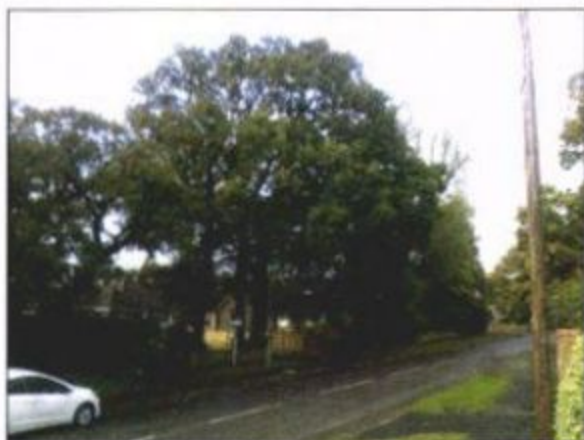
TG1 Oak x2

| Tree No. | Species | Age Cat | Approx. Height (m) | Distance to Building (m) | Ownership | Action | Requirement |
|---|---|---|---|---|---|---|---|
| TG1 | Oak | 3 | 16.8 | 15.1 | A - Third Party<br>33 Hollybank Road,<br>Emsworth, West<br>Sussex, PO10 7UE | Remove | Remove the closest Oak subject to heave assessment. Do not allow remainder to exceed current dimensions. |

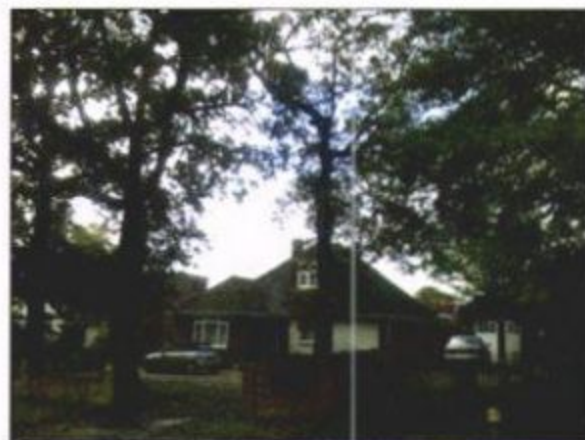
T3 Oak

| Tree No. | Species | Age Cat | Approx. Height (m) | Distance to Building (m) | Ownership | Action | Requirement |
|---|---|---|---|---|---|---|---|
| T3 | Oak | 2 | 11.5 | 17.5 | E - Boundary Veg (ownership to be confirmed) | Action to avoid future risk | Do not allow to exceed current dimensions. |

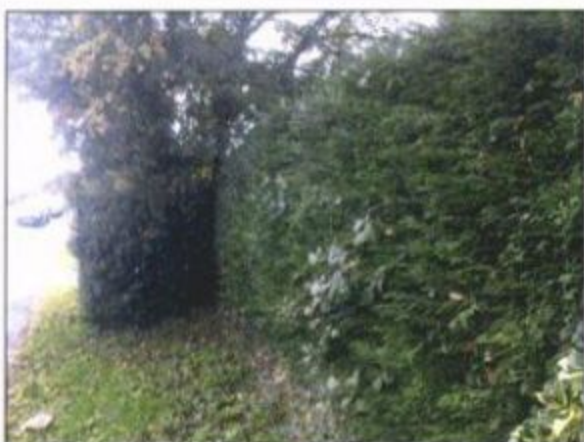
H1 Cypress

| Tree No. | Species | Age Cat | Approx. Height (m) | Distance to Building (m) | Ownership | Action | Requirement |
|---|---|---|---|---|---|---|---|
| H1 | Cypress | 1 | 2.4 | 12.4 | E - Boundary Veg (ownership to be confirmed) | Action to avoid future risk | Do not allow to exceed current dimensions. |

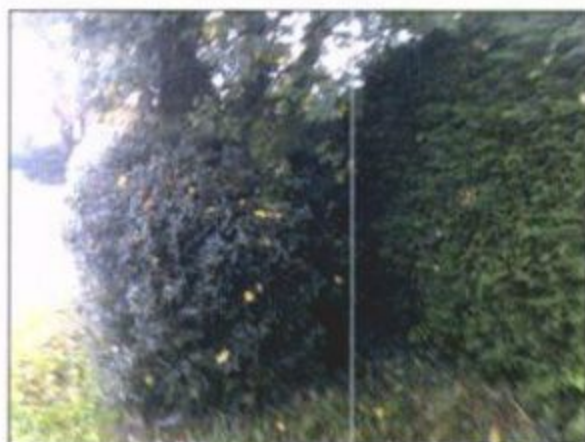
S1 Holly

| Tree No. | Species | Age Cat | Approx. Height (m) | Distance to Building (m) | Ownership | Action | Requirement |
|---|---|---|---|---|---|---|---|
| S1 | Holly | 1 | 2 | 13.6 | E - Boundary Veg (ownership to be confirmed) | No Action | No works. |
