**Boundary Wall  
Inspection Report**

**Land at Oaktree Drive  
Emsworth**

**Prepared for  
Banner Homes  
by  
Stuart Michael  
Associates Limited**

**April 2014**

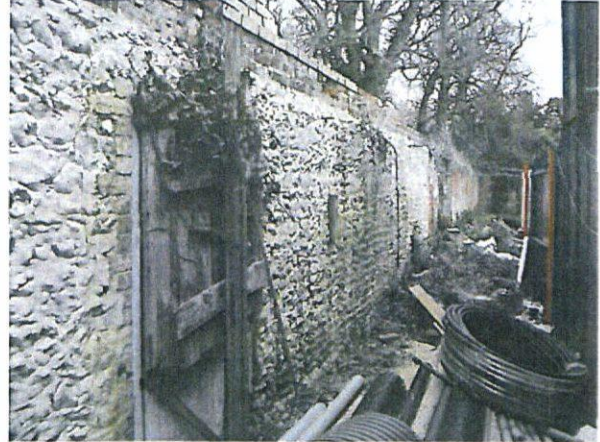
**Photograph No. ( 2 )**

- 3.3 There is an existing timber door through the middle section of the wall (refer to photo number 2). There are signs of previous rendering on the middle part of this wall (refer to photo number 9). Open mortar joints, cracks and some local spalling of brickwork were noted along the top section of the wall (refer to photo number 10).

- 4.3 We recommend that Section 2 of the wall is demolished and replaced with a new wall. The depth of the new foundations and the new wall thickness should be designed to suit the proposed levels.

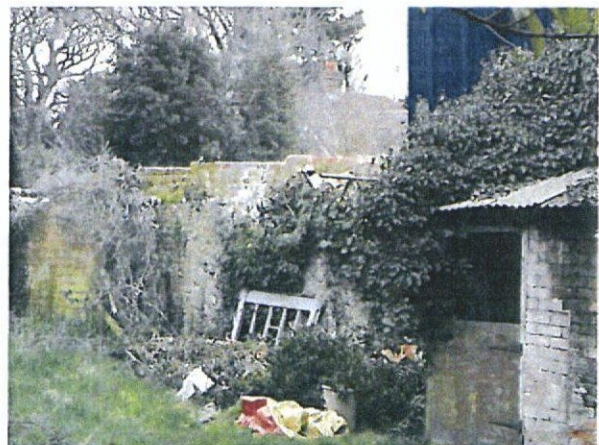
**Photograph No. ( 4 )**

- 3.7 No access was available to inspect the back of the wall. However, photos were taken from the opposite side of the Site showing the back of the wall. The majority of the back of the wall is covered with vegetation (refer to photo number 4).

- 3.4 We recommend that Section 3 of the wall is demolished and replaced by a new wall. The depth of foundations and thickness of the new wall should be designed to suit the proposed levels.

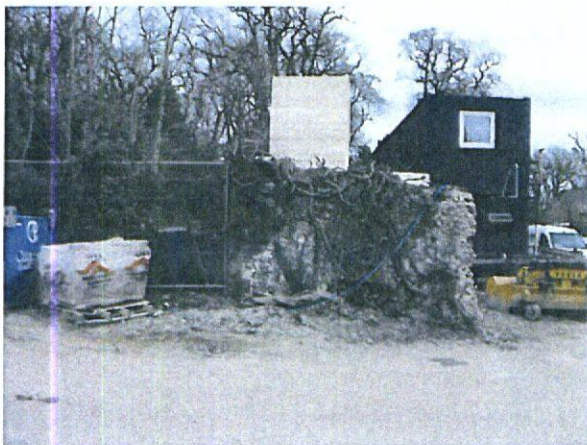
**Photograph No. ( 5 )**

- 3.1 This section of the wall was originally part of a longer wall which was partially demolished to gain access to the Site. The remaining part is about 3 m long by 2 m high. Section 1 forms a return to Section 2 (refer to photo number 5). The wall is constructed of what appears to be two skins of rubble stone with mortared joints separated by a cavity. The overall thickness of the wall is about 300mm thick (refer to photo number 6). This section of wall is overgrown with roots penetrating the joints and cavity.

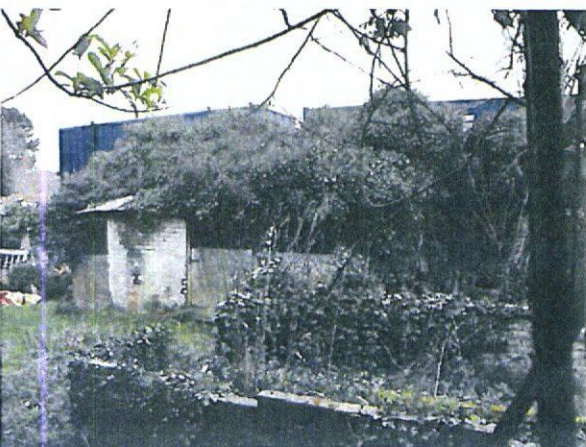
Photograph No. ( 11 )

- 3.4 No access was available to inspect the back of the wall. However, photos were taken from the opposite side of the Site showing the back of the wall. The majority of the back of the wall is covered with vegetation. There is also a small brick built lean-to with metal sheet roof at the back of the wall (refer to photo number 11).

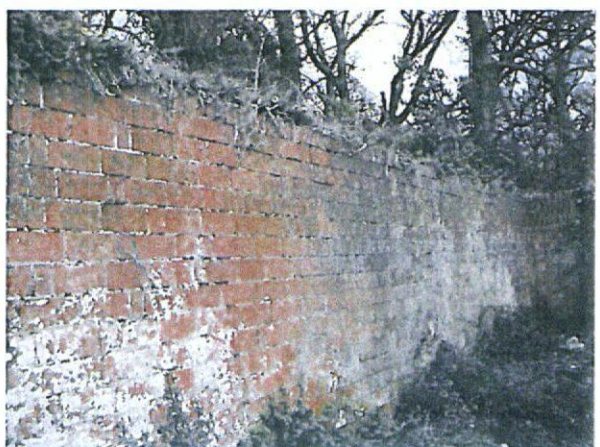
Photograph No. ( 12 )

- 3.5 This section of existing wall is about 20 m long by 2.2 m height. The wall is constructed of brickwork. The wall is constructed using Flemish garden wall bond. (1 no. header to 3 no. stretchers in each course). Refer to photo numbers 12 and 14. The wall is constructed with 2 skins of 75 mm brickwork with an 80 mm cavity (refer to photo number 13).

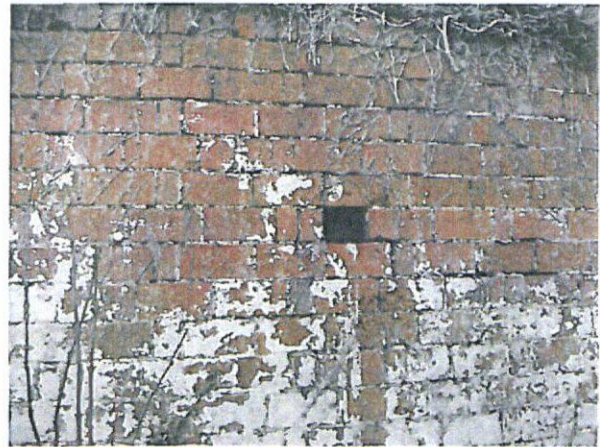
**Photograph No. ( 14 )**

- 3.6 There an existing opening through the wall which is covered with a timber fence panel and vegetation. Open and cracked mortar joints are visible in some areas. In other areas the mortar layers between the bricks has deteriorated completely. Some bricks are loose and some are missing (refer to photo number 14).

- 4.4 The overall condition of the wall is poor. The client would like to retain wall Section 3. . By reviewing the proposed finished ground levels for the site side of the wall against the existing levels on the survey, it appears that the proposed ground levels will be approximately 1 m lower than the existing levels. In this case, the top of the existing wall foundation is likely to be exposed. In a worst case, the proposed ground levels may be lower than the bottom of the existing wall foundation. In both cases, the stability of the existing wall will be compromised as the wall would have to retain the level difference between the front and the back faces.
