# Revisit Report

| Claim address | 22 Oakmont Drive,<br>Waterlooville,<br>Hampshire,<br>PO8 8TH |

## **Subsidence Report**

# PRELIMINARY REPORT

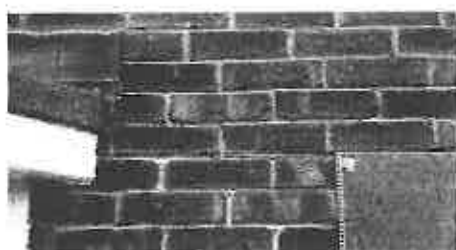
Externally, there is cracking around the rear right hand bay and the right hand corner of the property at high and low level, with cracks up to 5mm. The damage is indicative of a downward movement to the rear right corner of the property.

Crack to side of bay at high level

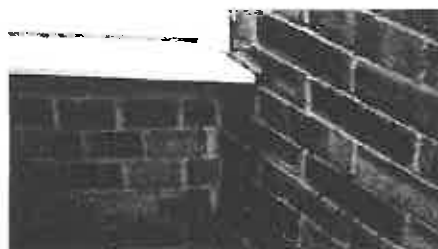
Crack below bay

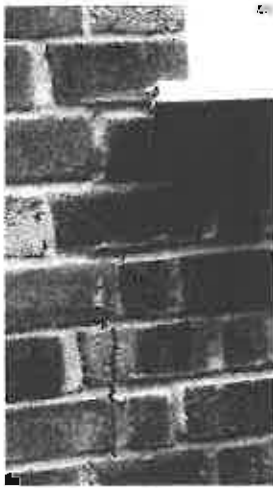
Crack on left hand flank,  
below window

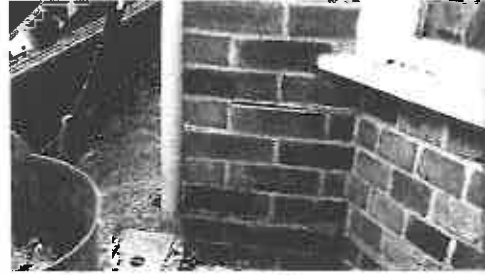
Crack at rear right hand corner

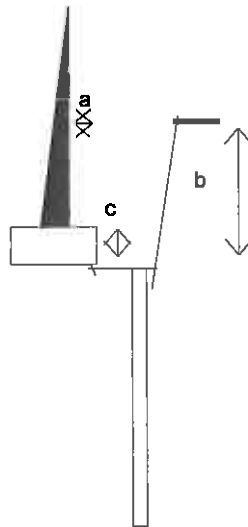
Foundation Details

A trial hole was excavated to expose the foundations. The trial hole revealed a concrete foundation at a depth of 1.1metres.

a = 200mm, b = 1100mm, c = 300mm

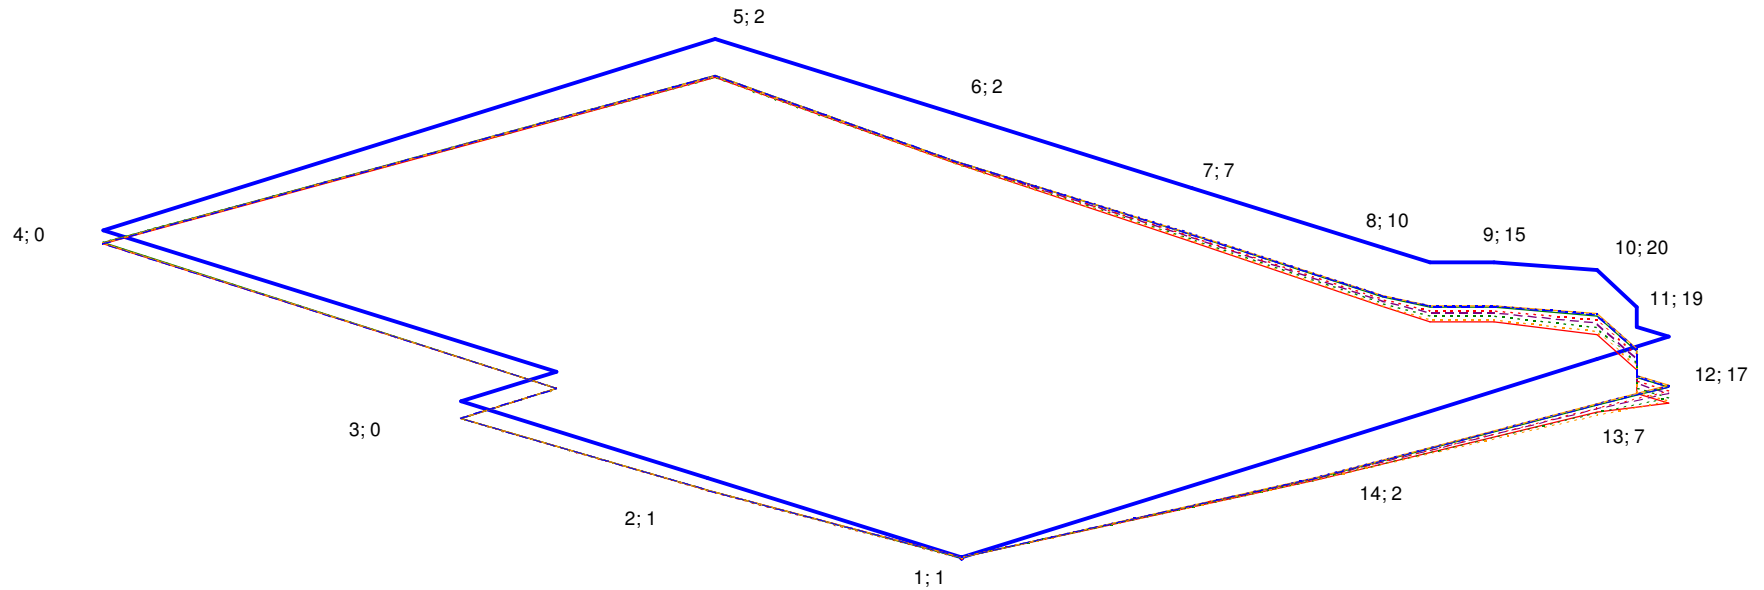
# LEVEL MONITORING - DISTORTION MOVEMENT SKETCH

Crack and level monitoring have been carried out over a period of twelve months and a clear pattern of cyclical movement established with a maximum movement of 22mm being recorded on the rear right hand corner of the building but with almost full recovery at the end of the growing season. If the tree is removed the heave prediction is around 28mm and this is consistent with the level monitoring results to date.
