**FIRST STAGE APPRAISAL**

**86 WEST STREET  
HAVANT  
HAMPSHIRE  
PO9 1LN**

**Job No: 2844**

**Date: 6<sup>th</sup> August 2009**

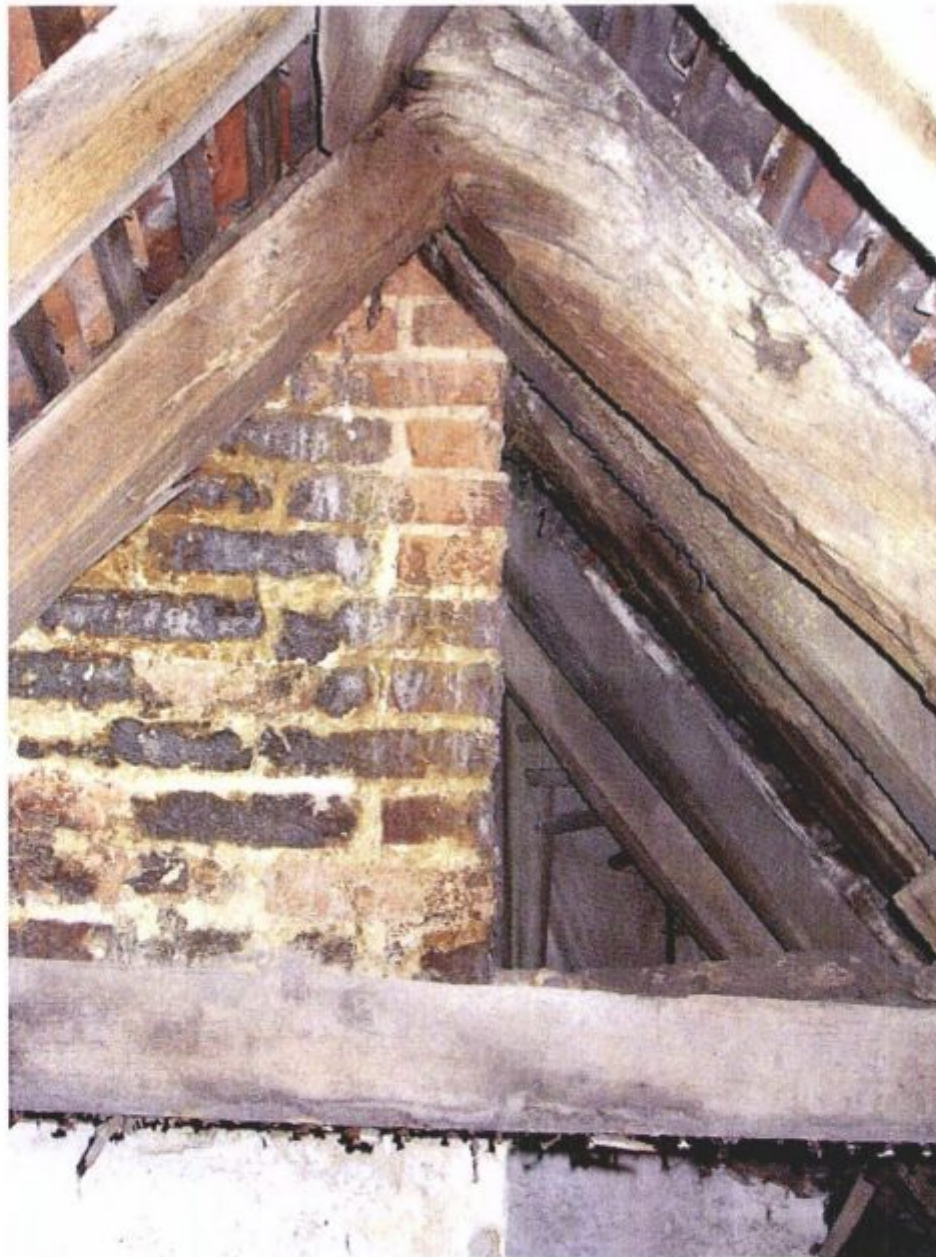
Photo 001 – Ridge at East Chimney Stack.

There is also an old ridge plate over the rafters at the rear pitch at this point (see Photo 001) and the rear rafters are bearing on it.

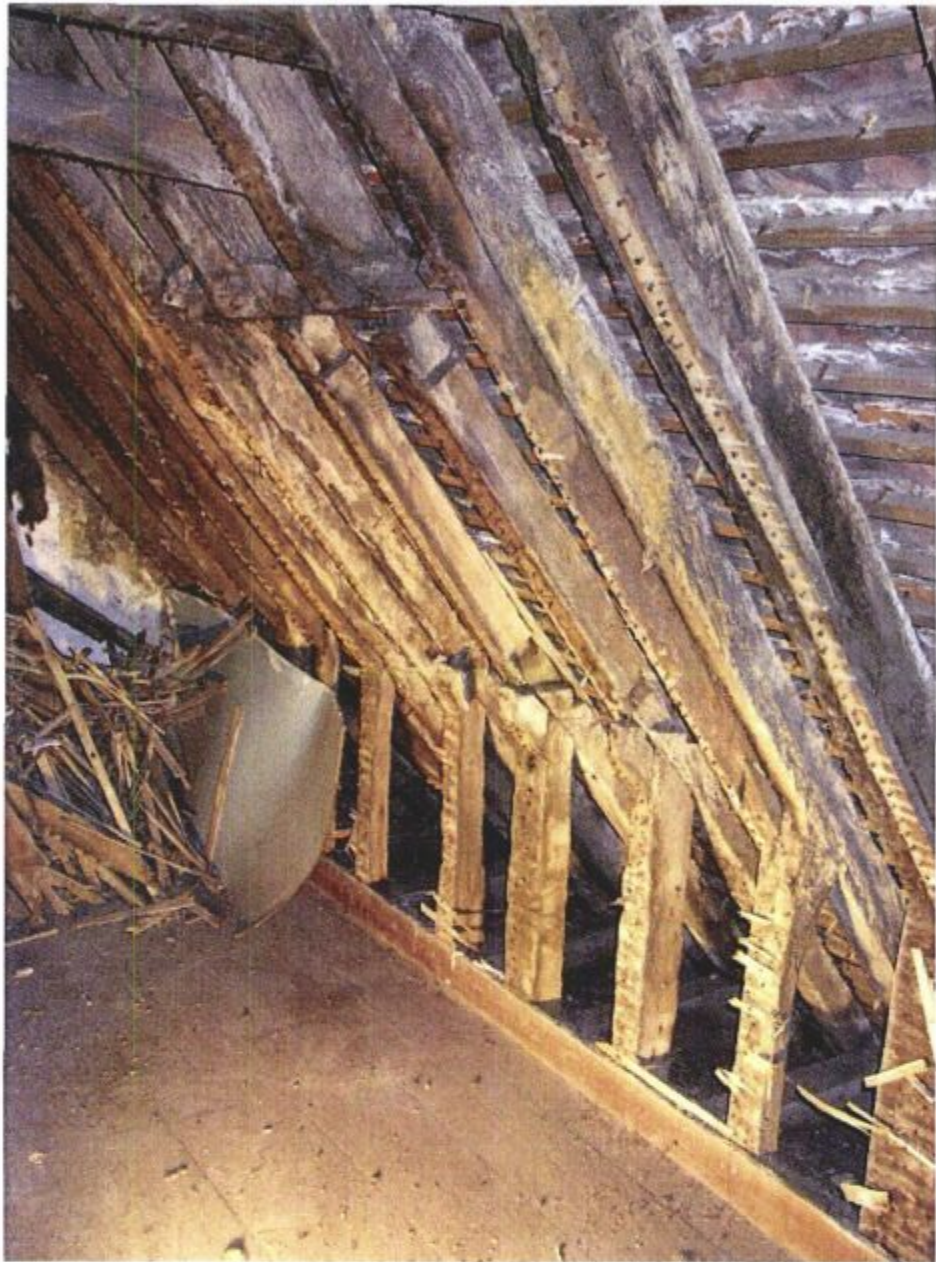
**Photo 003 – Roof Accommodation Area Front Pitch.**

- First 2 No. front rafters to West of stack are in extremely poor condition due to insect infestation and decay.

They have also been “furred out” in the past. (See Photo 003.)

The opening has been infilled with 2 No. loose rafters, which are in poor condition. (See Photo 003.)

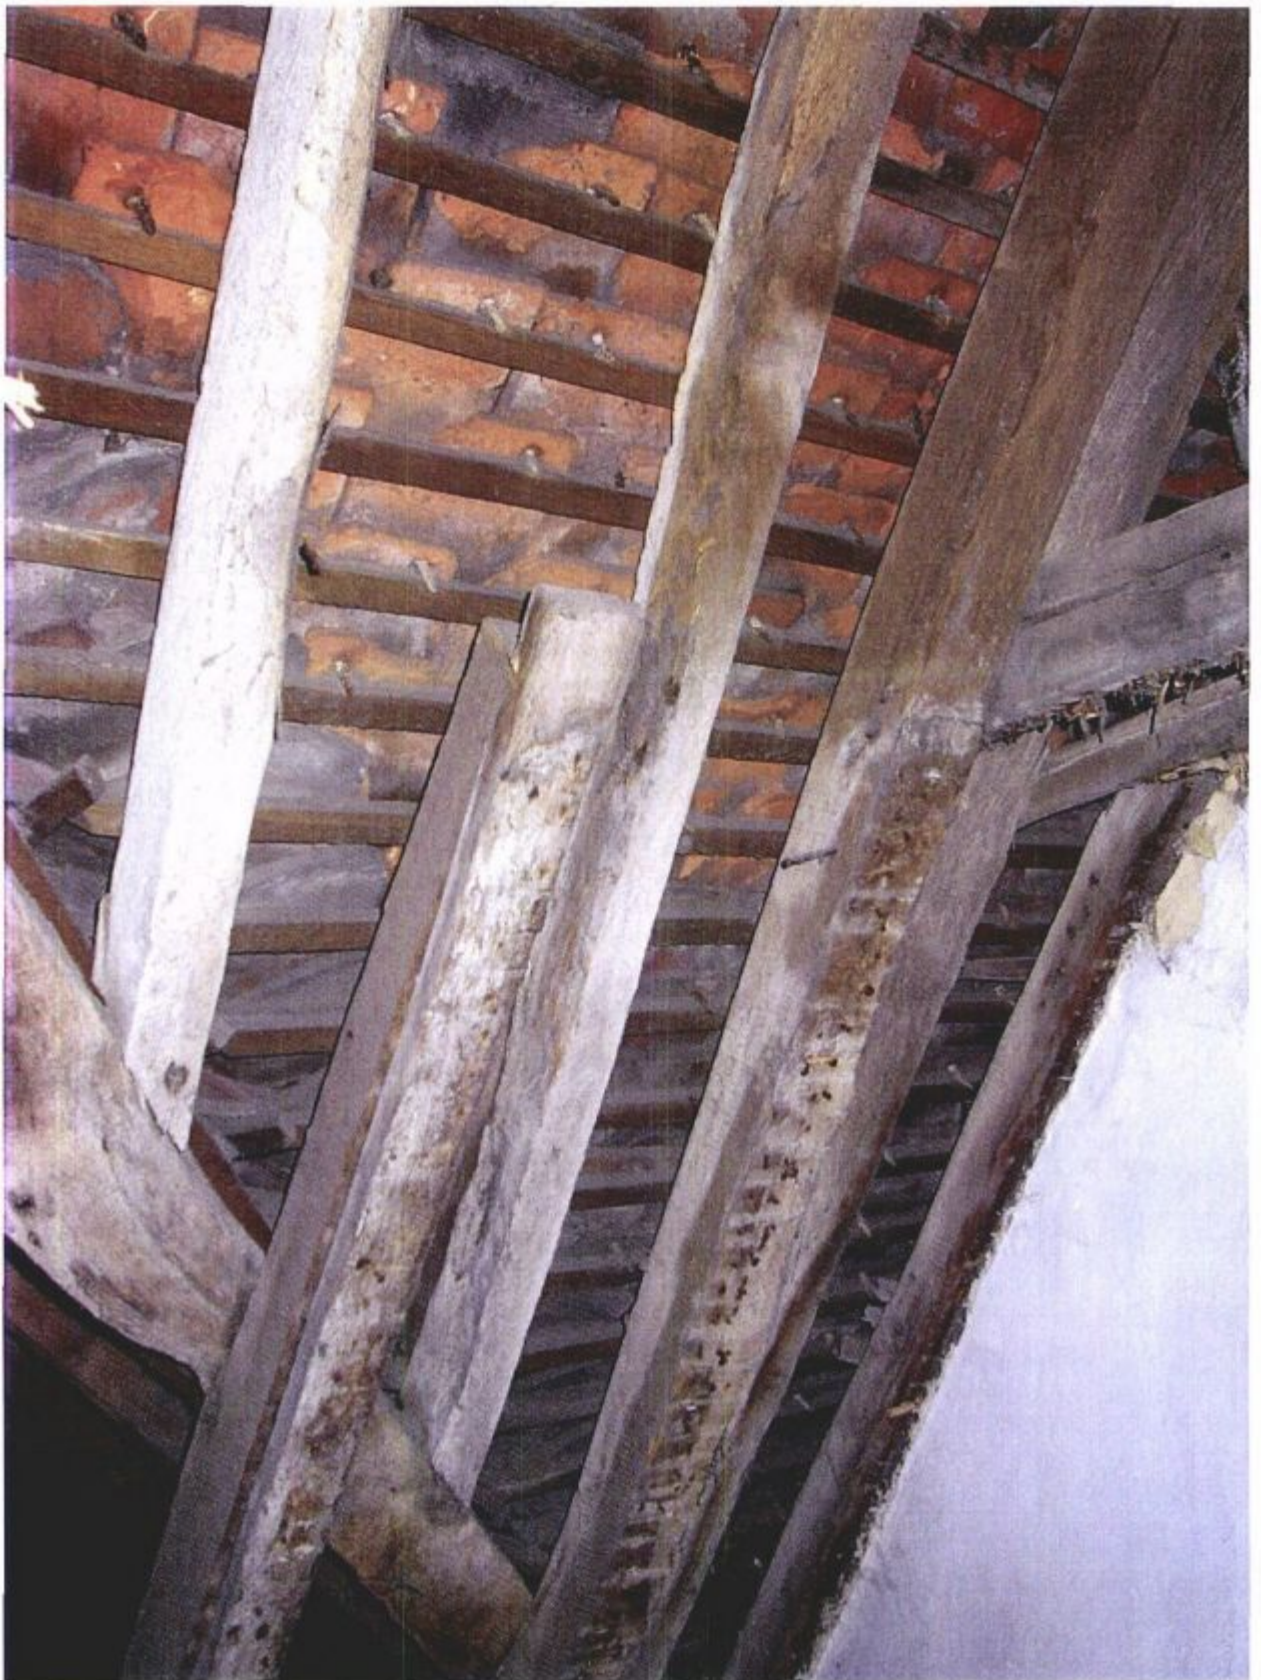
**Photo 004 – Roof Accommodation Area.  
Rear Pitch Northeast Layboard/Beam.**

Many are cut into the lay-board forming the rear valley. (See Photos 004 & 005.)

Most sections are in average to poor condition and several have furrings on their top surface.

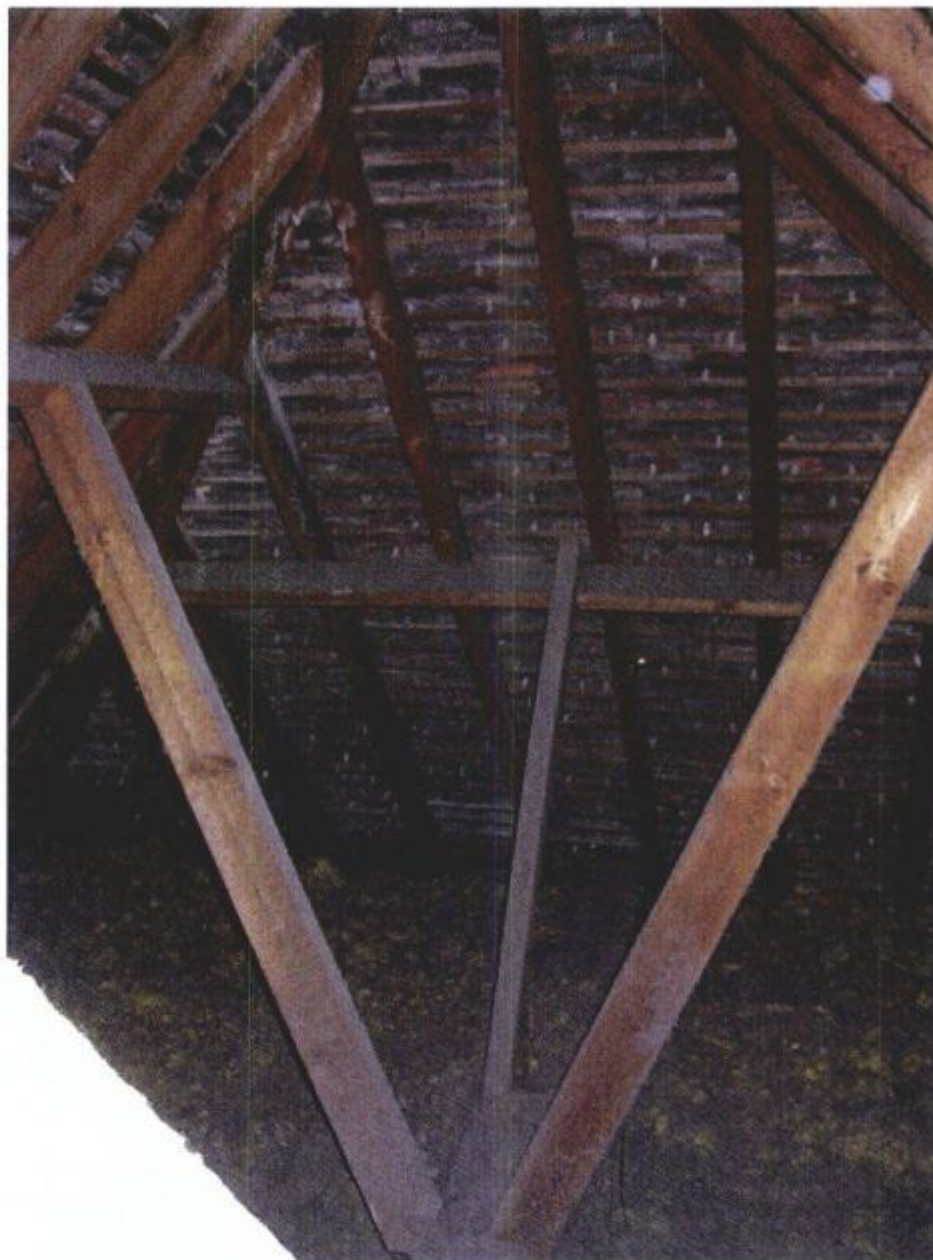
Photo 006 – E-W Roof behind Roof Accommodation Area.

- The roof is pitched East/West with a hipped end to the North. (See Photo 006.)

This roof has been totally replaced above ceiling joist level with softwood rafters over purlins at approx mid-pitch (see Photo 006).

These purlins have been struttled diagonally down onto the centre of the ceiling to what is considered to be a large timber carriage beam spanning North/South.

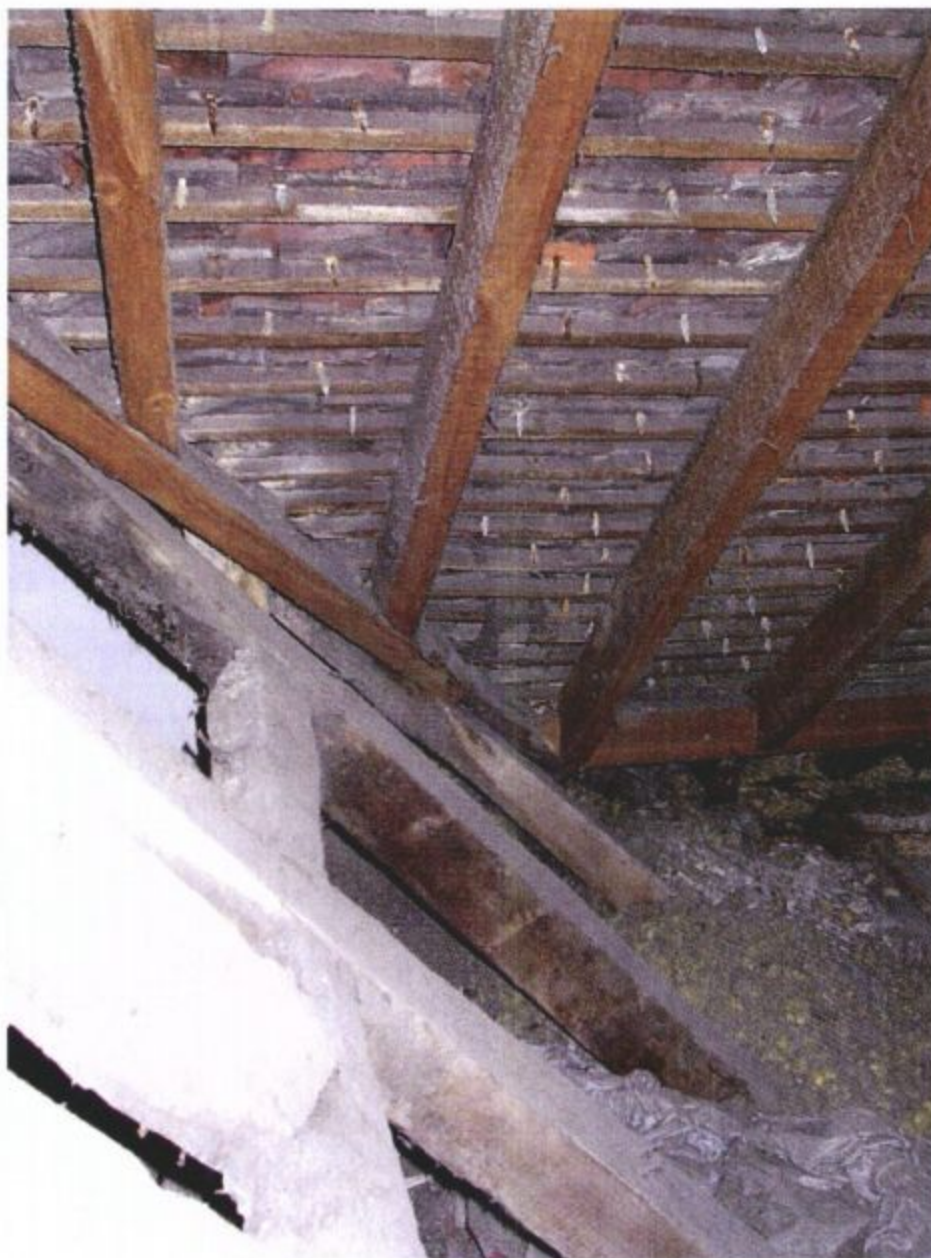
**Photo 007 – Rear West Pitch behind Roof Accommodation Area.**

The original ceiling joists are not readily visible due to the volume of insulation, but are believed to span East/West. (See Photo 007.)

**NB:-** The rafters are springing from a new timber plate bearing on the ceiling joists from the adjacent pitch to the West.

The roof is therefore not tied/restrained at eaves level.

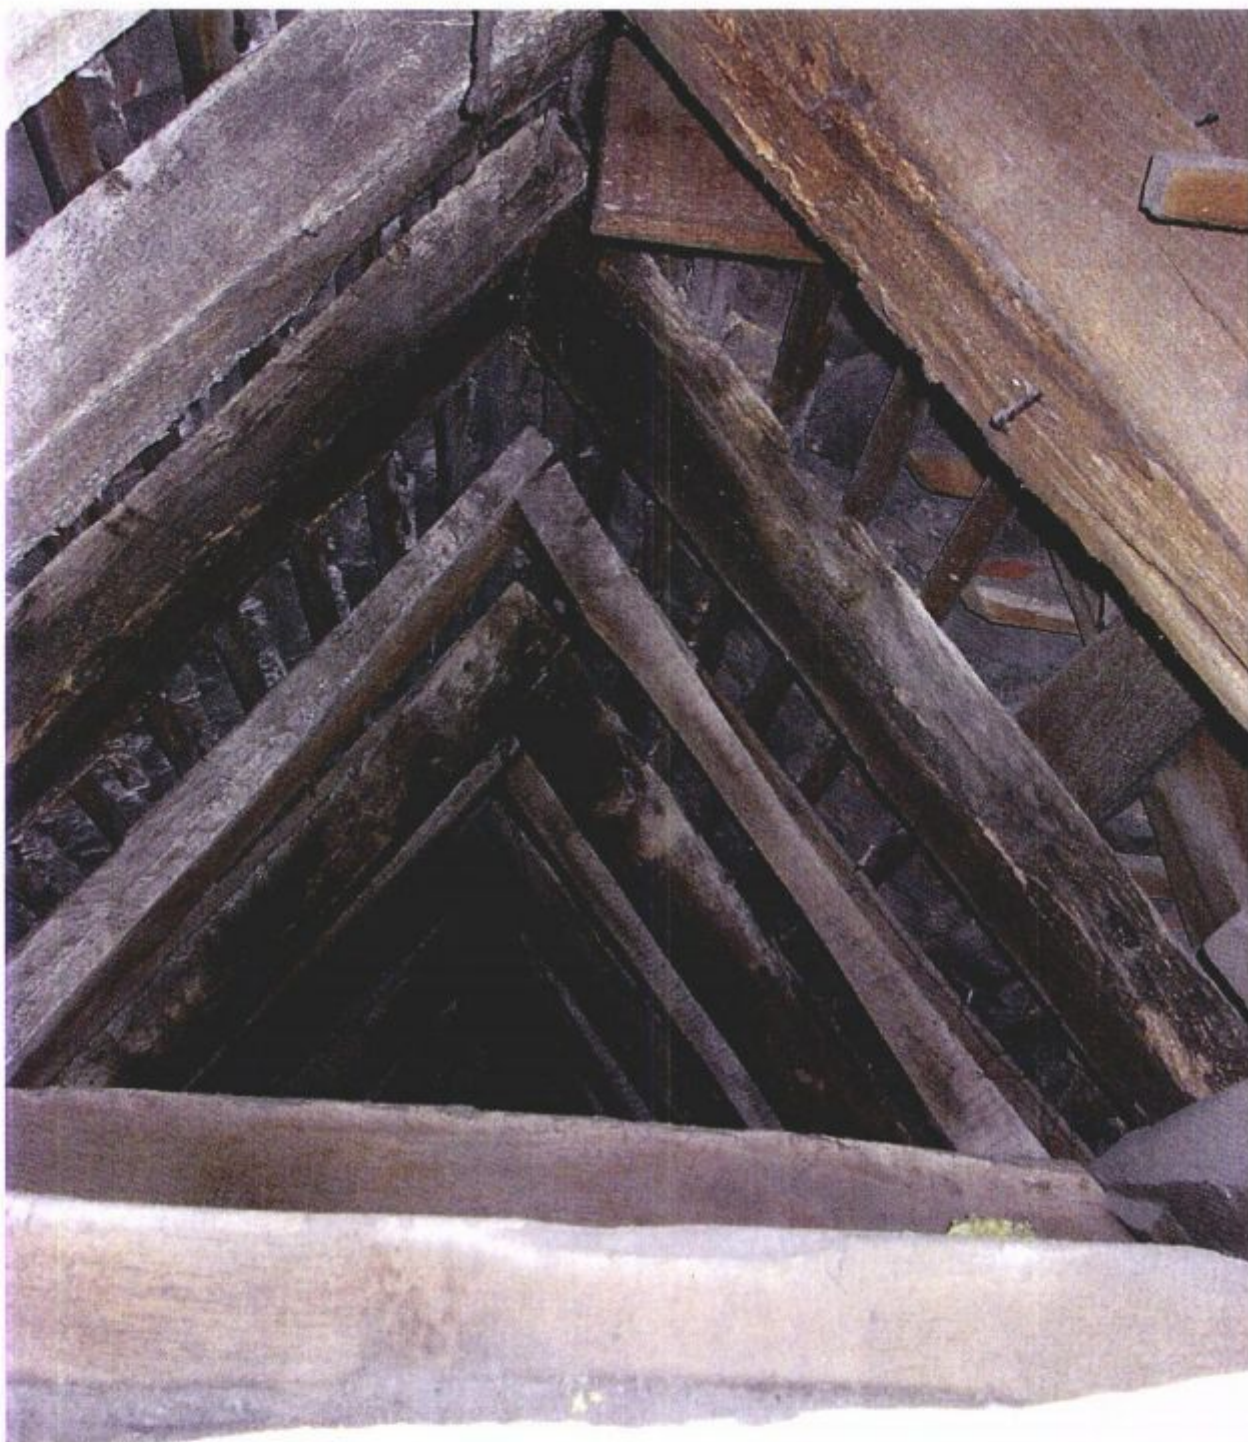
**Photo 008 – Ridge over Accommodation Area.  
Showing Ridge Board from Rear Pitch.**

- West of the incoming rear ridge-board, the rafters to the front and rear pitch, are aligned and are probably tenoned into one another, since there is no ridge board. (See Photo 008.)

Front pitch timbers West of the rear ridge beam appear in better condition, but have been previously “furred out” on their top face in order to remove some considerable deflection.

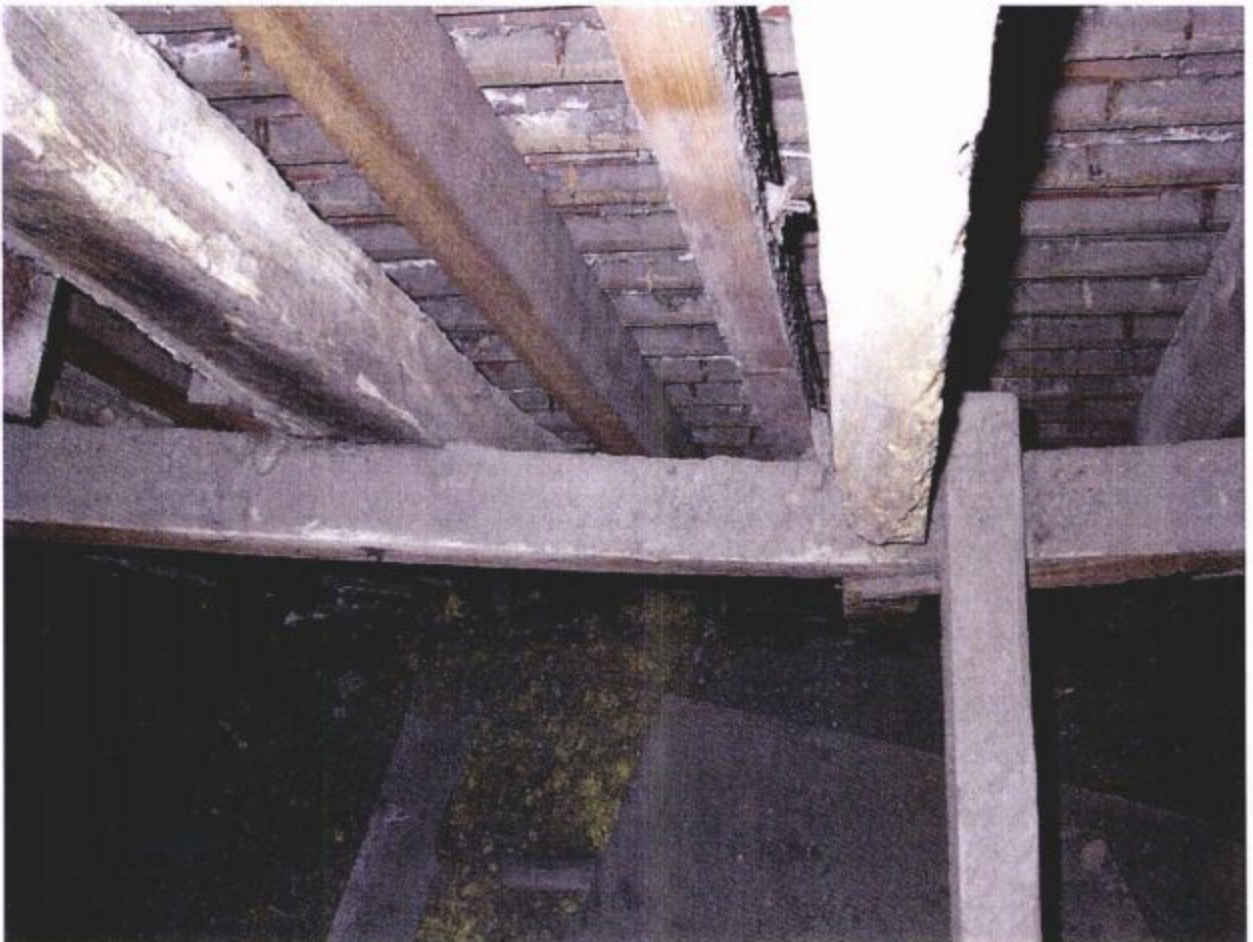
Considerable deflection (approx 150mm) has been made good by overlaying with 50 x 100 softwood rafters. (See Photo 012.)

**Photo 012 – S.W. Roof Space. Front Pitch. Broken Purlin at Strut Position.**

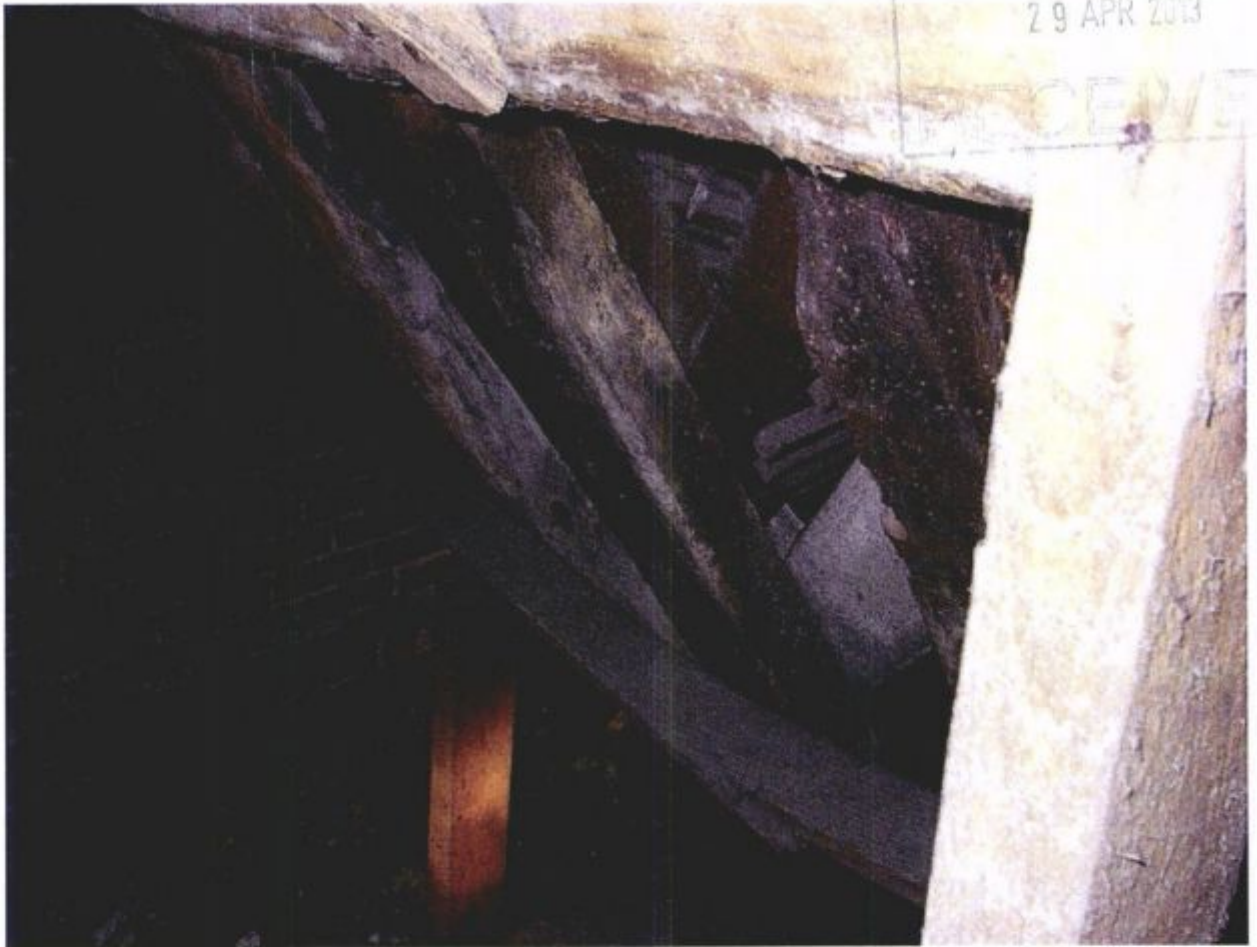
- The front purlin is broken at mid-span and has been diagonally struttled, although there appears to be no loadbearing element below the strut.
- The rear pitch has 2 No. intermediate purlins, both of which are broken at mid-span. (See Photos 014 & 017.)

**Photo 014 – S.W. Roof Space. Rear Pitch. Broken Lower Purlin.**

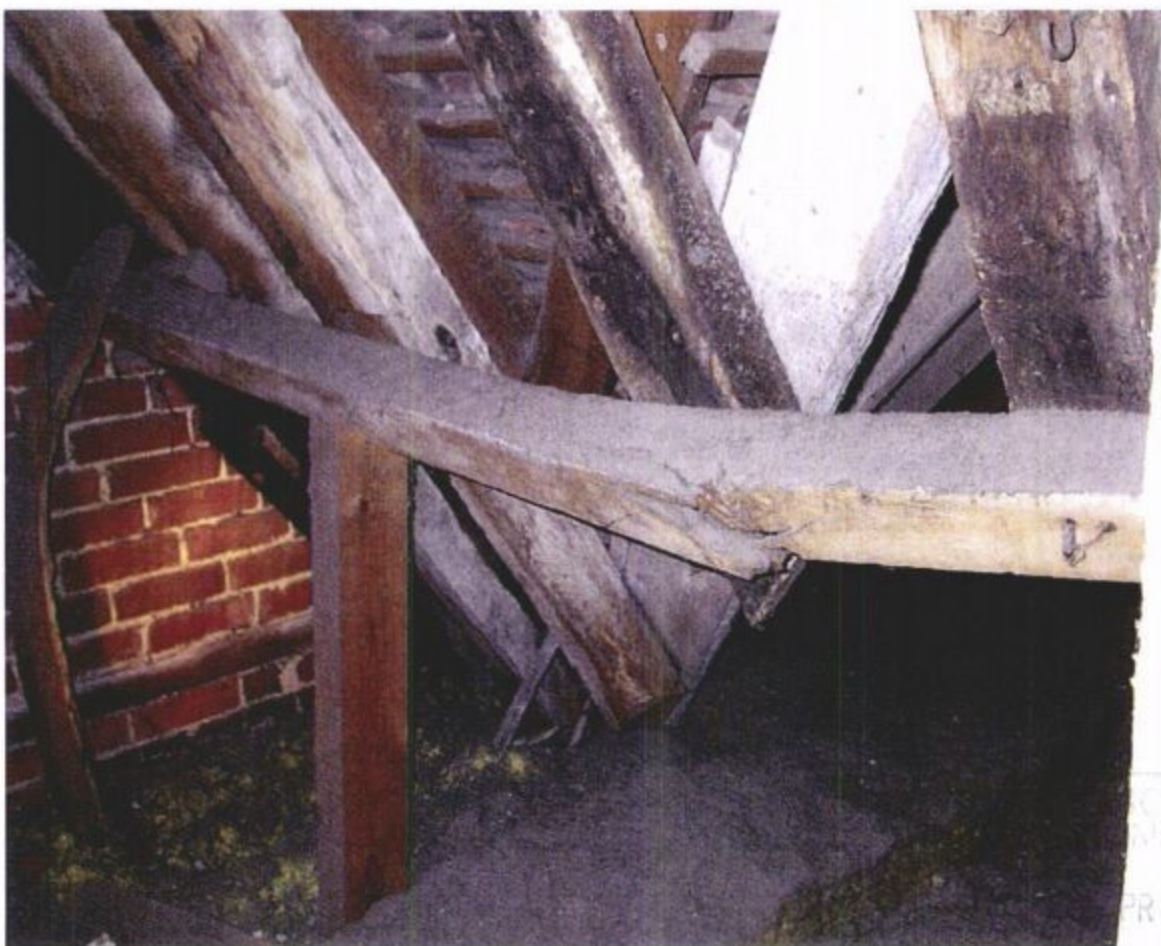
The rear pitch rafters are trimmed into the lower purlin and valley lay-board and are inadequately supported causing the purlin failure. (See Photo 017.)

- The rear rafters have been “furred out” to compensate for the serious deflections evidenced. (See Photo 017.)
- The complete roof has been crudely and incorrectly strengthened in the past.

**Photo 017 – S.W. Roof Space. Rear Pitch. Broken Lower Purlin.**

Repairs/strengthening works are considered unwarranted.

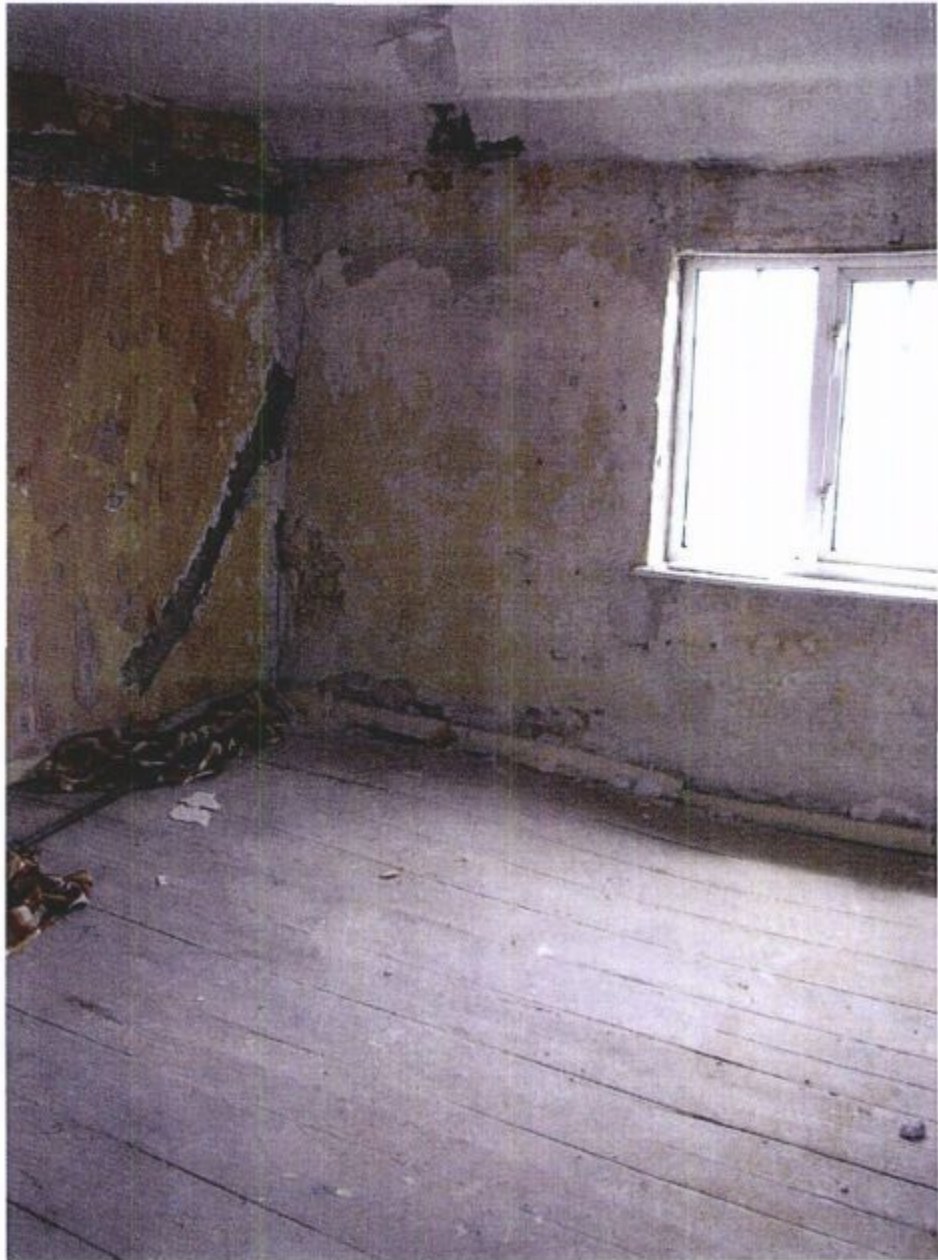
**Photo 018 – Bedroom 1. S.E. Corner.**

- Diagonal brace exposed in wall would be expected to be housed into a vertical post at the South, but none evidenced. (See **Photo 019.**)
- At the Southwest corner, the timber framed party wall is fractured and showing a separation from the front (South) wall. (See **Photo 023.**)
- The first floor shows considerable distortion on centre. (See **Photo 018.**)

The floor has been “over-boarded” East/West indicating the original North/South boarding to have decayed.

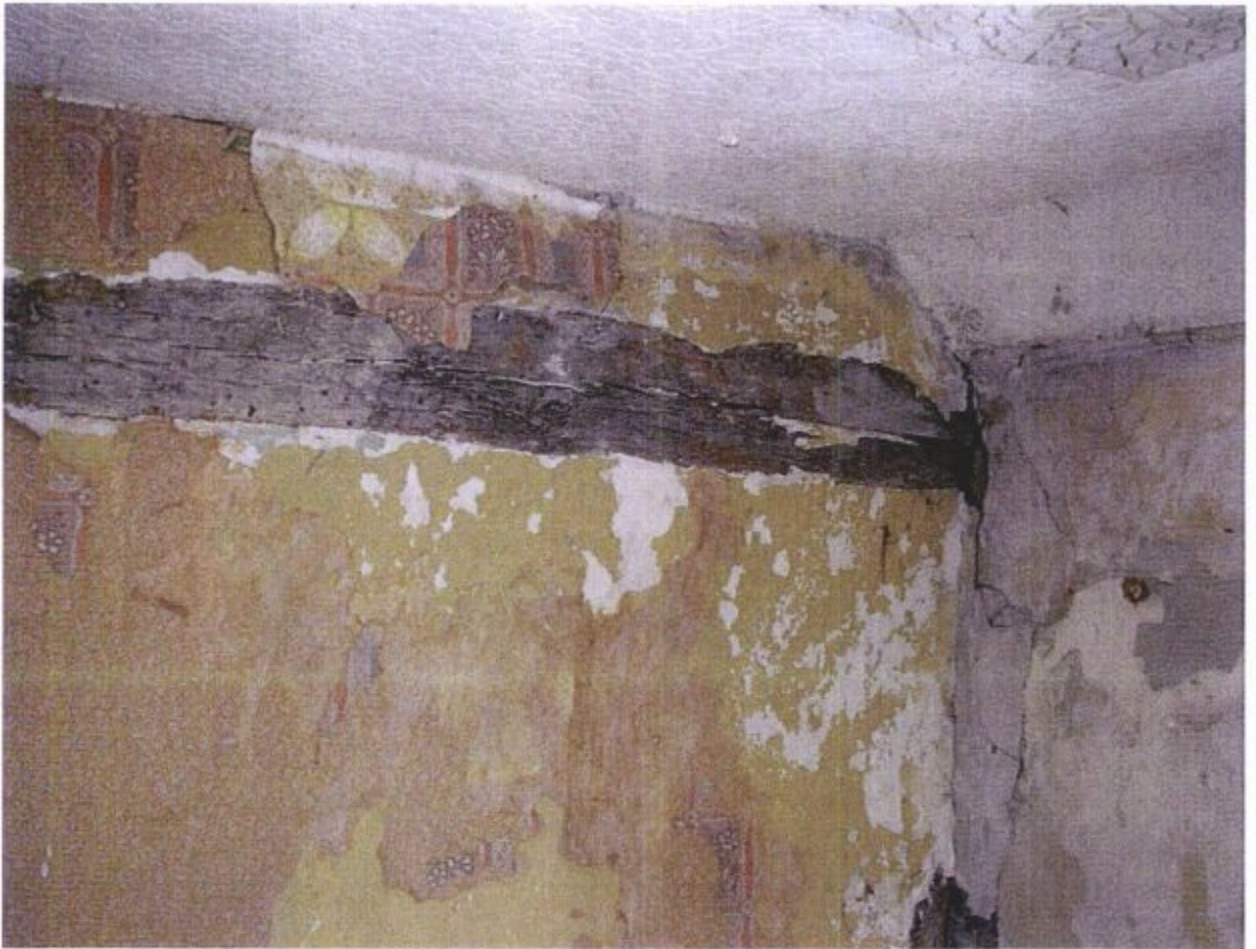
- Front (South) wall bowing outwards on centre, particularly at the eaves.
- Front (South) wall separating approx 50mm from loadbearing timber framed partition to Bedroom 2. (See Photos 018 & 019.)
- Partition formed in timber frame with brick infill. (See Photo 022.)
- Head plate showing separation at South and considerable splitting and insect infestation. (See Photo 021.)

**Photo 021 – Bedroom 1. S.E. Corner. Partition Junction with South Wall at Frame Head.**

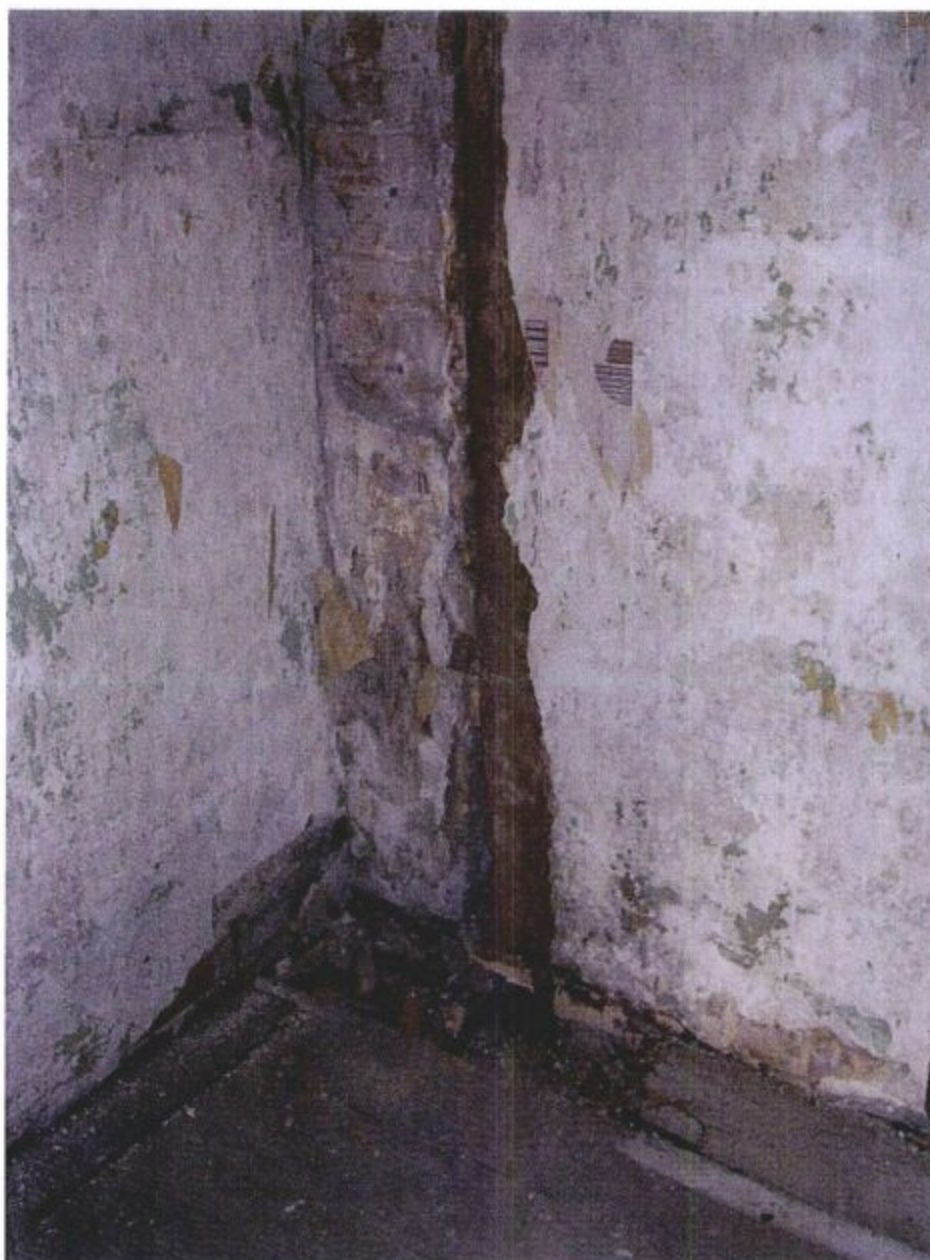
**Photo 024 – Corridor.**  
**West Party Wall Junction with Loadbearing Timber Framed Bathroom Wall.**

- The corridor/Bathroom partition is timber framed with brick infill and is expected to be supported on a beam over the Kitchen.
- The floor is over-boarded and there is evidence of decay in the lower boarding. (See **Photo 024.**)
- Originally, a stair from the ground floor passageway exited through this corridor at first floor, but has now been infilled. (See **Photo 025.**)

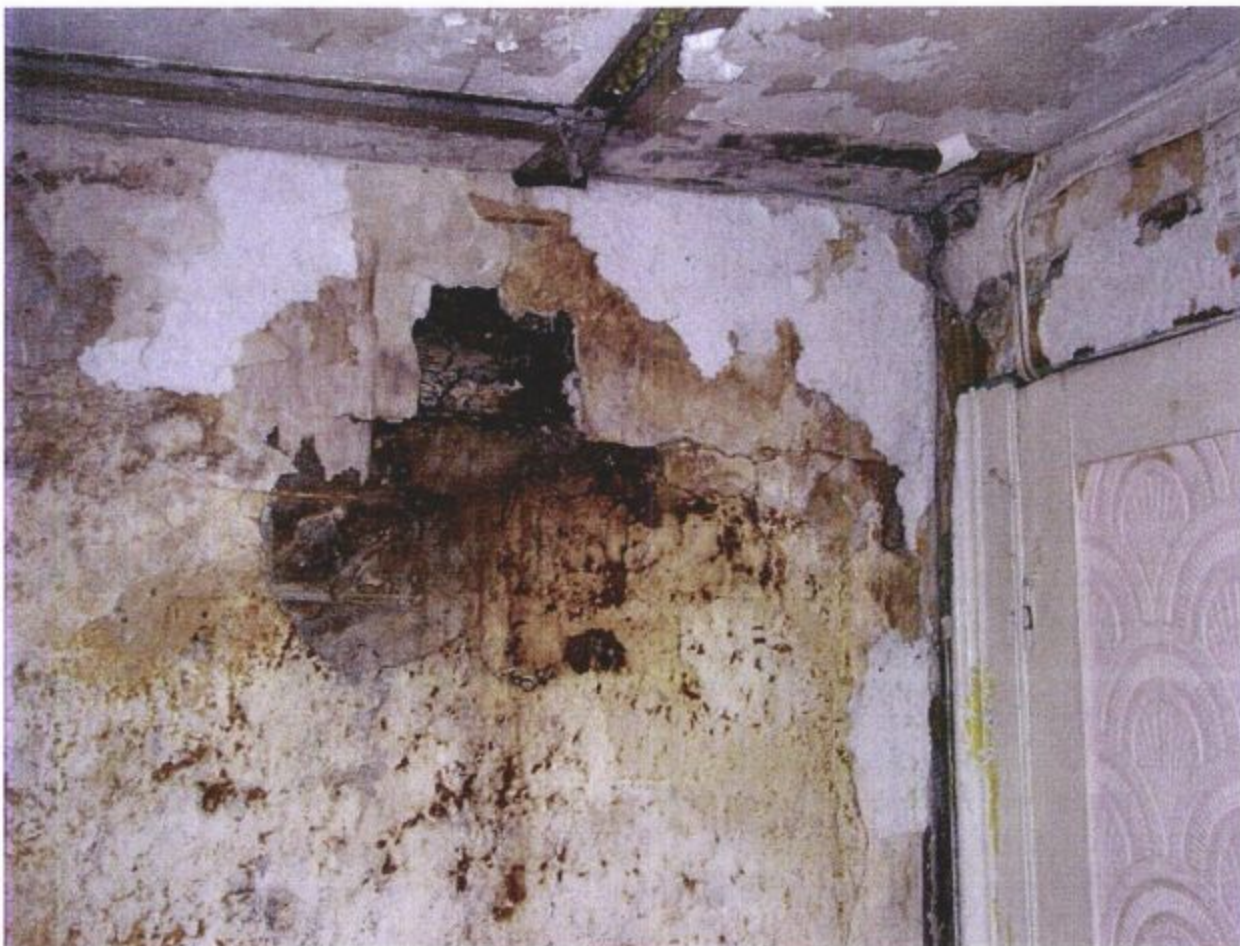
- 75mm Step up into Bathroom from corridor.
- First floor boarding running East/West and if not over-boarded, suggests floor joists span North/South.
- Timber framed loadbearing partition with Bedroom 3 at East, shows severely decayed head plate at Southeast corner. (See Photo 026.)

**Photo 026 – Bathroom S.W. Corner.  
Bedroom 3 Partition. Timber Frame Decay.**

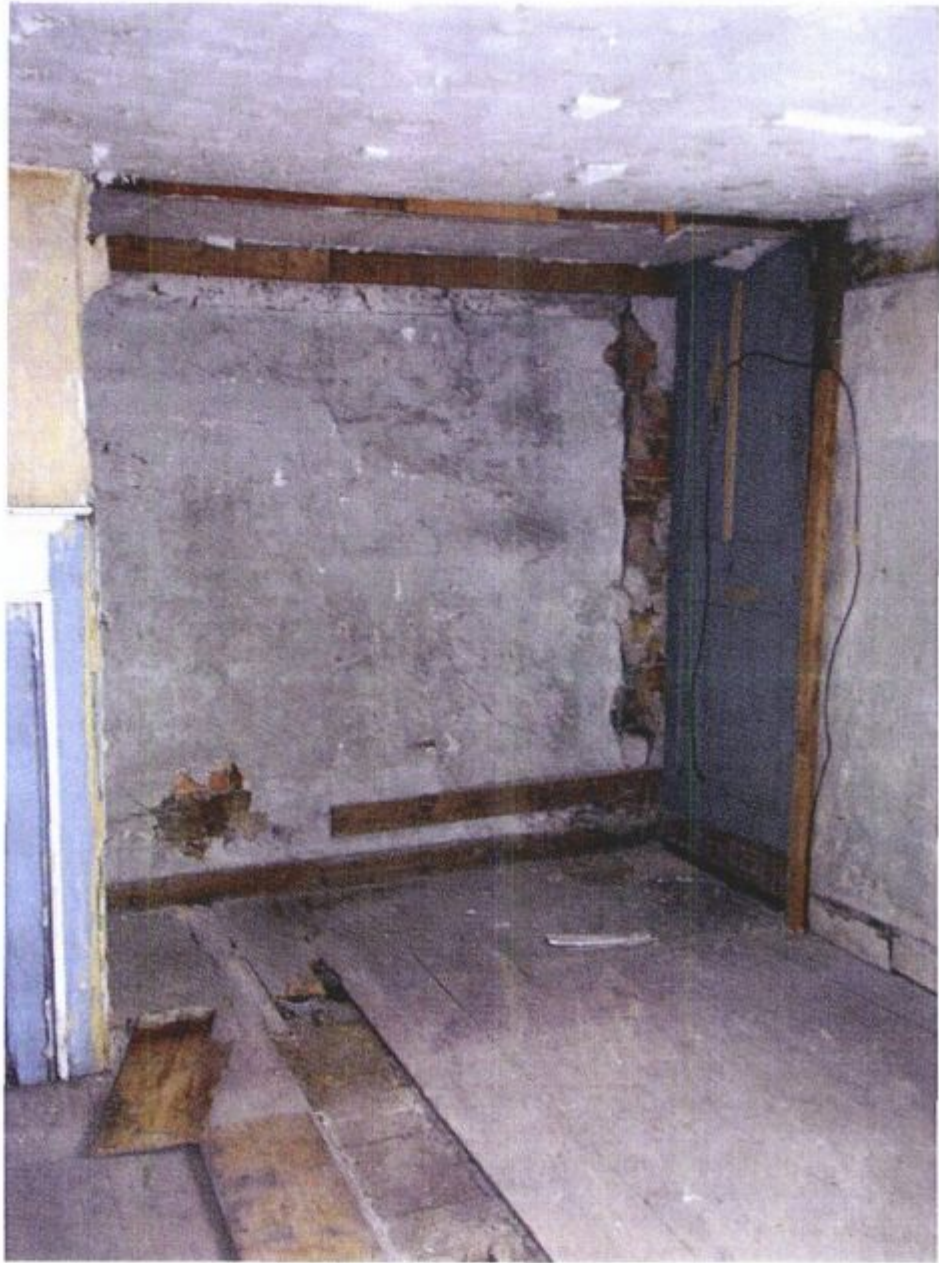
Photo 028 – Bedroom 2. S.E. Corner. Showing East Party Wall.

- Outward lean in front elevation at eaves, but not as pronounced as at Bedroom 1.
- Separation at first floor with junction at front wall, becoming worse towards Bedroom 1.
- Vertical separation of Bedroom 1 / 2 partition to front wall.
- A vertical joint at brick pier in East party wall at junction with front wall. (See Photo 027.)
- Evidence of timber framing to party wall at East. (See Photo 028.)

Considerable cracking evident in plasterwork.

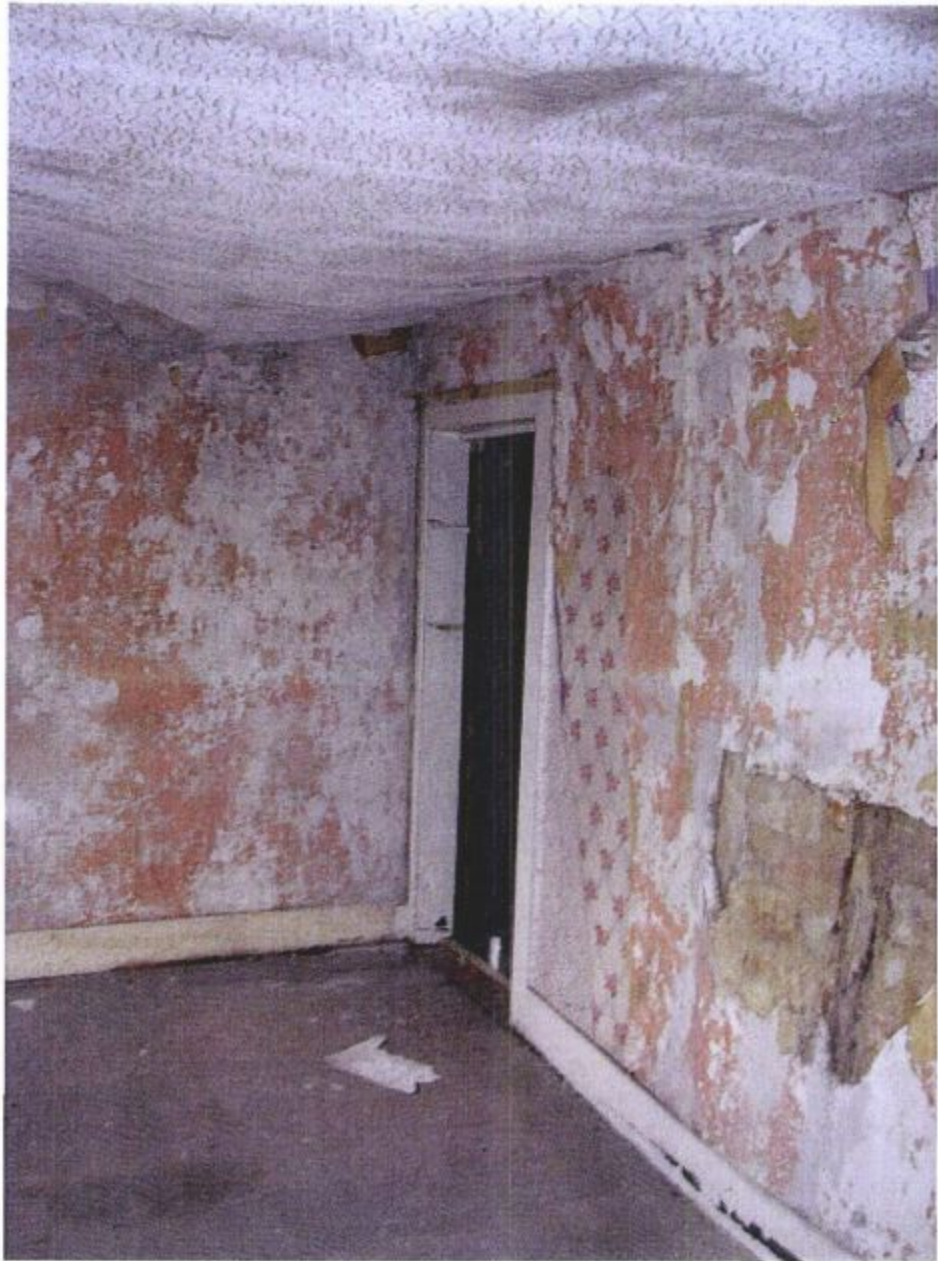
Photo 032 – Bedroom 3. S.E. Corner. East Party Wall/Stair Wall Junction.

- Internal loadbearing Bedroom 3 / Stair partition is timber framed with brick infill. The wall is very distorted on centre.

The exposed timber framing is in poor condition.

There is a drop in the floor at this point. (See Photo 032.)

This may relate to decay in the carriage beam bearing below.

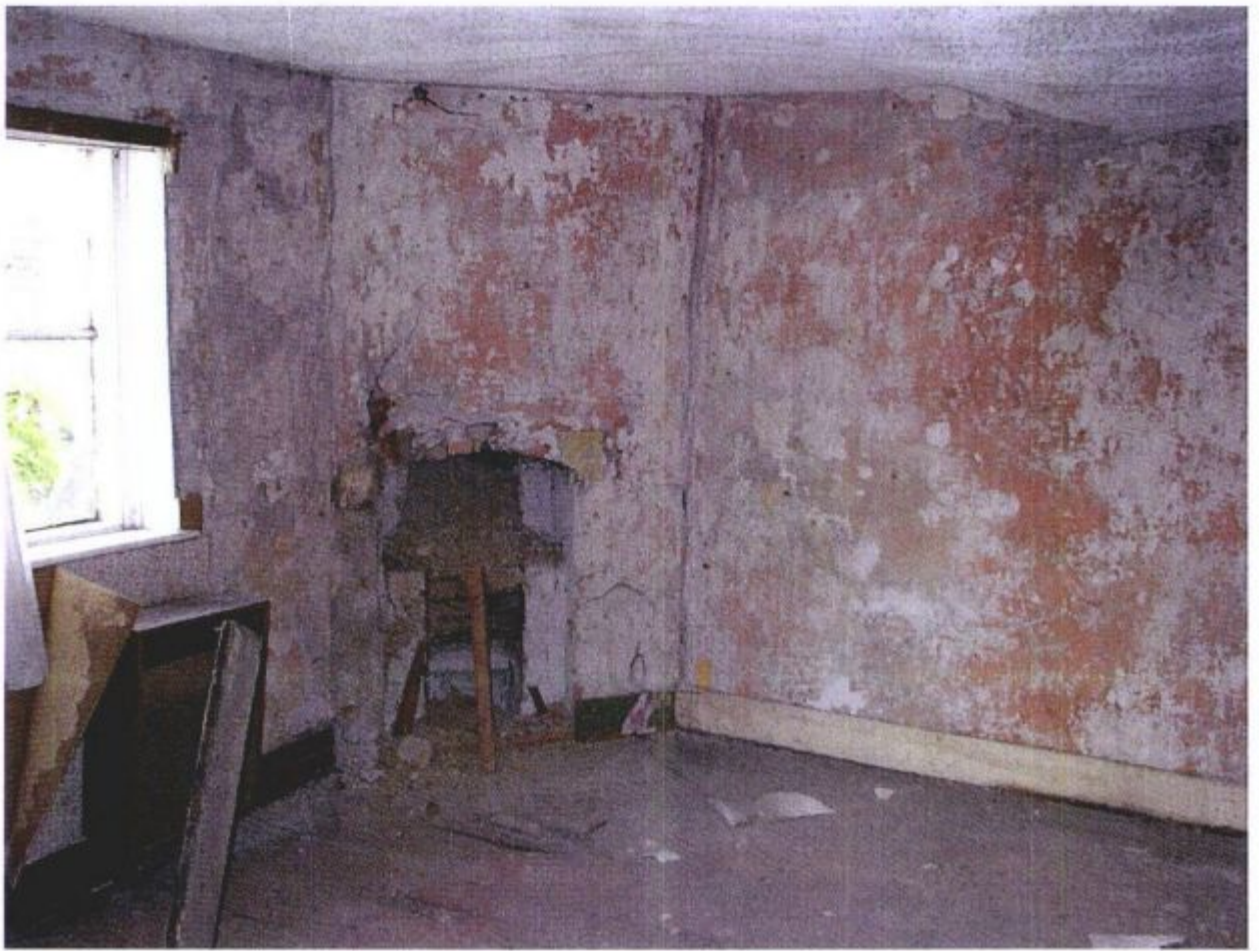
Photo 034 – Bedroom 3. N.E. Corner.

- There is slight horizontal bow in the external rear (North) wall on centre.
- There is a pronounced bulge in the ceiling against the East party wall indicating failure of joisting over, or of the roof supports. (See Photo 034.)
