**FIRST STAGE APPRAISAL**

**86 WEST STREET  
HAVANT  
HAMPSHIRE  
PO9 1LN**

**Job No: 2844**

**Date: 6<sup>th</sup> August 2009**

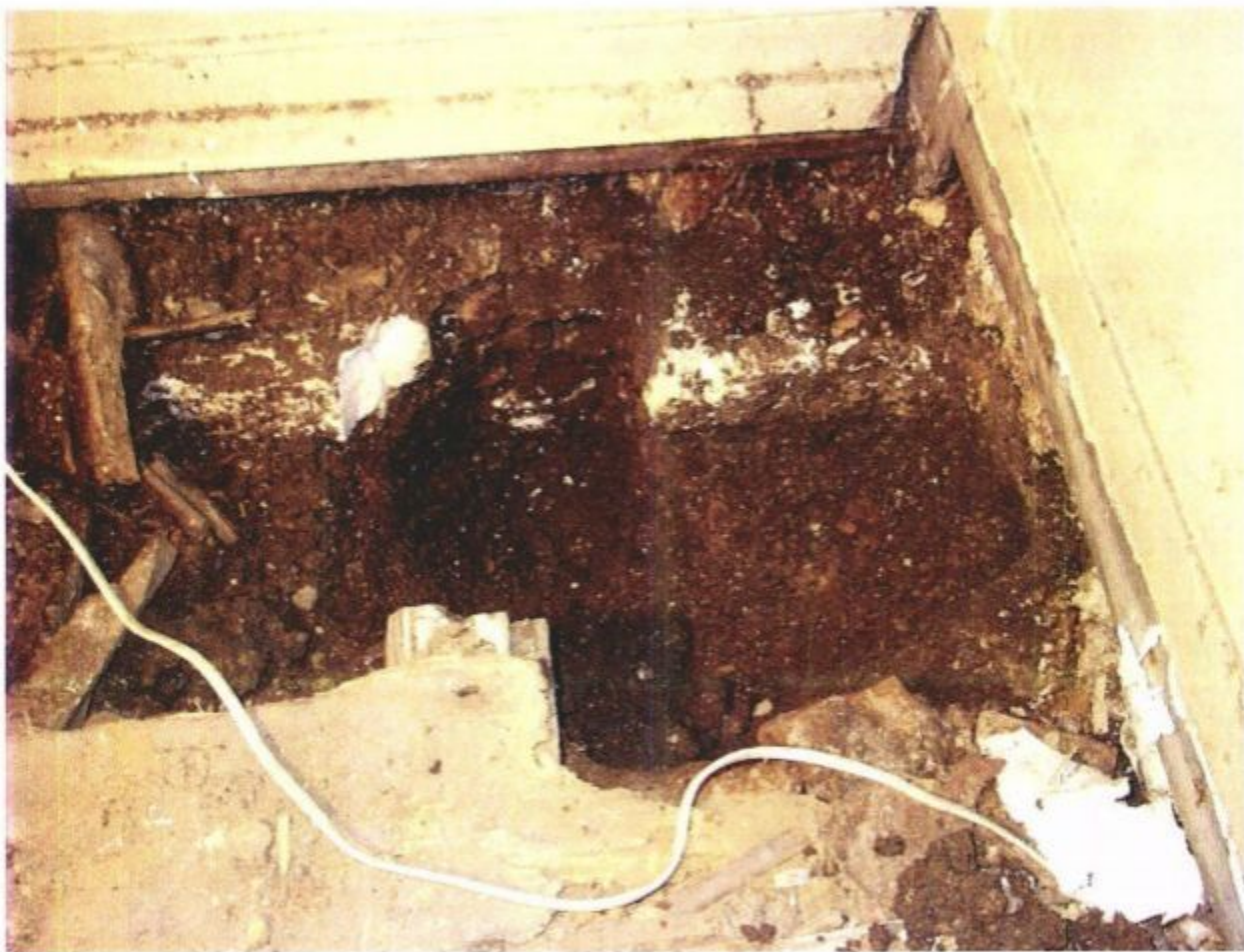
**Photo 039 – Lounge. S.E. Corner.  
Trial Pit Through Timber Ground Floor.**

- The South wall originally had a lathe and plaster finish on studwork, presumably to improve insulation.
- The ground floor has boarding on joisting directly onto the earth below and the majority has disintegrated from decay.
- A small trial hole was formed in the Southwest corner against the loadbearing partition to the passageway, to examine the foundations.

The wall may have been constructed over a layer of chalk laid onto the coarse stony, natural ground.

(A larger trial pit and more detailed examination is required.)
