# ARBORICULTURAL REPORT

**The Lodge  
Lavender Lane  
Waterlooville**

**Produced for:** Guinness Hermitage  
**Prepared by:** Nicholas van Pelt Dip Arb (RFS), MRAC, Dip REM (Cirencester)  
**Reference:** NvP3245  
**Date:** 12<sup>th</sup> July 2012

**Site Address:** The Lodge, Lavender Lane, Waterlooville, Hants.  
**Client:** Guinness Hermitage  
**Report Reference:** NvP3245  
**Inspection Date:** 20<sup>th</sup> May 2013  
**Inspected By:** Nick van Pelt

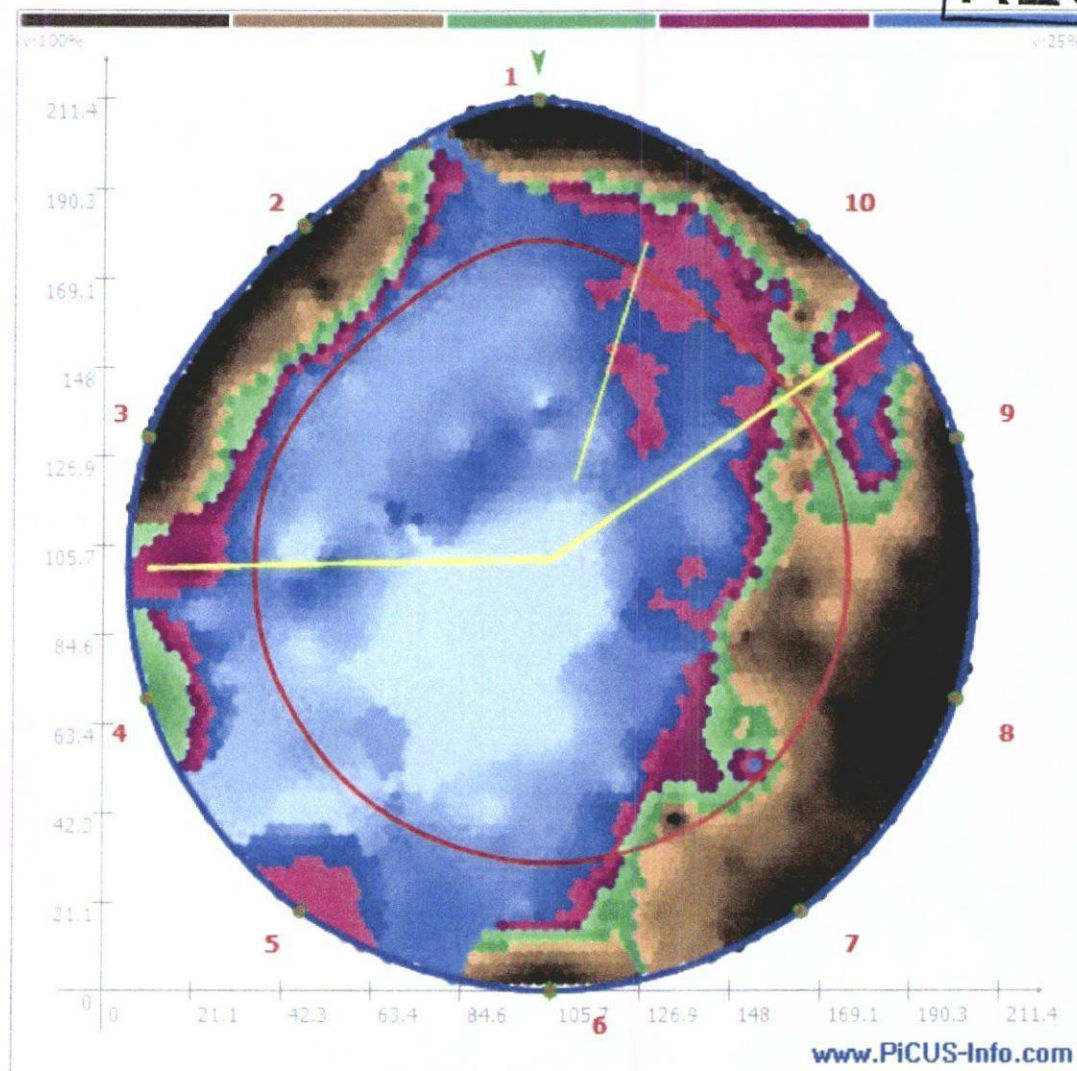
### Picus Sonic Tomograph Test 2013

Tests undertaken: 20<sup>th</sup> May 2013 using Picus software Q72std, 10 modules in accordance with manufacturers manual.

Test 1. level: 85cm approximately from ground level.

Picus Test Analysis: The Tomographic image shows the sonic representation, high velocity readings across the timber depicted as brown and green. Lower readings in the central column depicted as the blue and mauve colours and indicate severe decay.

This indicates decay beyond accepted limits.

- 6.1 It is my conclusion is that the tree is now significantly decayed and has reached a degree of stem decay percentage which is beyond acceptable safety levels.
- 6.2 There is no realistic work or action that can be undertaken that can render the tree safe.
- 7.0 **Recommendations**
- 7.1 It is recommended that the tree is carefully felled and that the stump is ground out.
- 7.3 This work should be carried out before autumn 2013/14.
- 7.4 The area around the tree should be entirely fenced off until the tree has been felled and only experienced and competent arboricultural personnel should be allowed in that area.
