# Arboricultural Consultancy for Groupama

| Insured | Mr & Mrs Gruchy | Address | 5 Hitherwood Close, Waterloooville, PO7 8SA | | |

**Scope of Report:** To survey the property and determine significant vegetation contributing to subsidence damage, make recommendation for remedial action, initiate mitigation action and assess recovery prospects. The survey does not make an assessment for decay or hazard evaluation.

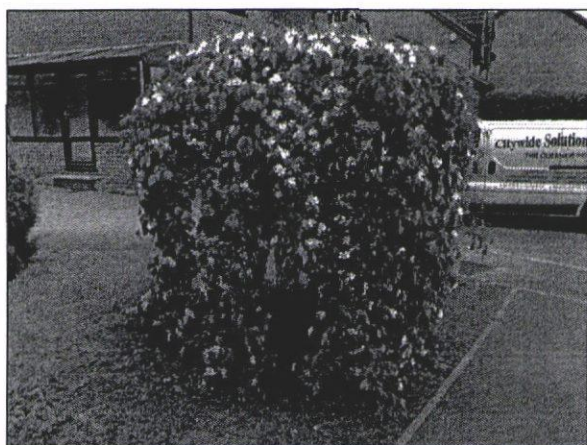
T1 - Pear (willow leafed)

| T1 | Pear (willow leafed) | 1 | 2 | 4.5 | C - Insured | Action to avoid future risk | Do not allow to exceed current dimensions. |

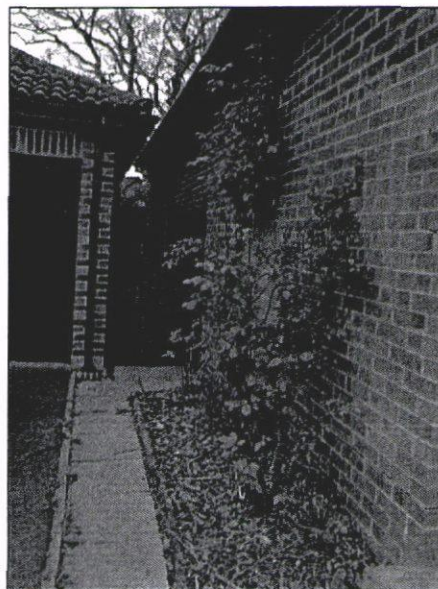
SG1 - Rose

| Tree No. | Species | Age Cat | Approx. Height (m) | Distance to Building (m) | Ownership | Action | Requirement |
|---|---|---|---|---|---|---|---|
| SG1 | Rose | 1 | 3 | 0.2 | C - Insured | Action to avoid future risk | Do not allow to exceed current dimensions. |

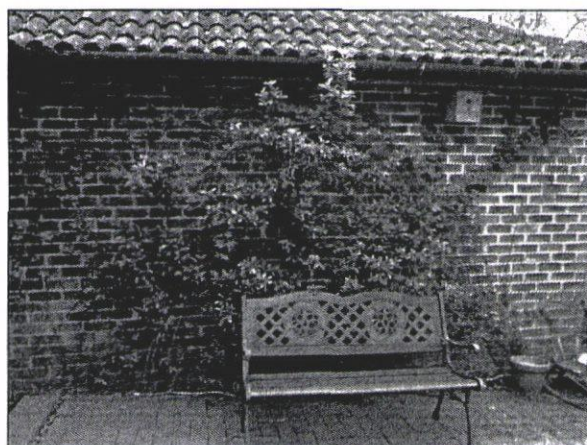
S4 - Pyracantha

| Tree No. | Species | Age Cat | Approx. Height (m) | Distance to Building (m) | Ownership | Action | Requirement |
|---|---|---|---|---|---|---|---|
| S4 | Pyracantha | 1 | 2 | 1 | C - Insured | Action to avoid future risk | Do not allow to exceed current dimensions. |

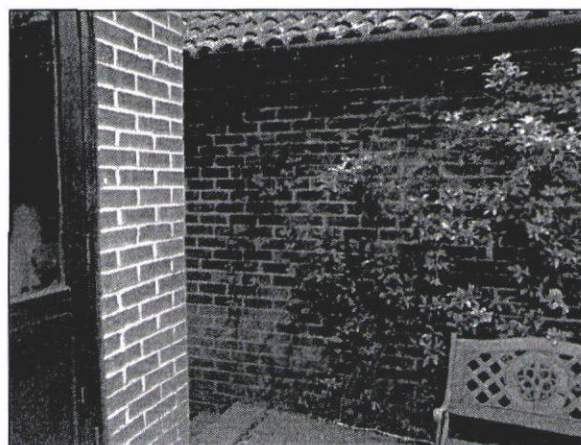
C1 - Virginia Creeper

| Tree No. | Species | Age Cat | Approx. Height (m) | Distance to Building (m) | Ownership | Action | Requirement |
|---|---|---|---|---|---|---|---|
| C1 | Virginia Creeper | 1 | 2 | 1 | C - Insured | Action to avoid future risk | Do not allow to exceed current dimensions. |

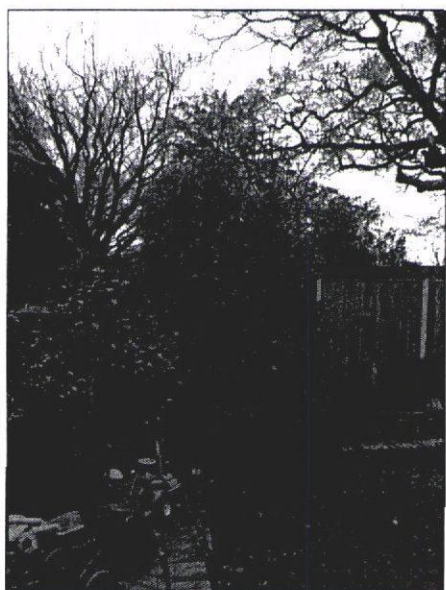
T5 - Cypress (Lawson)

| T5 | Cypress (Lawson) | 1 | 3 | 6 | C - Insured | Action to avoid future risk | Restrict to 10m in height. |

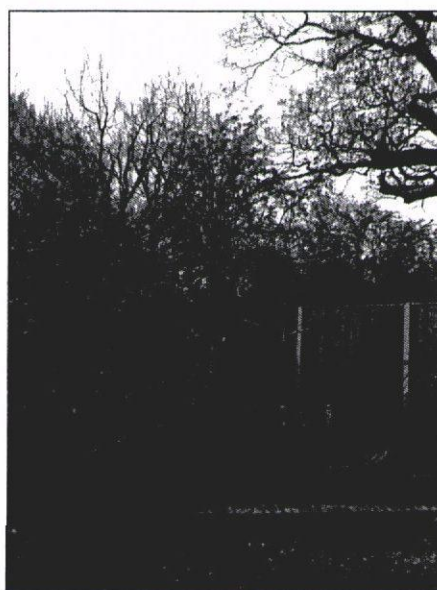
T6 - Rhus

| T6 | Rhus | 1 | 4 | 9 | C - Insured | Action to avoid future risk | Restrict to 7m in height. |

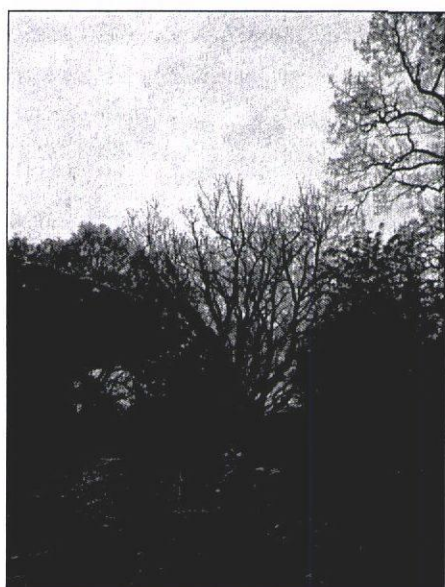
T7 - Oak

| T7 | Oak | 2 | 8 | 14* | D - Unknown | Action to avoid future risk | Restrict to 10m in height. |

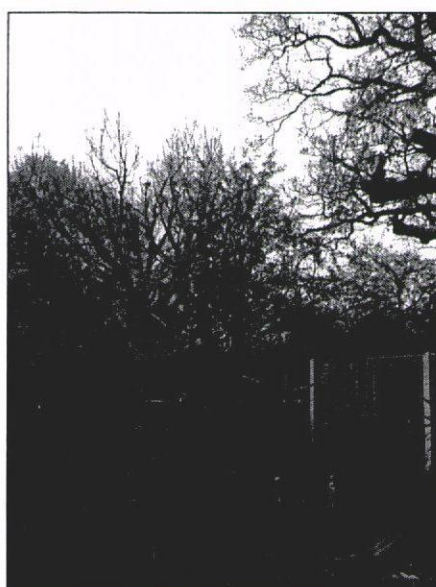
T8 - Hawthorn

| T8 | Hawthorn | 1 | 6 | 11* | D - Unknown | Action to avoid future risk | Restrict to 8.5m in height. |

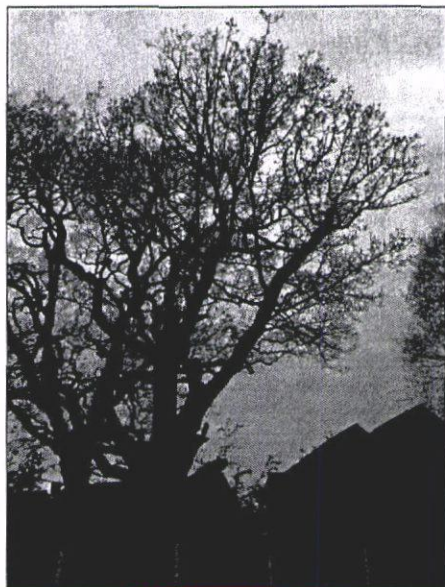
T9 - Oak

Based on our site inspection and investigations undertaken by engineers, and taking account of vegetation location, relative to the focal area of damage, it is our opinion that T11 (Oak) will be exerting the principal vegetative influence to the rear extension. It is also our opinion that T9 (Oak), T12 (Willow (Contorted)) and TG2 (Mixed Species Group) are considered to be contributory factors in the damage.

| T9 | Oak | 3 | 10 | 9.5 | D - Unknown | Remove | Remove subject to heave assessment. |

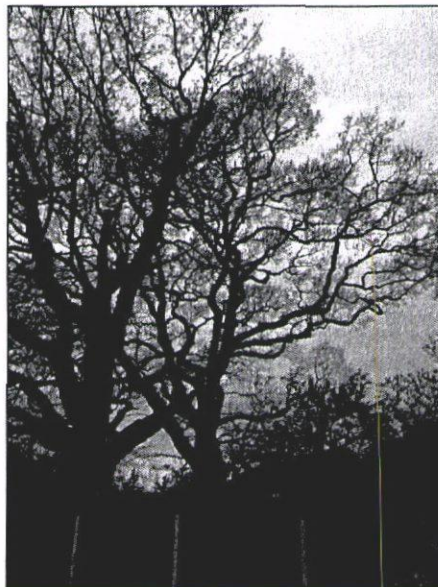
T10 - Oak

| T10 | Oak | 3 | 16 | 18* | D - Unknown | Action to avoid future risk | Reduce and maintain below 14m in height. |

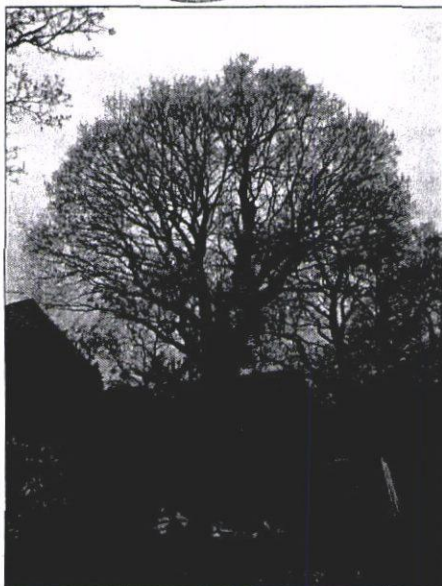
T11 - Oak

| T11 | Oak | 3 | 14 | 8* | D - Unknown | Remove | Remove subject to heave assessment. |

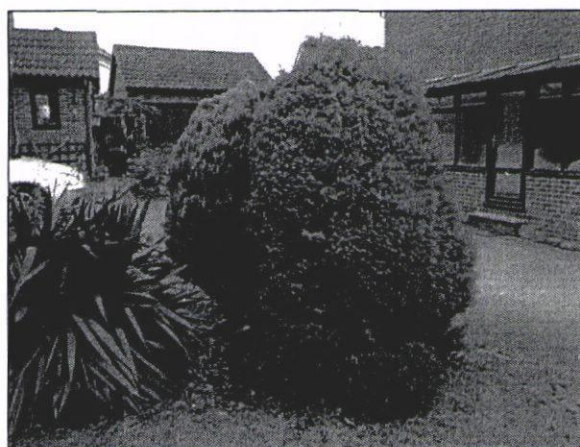
TG1 - Mixed Species Group (M)

| TG1 | Mixed Species Group (M) Cypress (Lawson) x 1. Japanese Red Cedar x 1. | 1 | 2 | 2 | C - Insured | Action to avoid future risk | Do not allow to exceed current dimensions. |

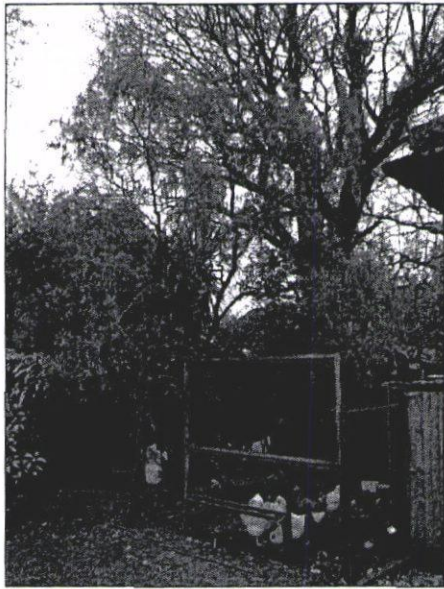
T12 - Willow (Contorted)

| T12 | Willow (Contorted) | 1 | 6 | 7* | C - Insured | Remove | Remove and treat stump to inhibit regrowth. |

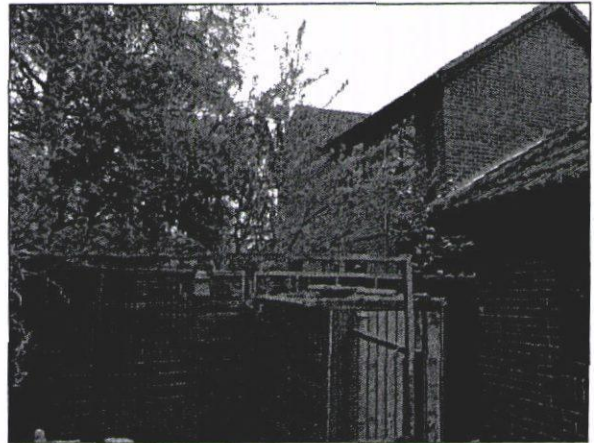
TG2 - Mixed Species Group (M)

| TG2 | Mixed Species Group (M) Apple x 2. Plum x 1. | 1 | 5 | 3* | A - Third Party<br>6 Hitherwood Close<br>Waterlooville<br>PO7 8SA | Remove | Remove and treat stump to inhibit regrowth. |

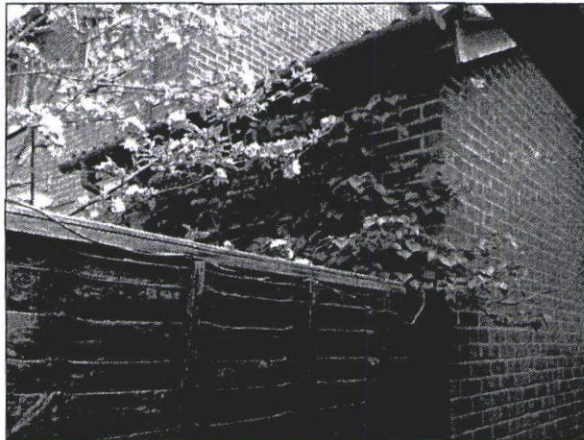
CG1 - Mixed Species Group (M)

| Tree No. | Species | Age Cat | Approx. Height (m) | Distance to Building (m) | Ownership | Action | Requirement |
|---|---|---|---|---|---|---|---|
| CG1 | Mixed Species Group (M)<br>Hydrangea x 1.<br>Rose x 1. | 1 | 3 | 1 | A - Third Party<br>6 Hitherwood Close<br>Waterlooville<br>PO7 8SA | Action to avoid future risk | Do not allow to exceed current dimensions. |

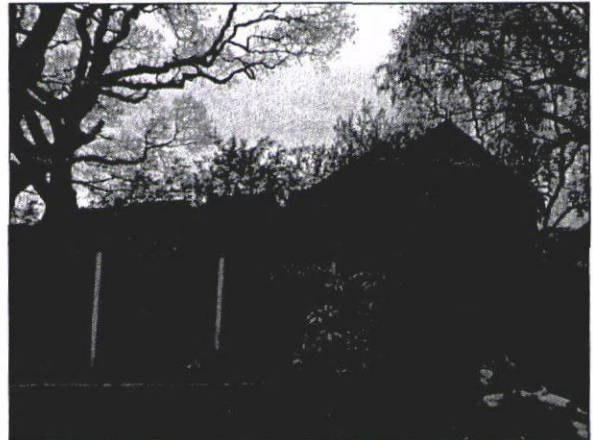
TG3 - Mixed Species Group (M)

| TG3 | Mixed Species Group (M) Blackthorn x 1. Hawthorn x 1. | 1 | 5 | 8.5 | D - Unknown | Action to avoid future risk | Restrict to 6.5m in height. |

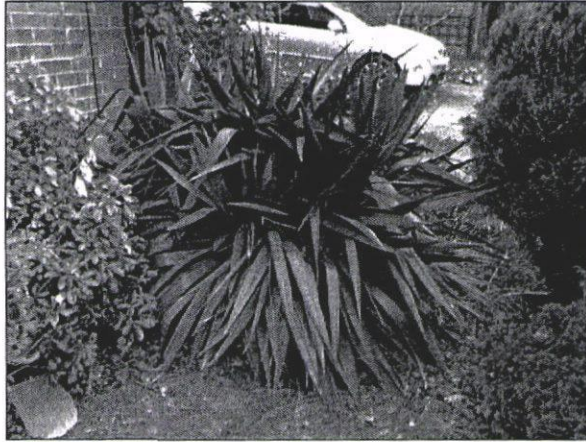
T2 - Palm

| T2 | Palm | 1 | 1 | 1.5 | C - Insured | Action to avoid future risk | Do not allow to exceed current dimensions. |

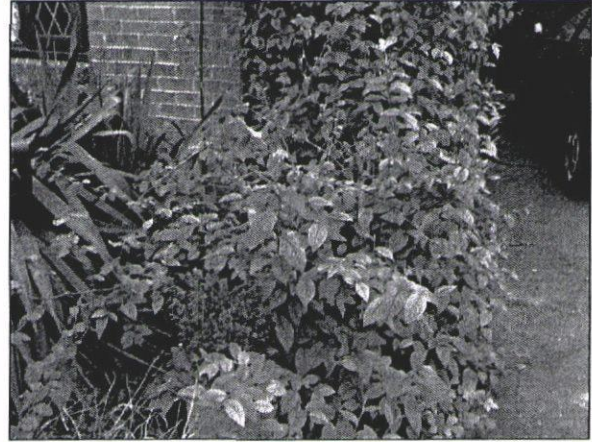
T3 - Hazel (Common)

| T3 | Hazel (Common) | 1 | 1 | 1 | C - Insured | Action to avoid future risk | Do not allow to exceed current dimensions. |

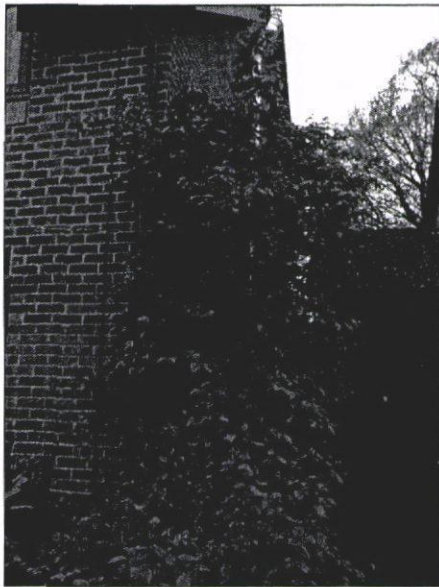
T4 - Cotoneaster

| T4 | Cotoneaster | 1 | 6 | 0.1 | C - Insured | Action to avoid future risk | Remove and treat stump to inhibit regrowth. |

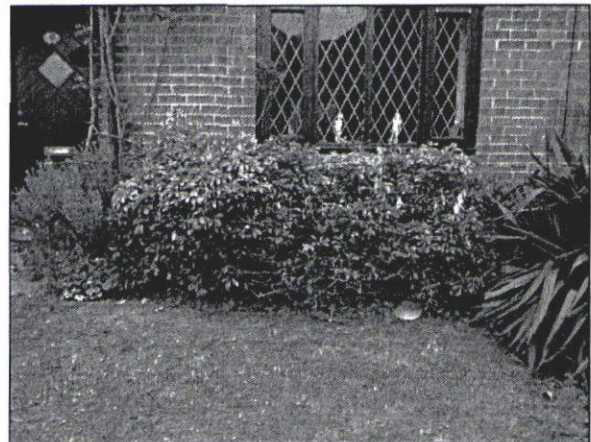
S1 - Choisya

| Tree No. | Species | Age Cat | Approx. Height (m) | Distance to Building (m) | Ownership | Action | Requirement |
|---|---|---|---|---|---|---|---|
| S1 | Choisya | 1 | 1 | 0.1 | C - Insured | Action to avoid future risk | Do not allow to exceed current dimensions. |

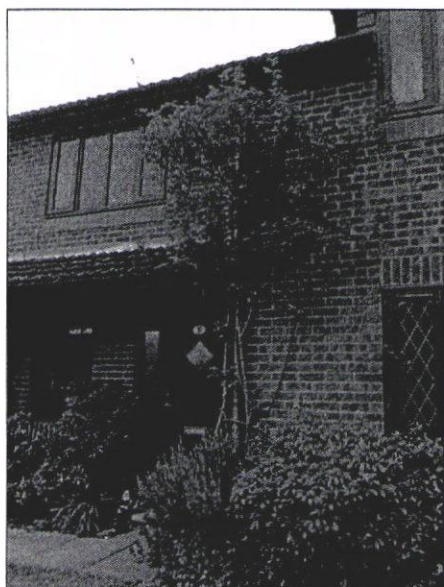
S2 - Rose

| Tree No. | Species | Age Cat | Approx. Height (m) | Distance to Building (m) | Ownership | Action | Requirement |
|---|---|---|---|---|---|---|---|
| S2 | Rose | 1 | 5.5 | 0.1 | C - Insured | Action to avoid future risk | Do not allow to exceed current dimensions. |

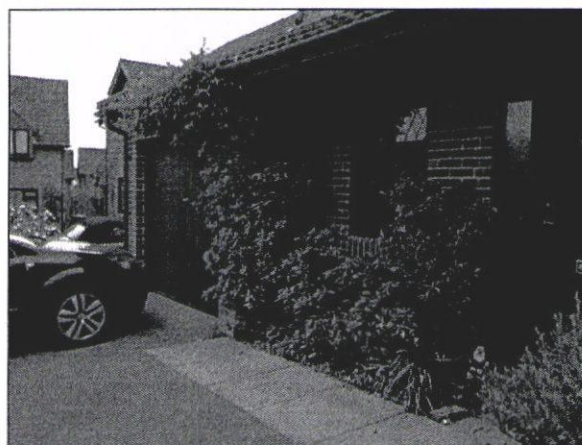
S3 - Pyracantha

| Tree No. | Species | Age Cat | Approx. Height (m) | Distance to Building (m) | Ownership | Action | Requirement |
|---|---|---|---|---|---|---|---|
| S3 | Pyracantha | 1 | 3 | 0.1 | C - Insured | Action to avoid future risk | Do not allow to exceed current dimensions. |

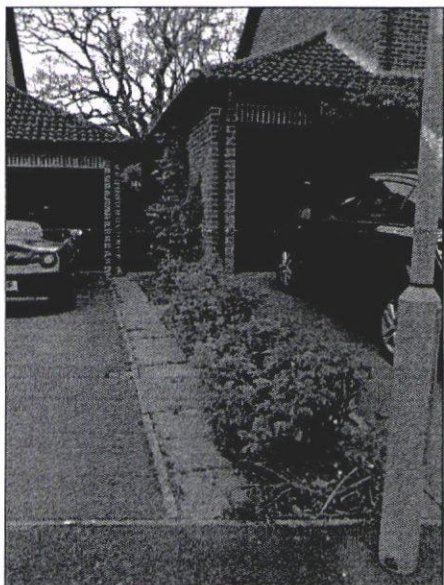
H1 - Rose

| Tree No. | Species | Age Cat | Approx. Height (m) | Distance to Building (m) | Ownership | Action | Requirement |
|---|---|---|---|---|---|---|---|
| H1 | Rose | 1 | 0.5 | 1 | C - Insured | Action to avoid future risk | Do not allow to exceed current dimensions. |
