Our Ref. 2844

Re: **86 West Street, Havant, Hampshire.**  
**Existing Front South Elevation.**

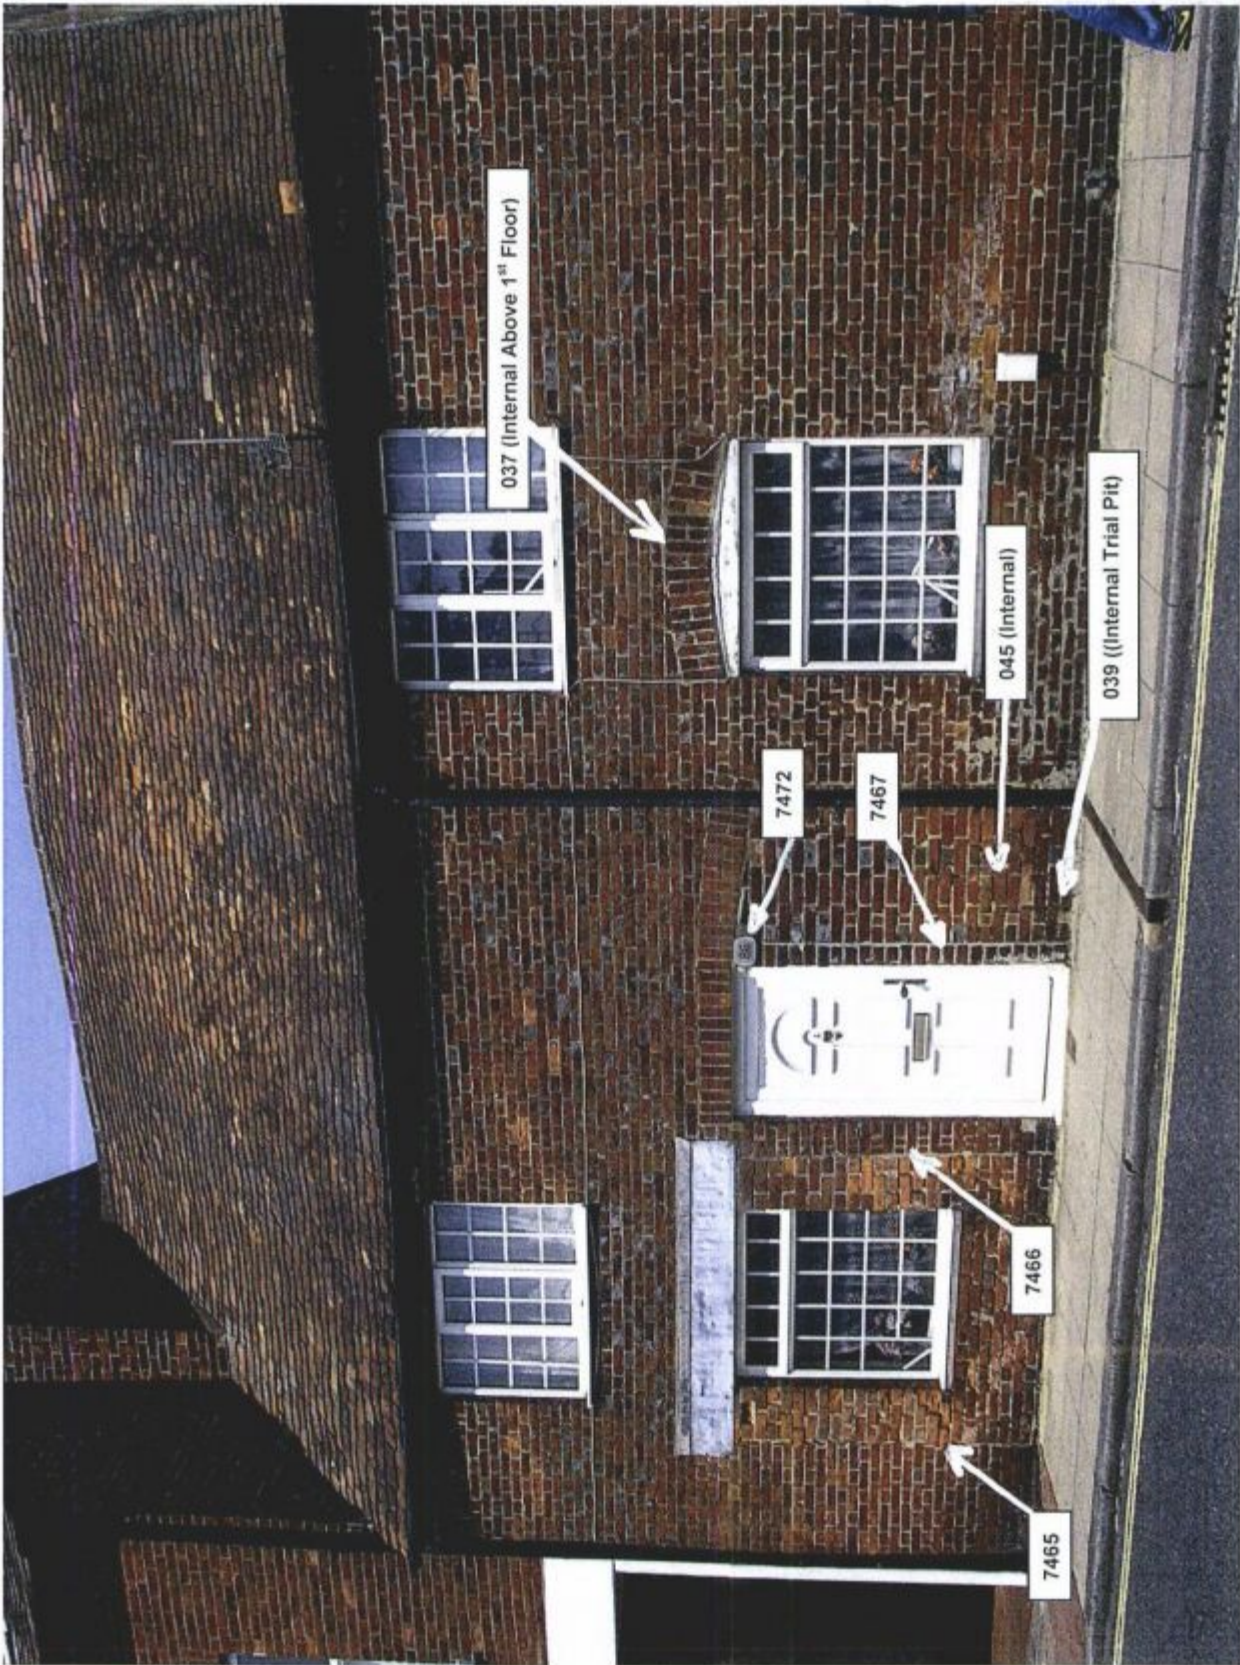
Photo No. 06.03.09/005

The bricks and coursings to the infill do not match the original Flemish bonded work and are straight jointed at the abutments. **(See Photo Nos:- 06.03.09/005, 7465 & 7466.)**

These unconnected straight vertical joints occur, not surprisingly, at the positions of worst vertical distortion and where the first floor joists have completely lost their bearings as a direct result.

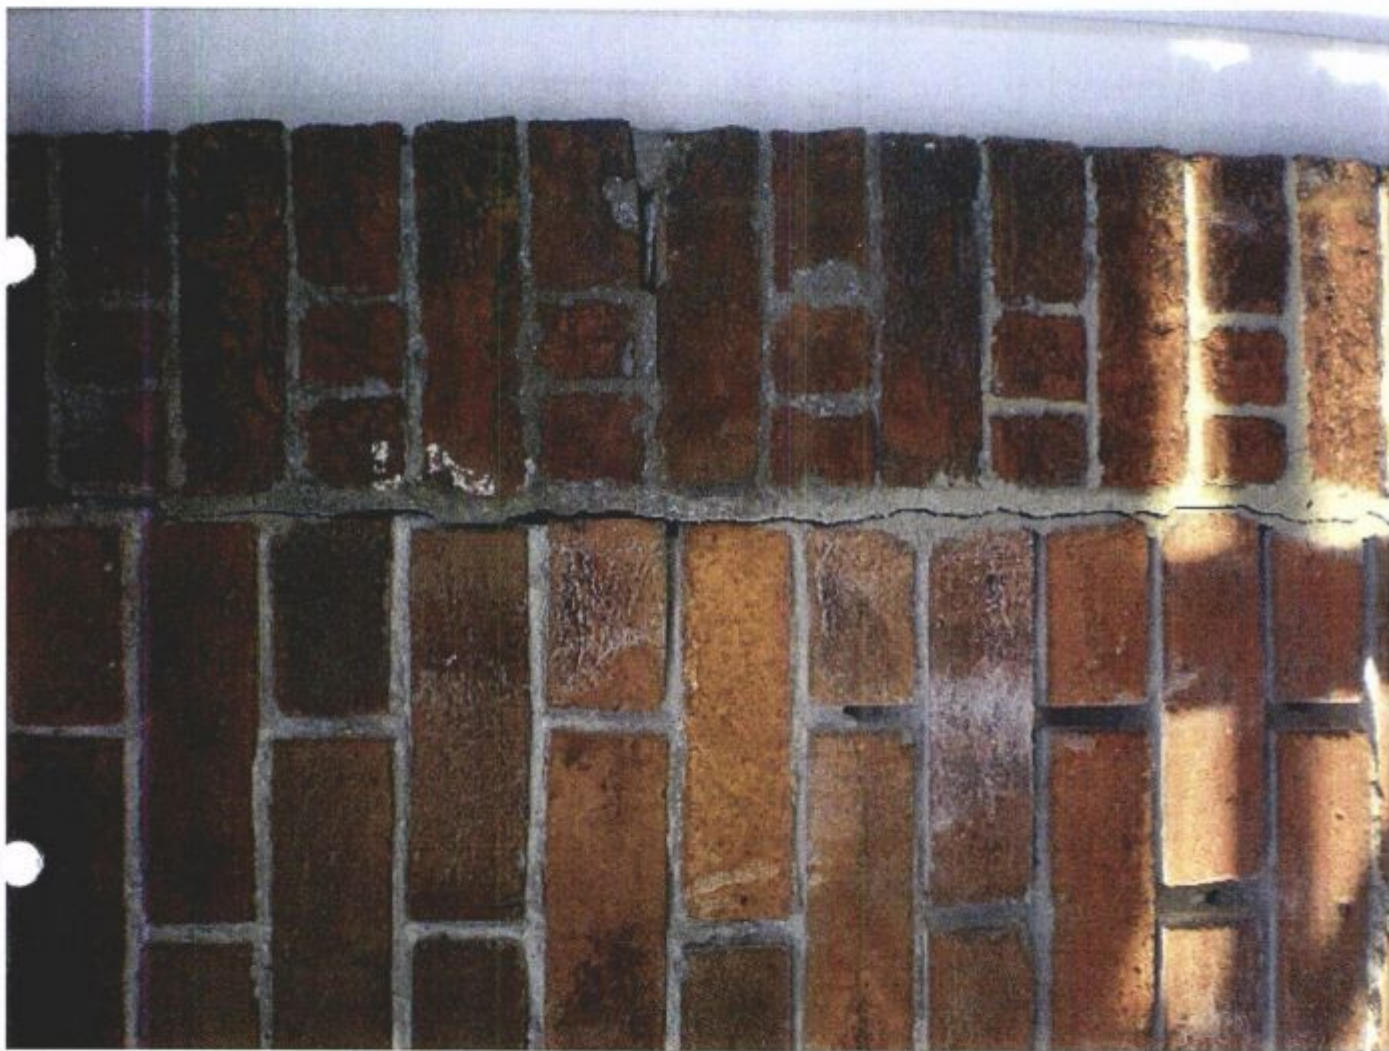
Photo No. 7466

- The brick pier between the existing ground floor western window reveal and the adjacent door is only 215mm wide. **(See Photo No. 7466.)**

Internally, it abuts, but is no longer connected to, a returning timber framed corridor wall.

The separation at this point is 66mm maximum internally.

The pier leans outwards at first floor level by 70mm.

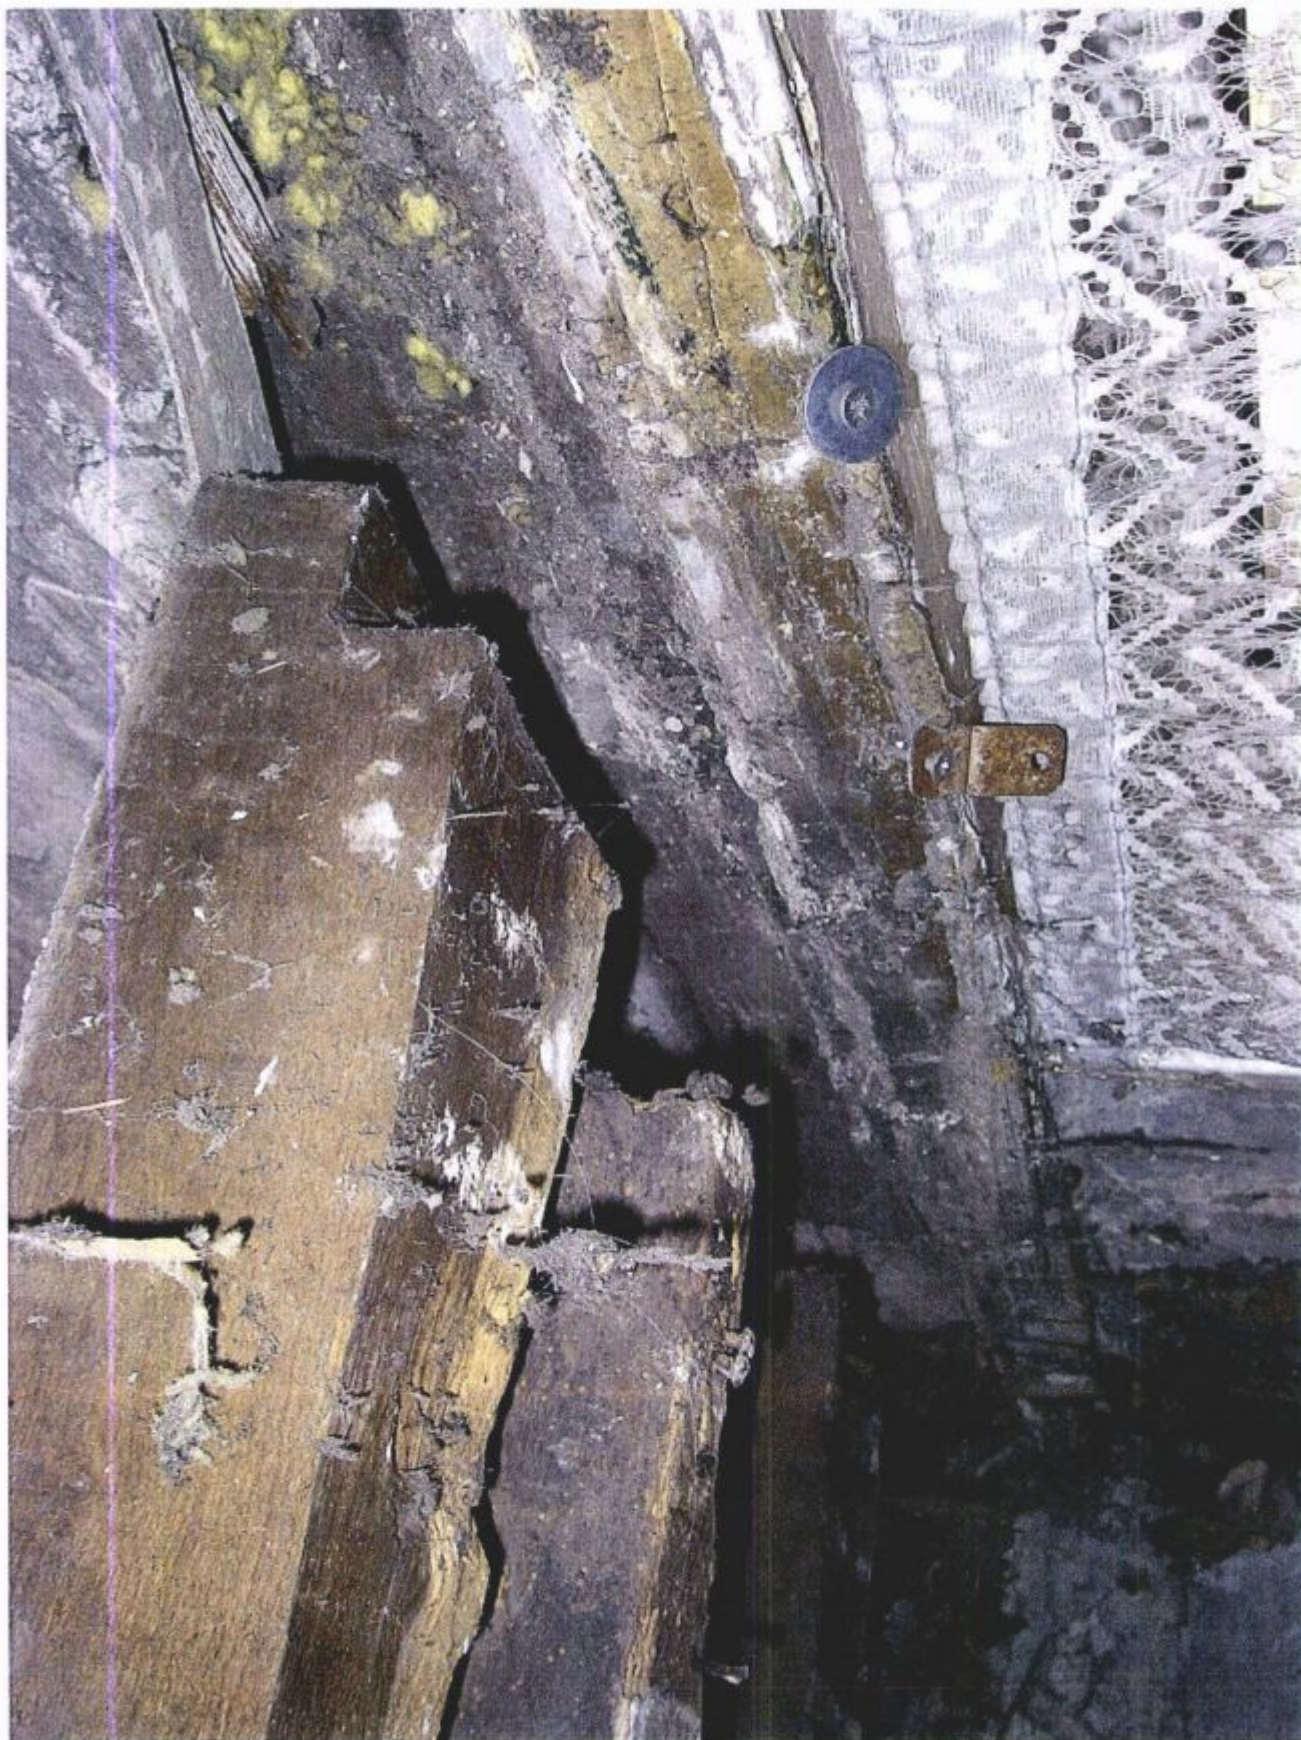
Photo No. 09.30.09/48

There are buried timbers over the window-head internally, which are suspect and which require to be replaced. [ 2/ 75 x 150 outer under flashing, 1/ 120 x 100 inner. All with worm infestation]. **(See Photo No. 09.30.09/48.)**

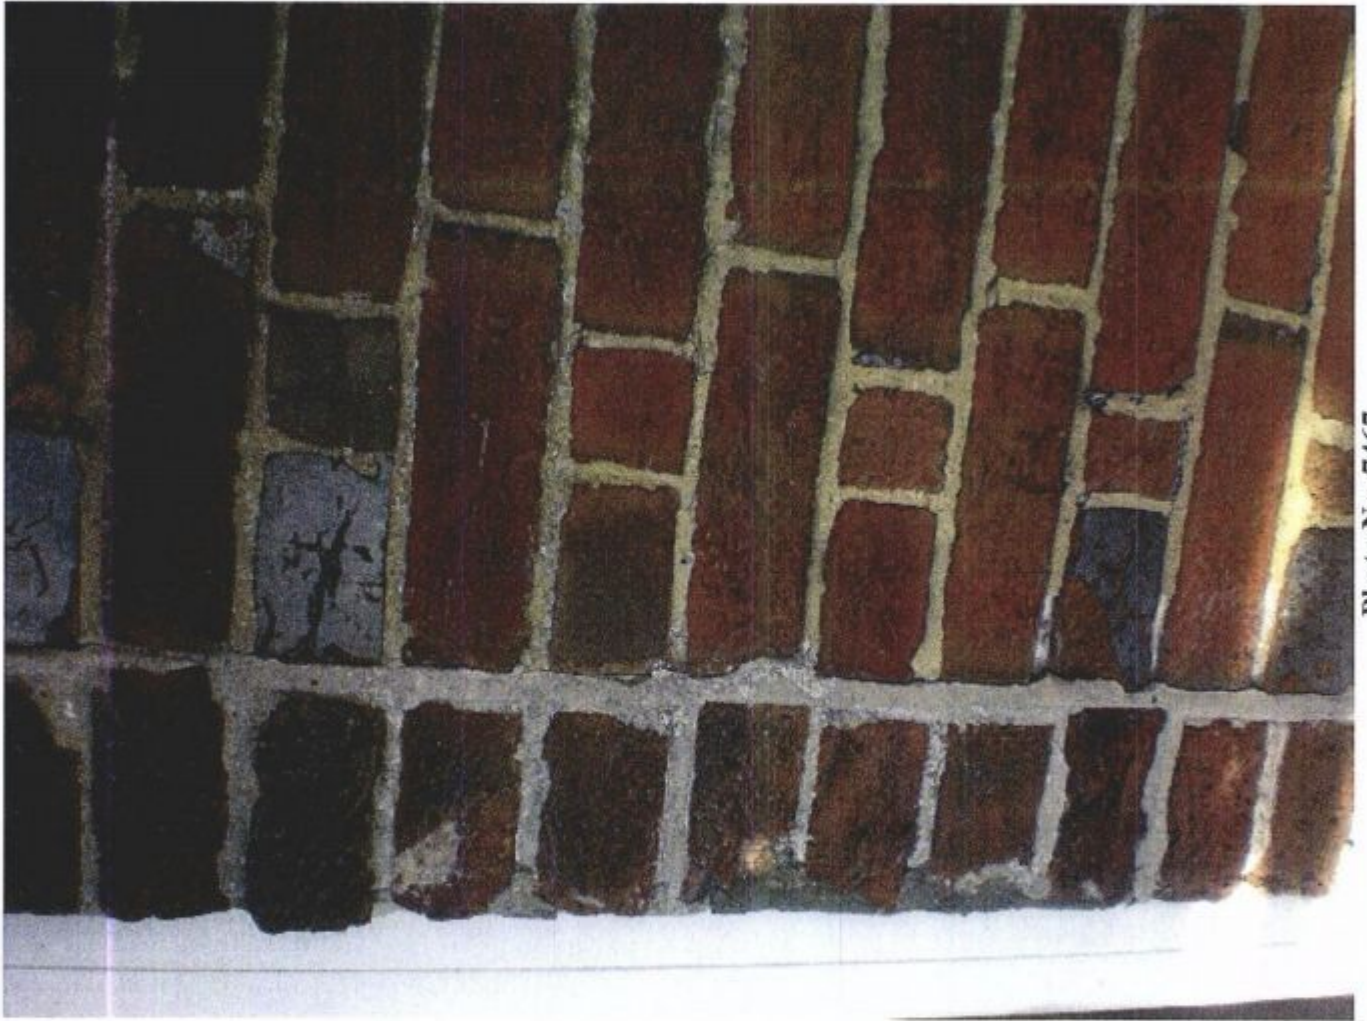
Photo No. 7467

The lintel over the present door is horizontal soldier coursed brickwork externally, which then adjoins the previous crown of a soldier coursed segmental brick arch at the east to a previous doorway.

The eastern bearing is only 102mm wide brick on end and straight jointed to the previously infilled opening. **(See Photo No. 7467.)**

- The old infilled doorway is to be re-opened, which will dictate widening of the opening to accommodate the party wall construction between the two doorways and the replacement of the existing lintel and partial segmental brick arch.

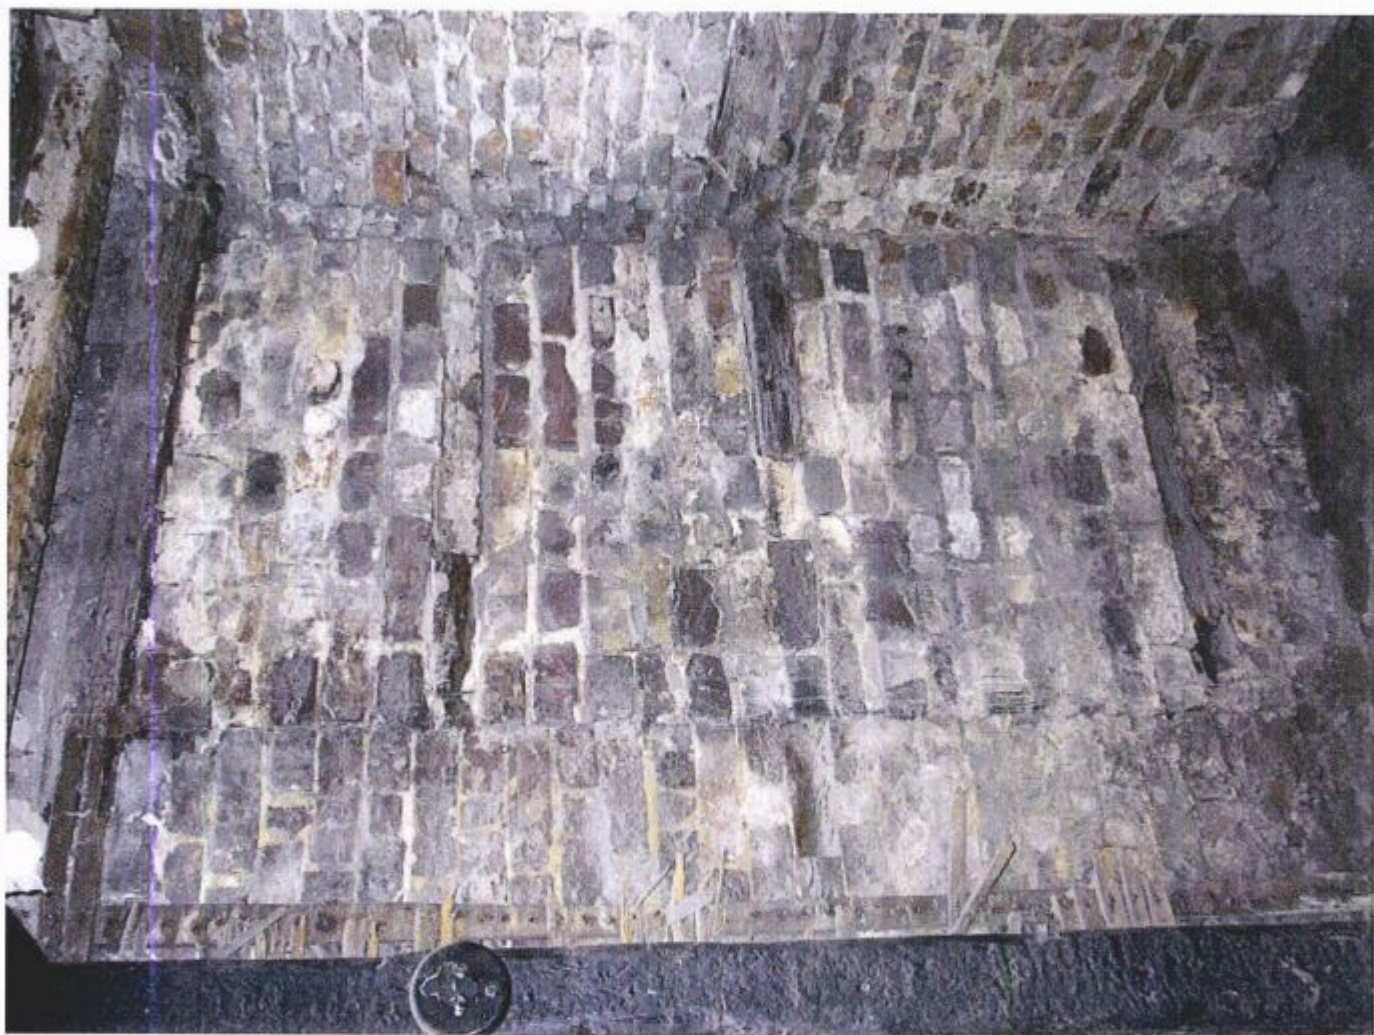
Internally, the infilled doorway has a buried timber lintel above and timber plates within the panel; all of which are suspect. **(See Photo No. 09.30.09/045 which shows the infilled panel and timber plates and see Photo No. 09.30.09/044, which shows the abutting 100mm infilled stud wall to the corridor and the outward lean to the front wall at the junction.)**

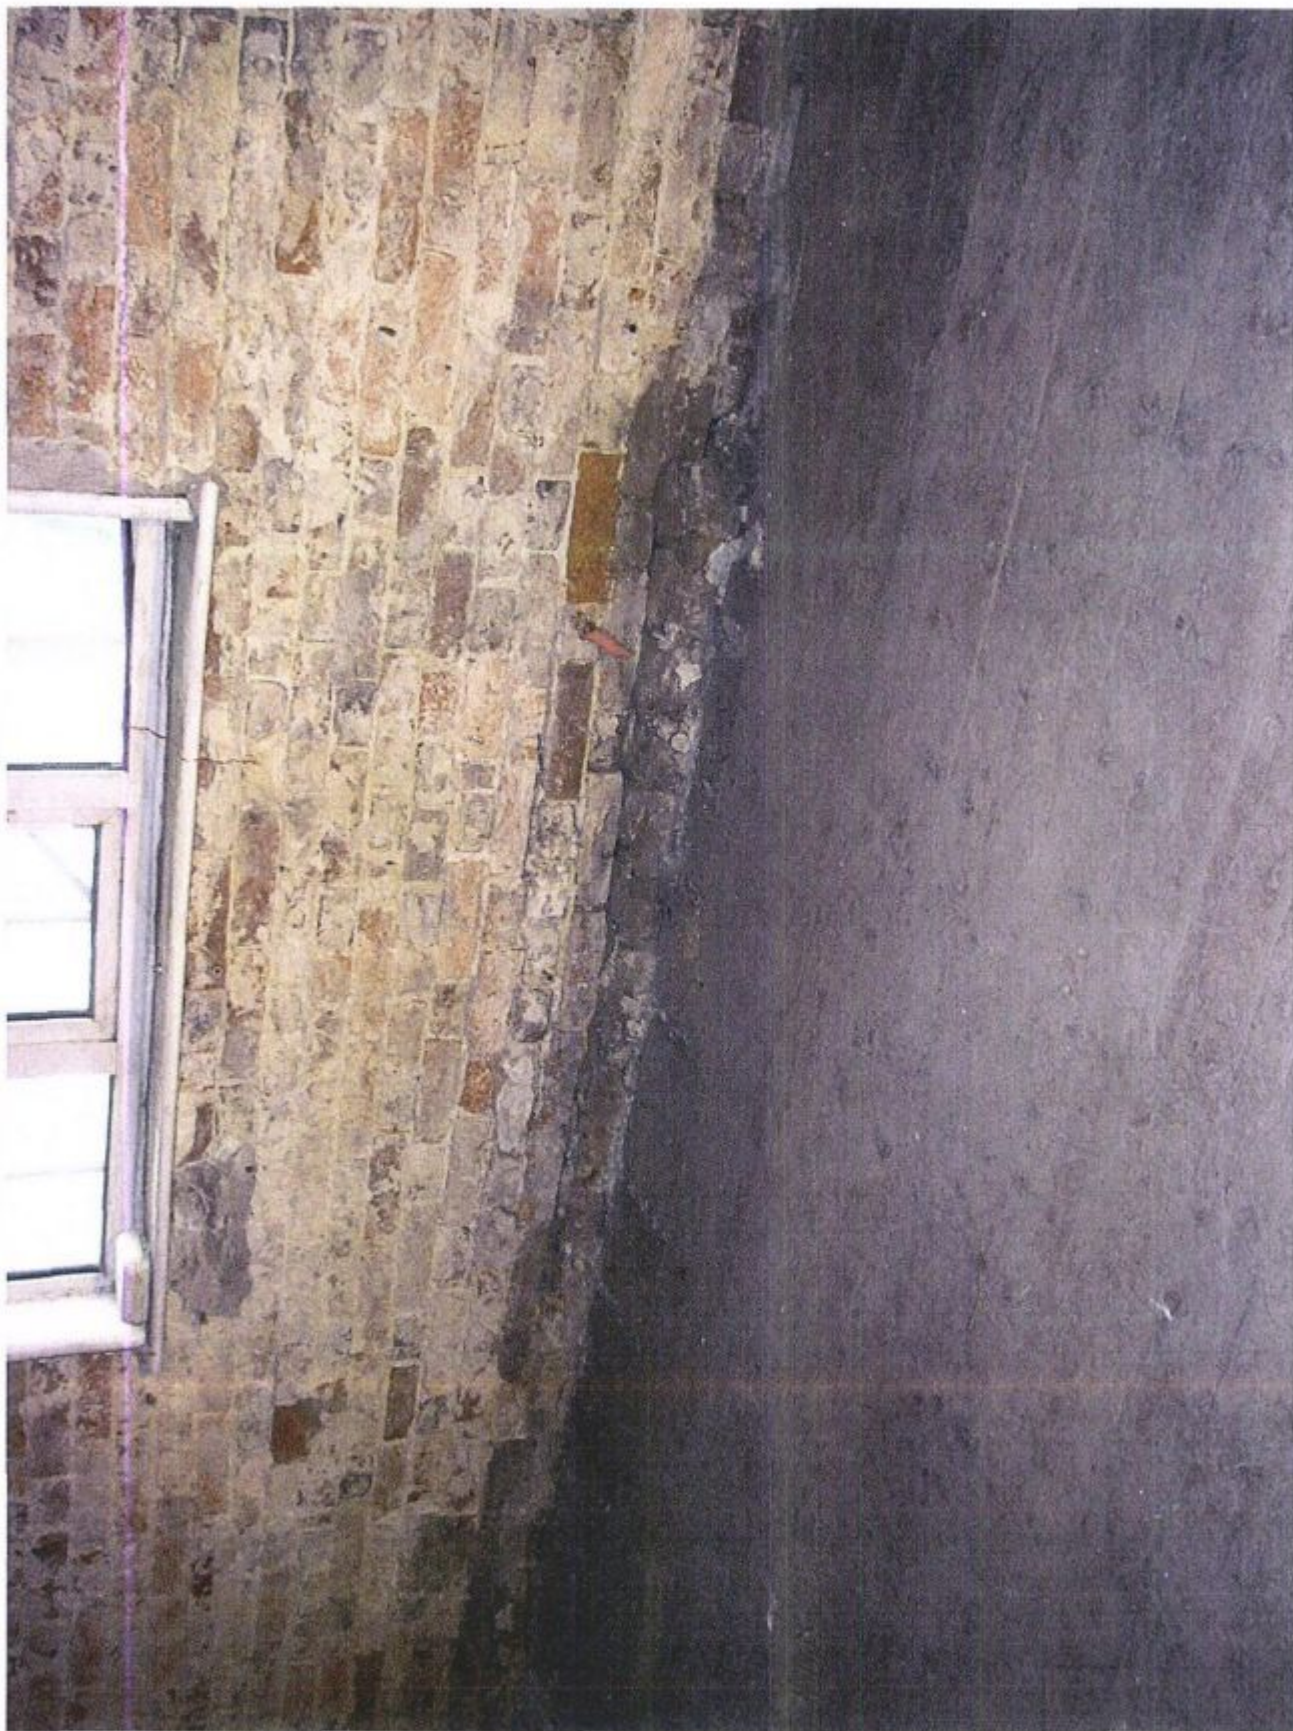
Photo No. 09-30-09/037

- Bedrooms 1 & 2 timber window lintels show pronounced deflection and are both suspect.
- Bedroom 2 shows a considerable length of loose/missing masonry below the window at first floor level. (**See Photo No. 9.30.09/037.**)

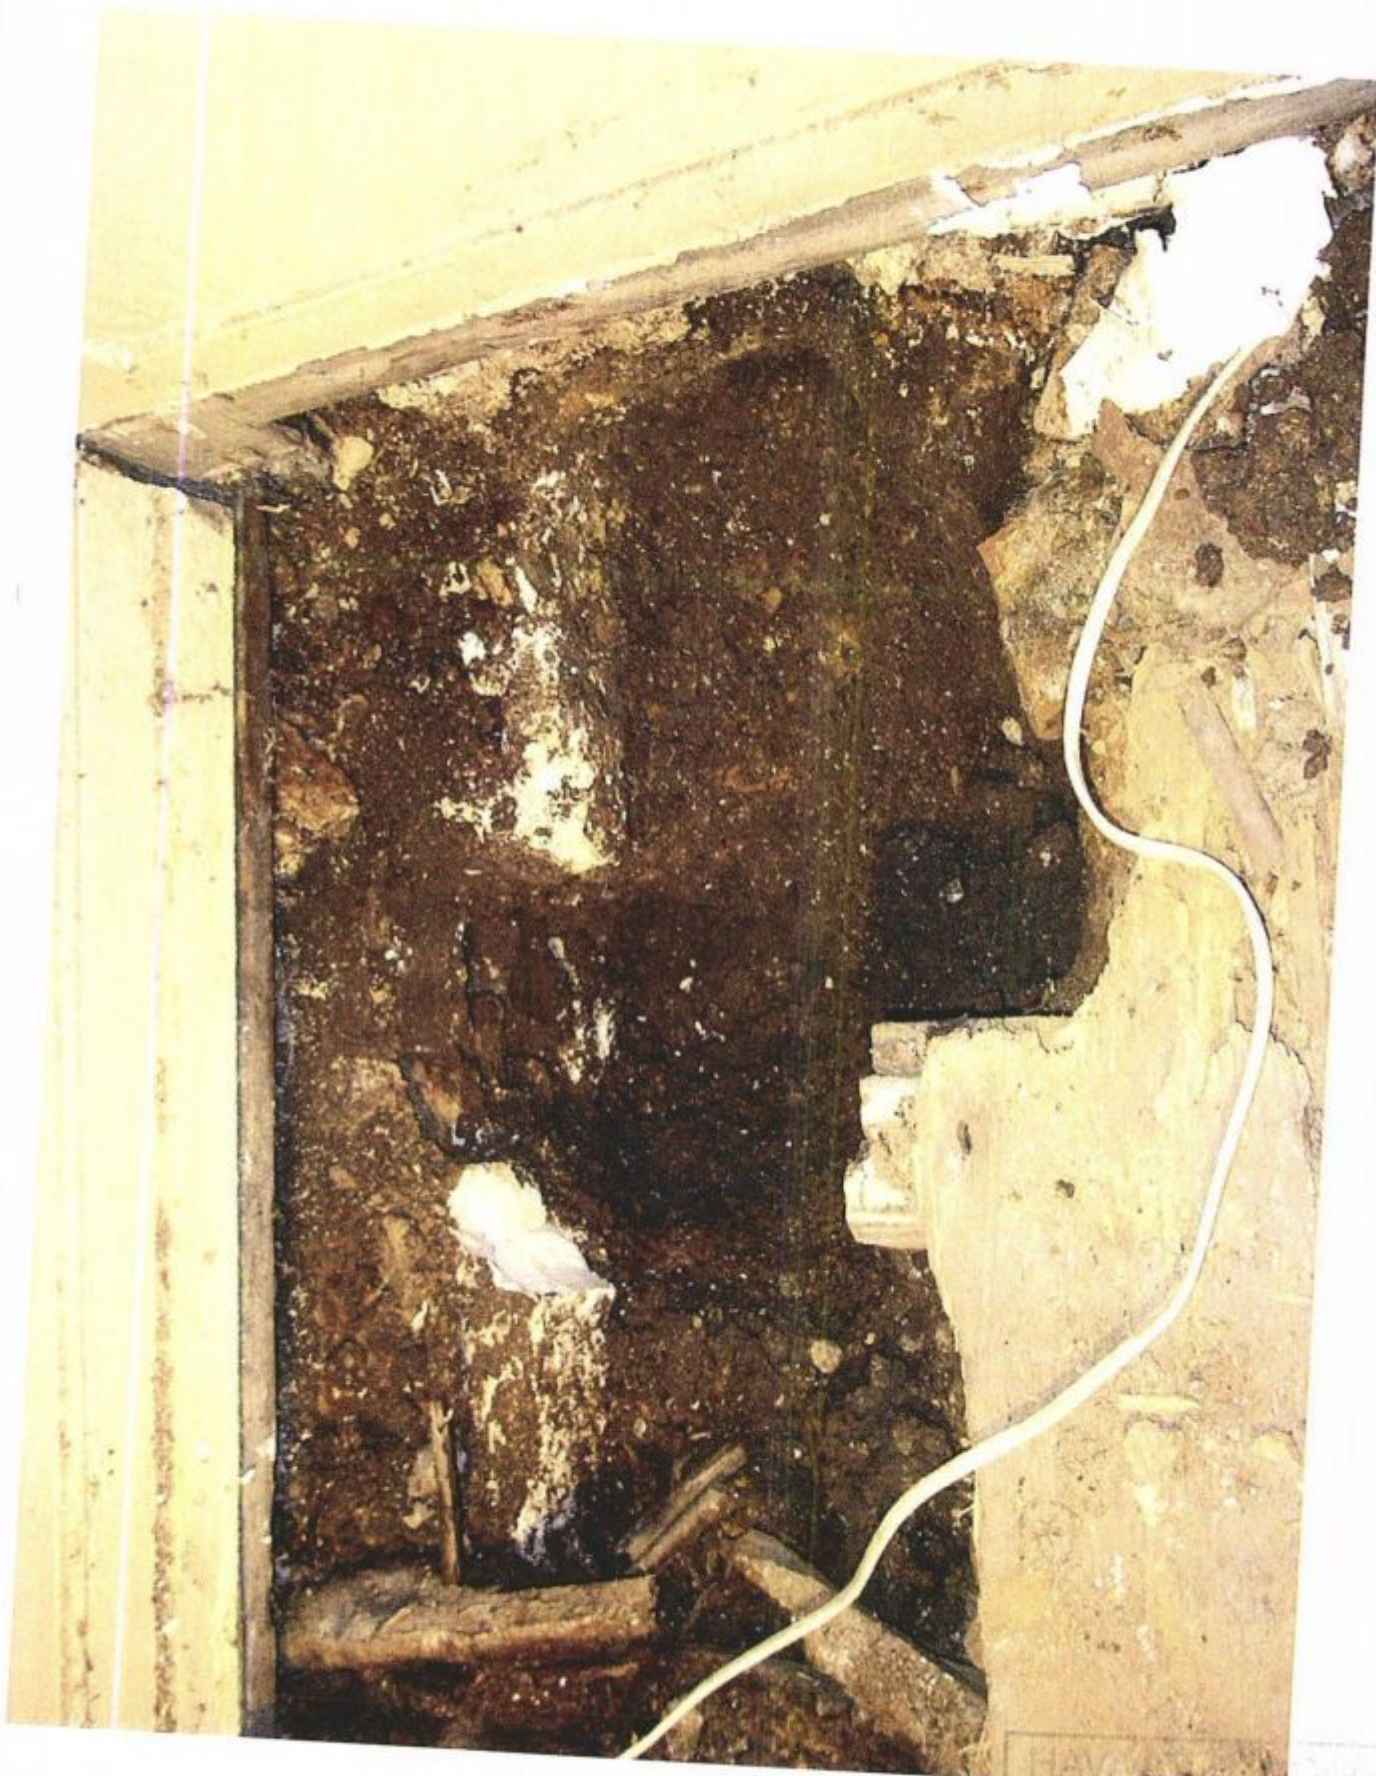
Photo No. 07-15-09/039

- The internal lintel to the eastern window is 120mm deep, worm infested and should be Replaced.
- A small trial pit undertaken internally adjacent to the infilled doorway and abutting the corridor wall (**see Photo No. 07.15.09/039**) though curtailed due to the fragility of the wall, suggests that there is very little by way of a foundation to the front or internal corridor walls.

Consequently, the whole front elevation will require a new foundation and dpc to suit the ground floor construction.

This would dictate underpinning over the complete wall length.

Obviously, the pronounced outward lean, particularly at the western side and the weakened ground floor storey due to the earlier straight jointed infills and decayed timber plates; make underpinning a serious Health and Safety risk, which should be avoided/designed out.

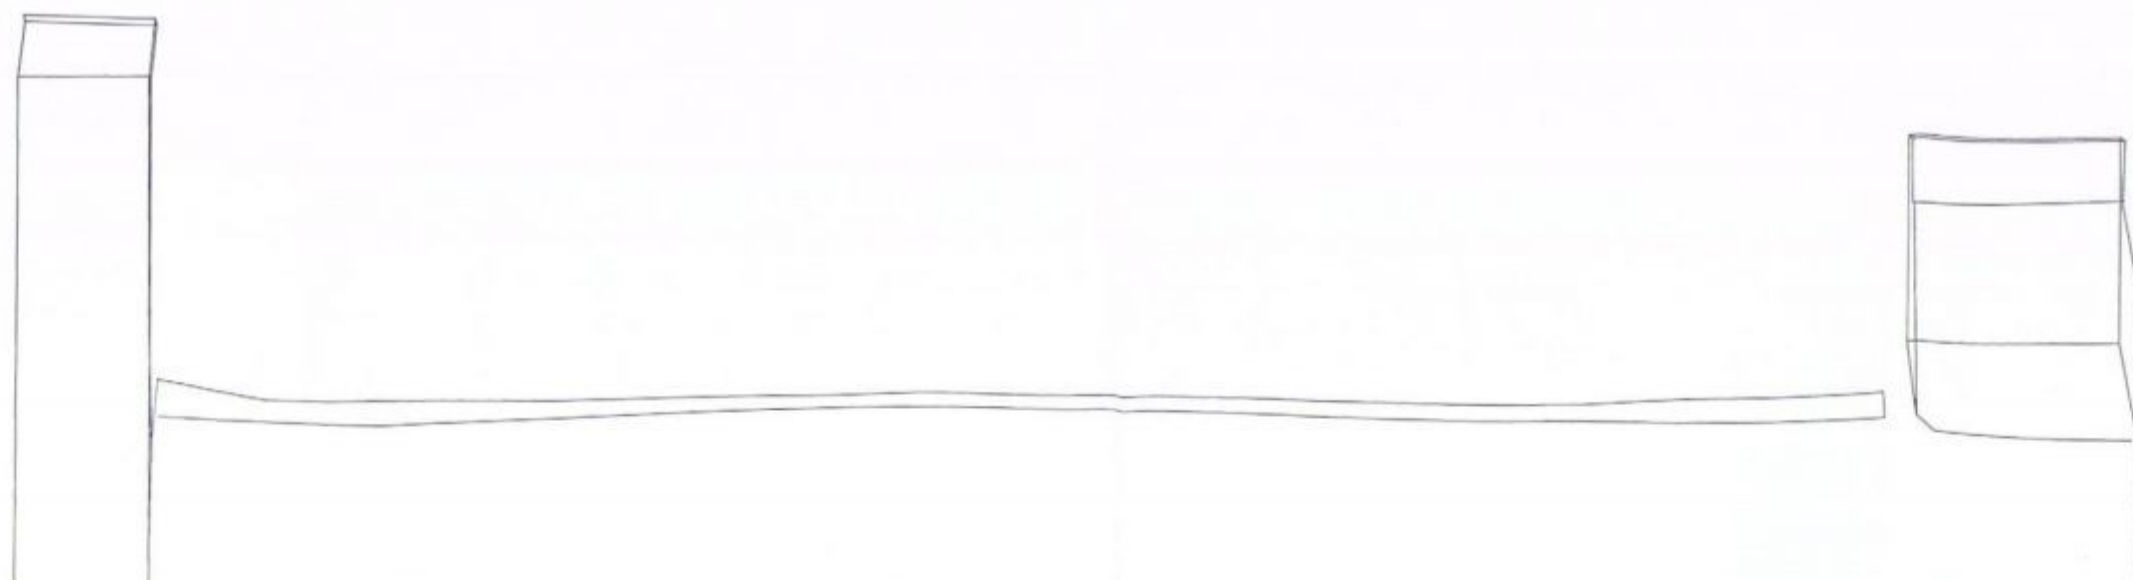
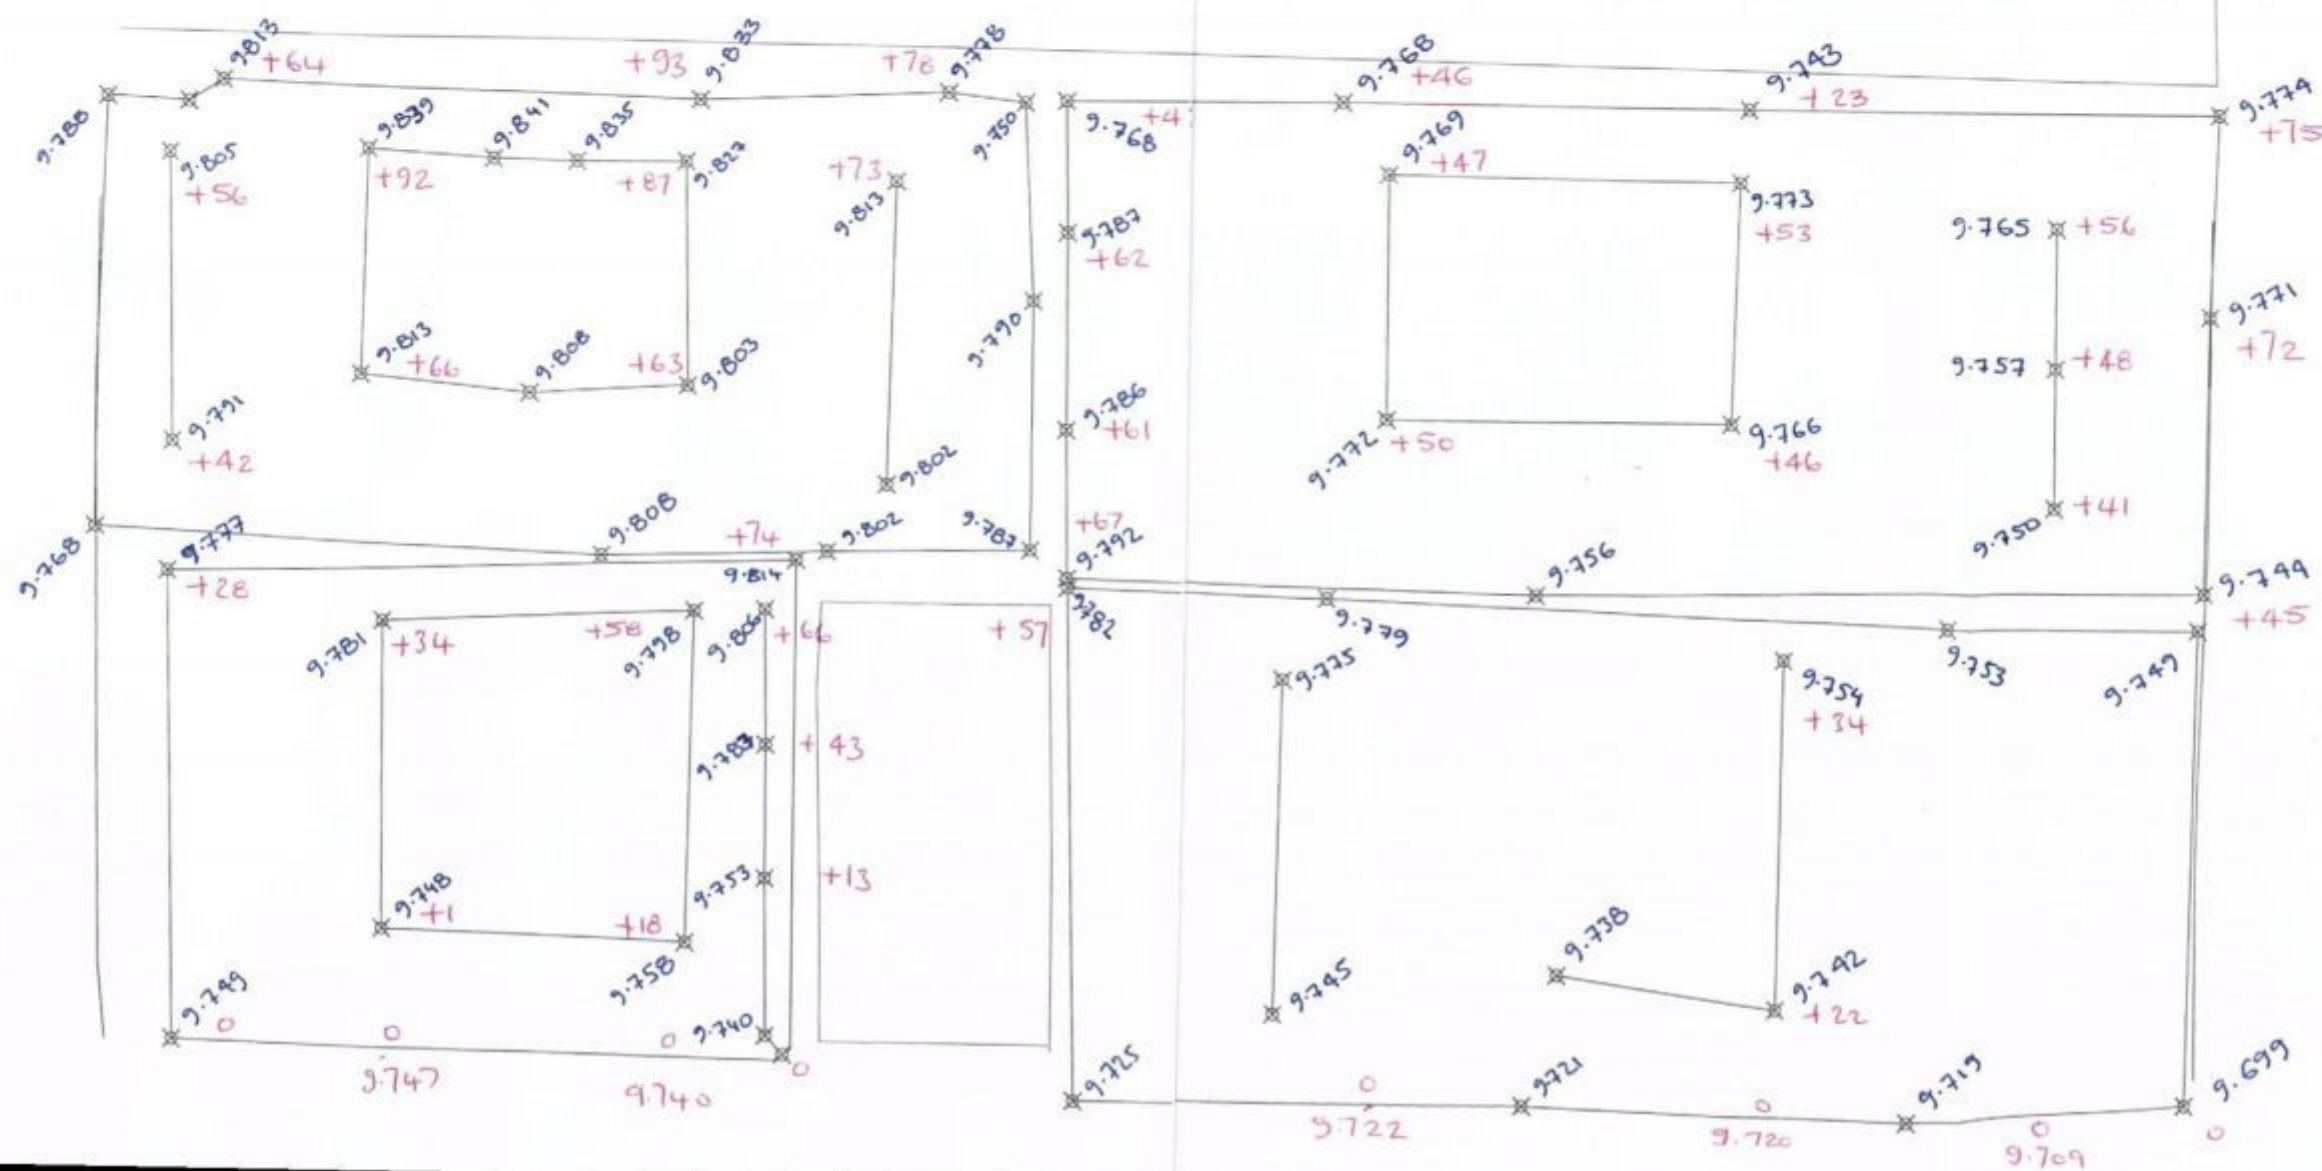
2844/S/02

The external distortion over the height in relation to the base of the wall is at its worst at the west, varying from 44mm at the east to 86mm at the western window-head externally and 93mm at plate level, internally at a similar location.
