**Application No. APP/13/00937**

**Address: 14, King Street, Emsworth PO10 7AZ**

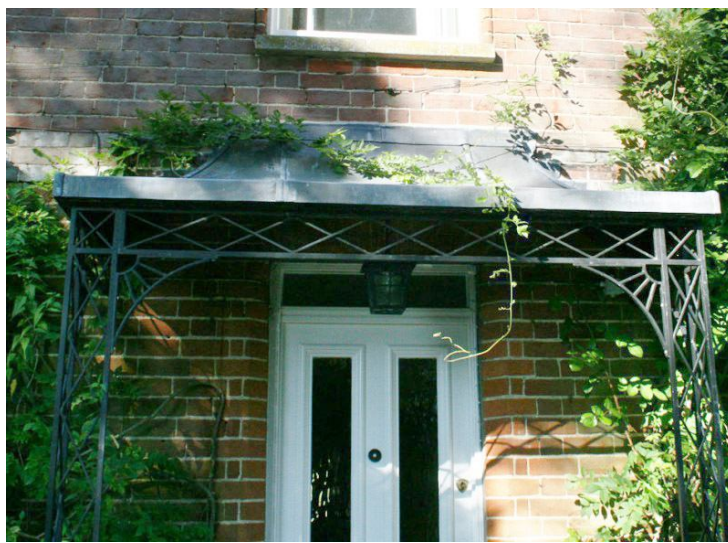
Can not be sure of date of porch (early/mid C20?) but it is a modern take on a Regency Porch usually executed in iron lattice work rather than timber. See photo example below.
