# 39 SEAFRONT, HAYLING ISLAND.

## RECOMMENDED 'LISTED BUILDING' WORKS FOLLOWING VISUAL SURVEY CARRIED OUT IN SEPTEMBER 2012

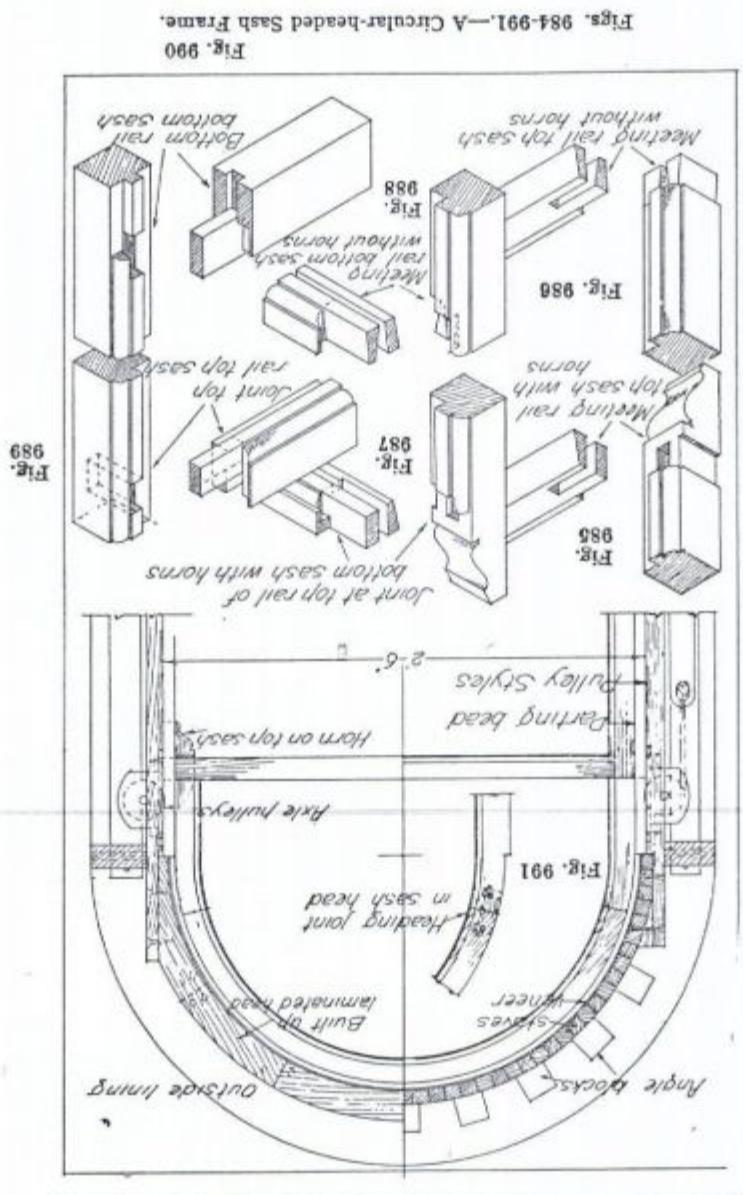
DETAIL A

| DESCRIPTION | EXISTING CONSTRUCTION | PROPOSED REPLACEMENT / WORKS |
|---|---|---|
| | 3 <sup>rd</sup> Floor - Dormer windows in replacement double glazed PVCu Nos. 1, 2 & 3 [ 4127.11.6 ] | Take out and replace with softwood single glazed vertical sliding sash windows as per Detail "A" |
