## **Arboricultural Report**

**2 Emsworth Road, Havant, Hampshire**

Beechdown ref: B/0003/11  
2 Emsworth Road – tree impact assessment – march 2011

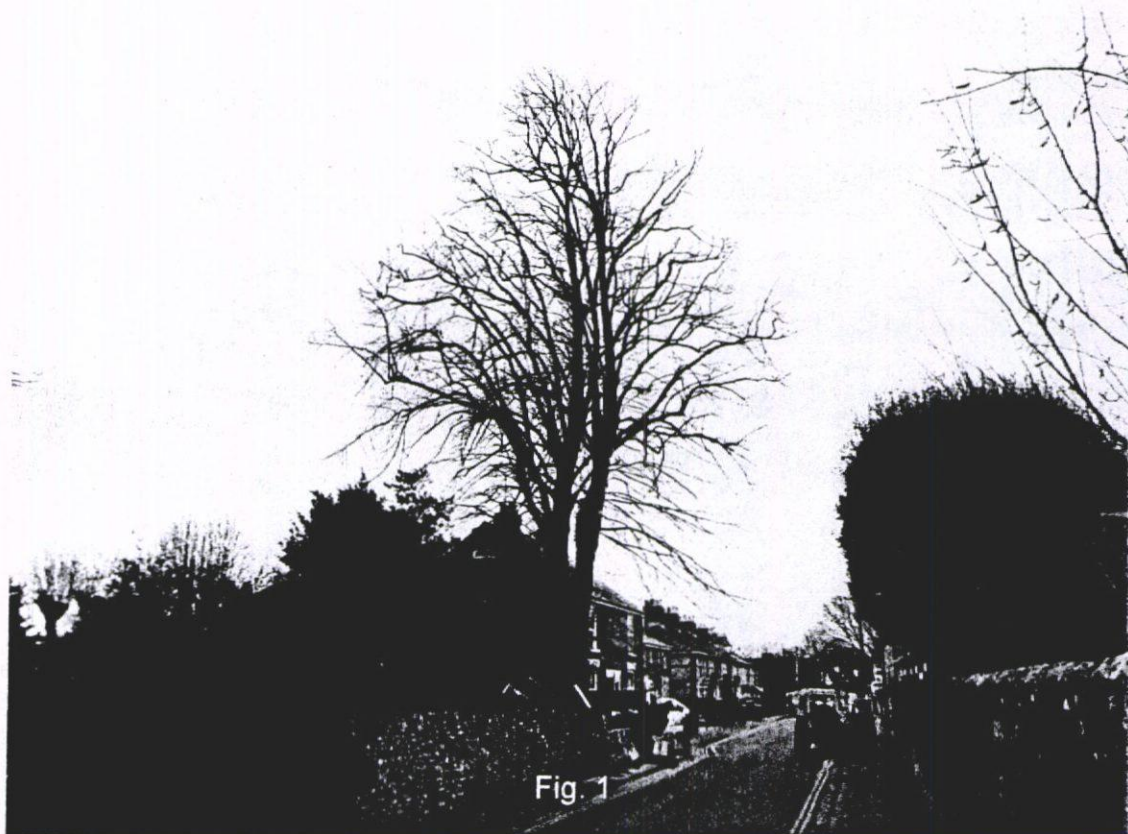
- 6.2 A mature tree dividing into two stems at 4m (**Fig. 1**) and subsequently pollarded at approximately 8m. The crown becomes multi-stemmed at the pollard points with the branches ascending sharply then arching to form a full and balanced crown.
- 6.3 The lateral growth is marginally less developed to the south.

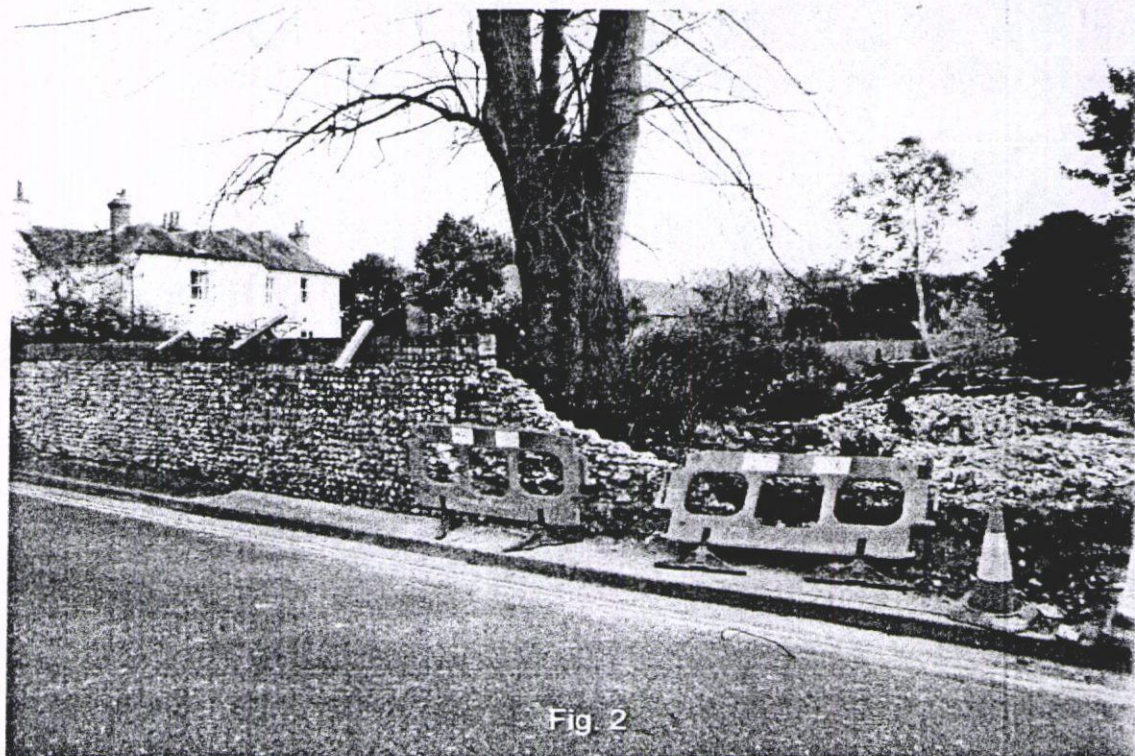
- 8.1 The boundary wall, running parallel with Lymbourn Road, was constructed of two leaves of flint facing with a rubble core (ref. Havant Borough Council correspondence 59352) with a brick coping.
- 8.2 The wall was fully collapsed from the southern end to approximately 3m from the tree at which point the inner flint facing partially remained and gradually stepped up to a point where it joined the intact wall (**Fig. 2**).

10.1.2 Reinststate the wall.

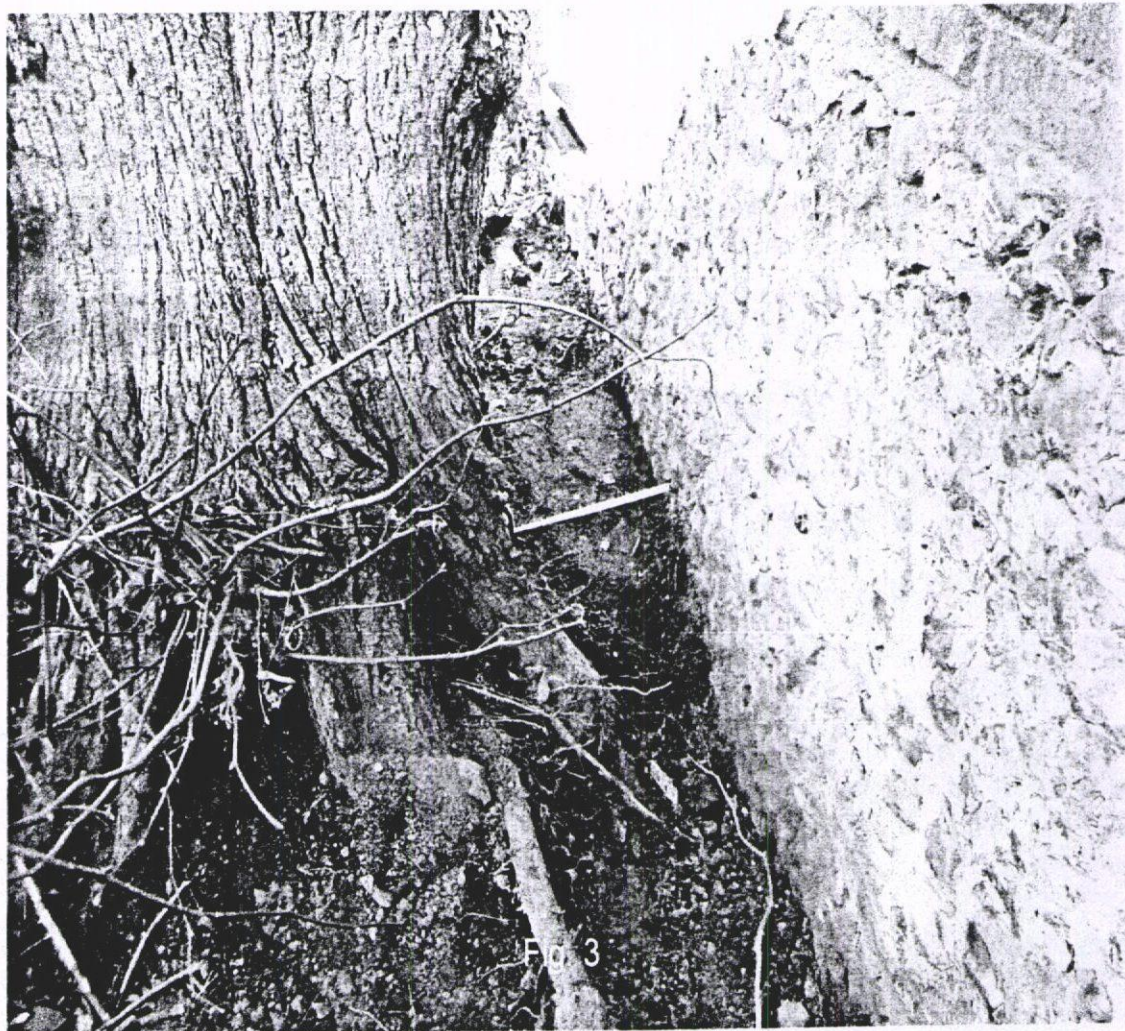
- Main stem above buttress flare - 50cm
- Buttress root at ground level - 30cm (**Fig. 3**)
- Buttress root 30cm below ground level - 20cm

9.2.3 As can be seen from **Fig. 3** there appears to be no obvious cracking or movement of the inner face of the flint wall at the closest point to the tree. Images from Google Earth taken in April 2007 show a section of wall missing at the southern end and some cracking in the adjacent brick coping but no apparent damage in the vicinity of the tree.

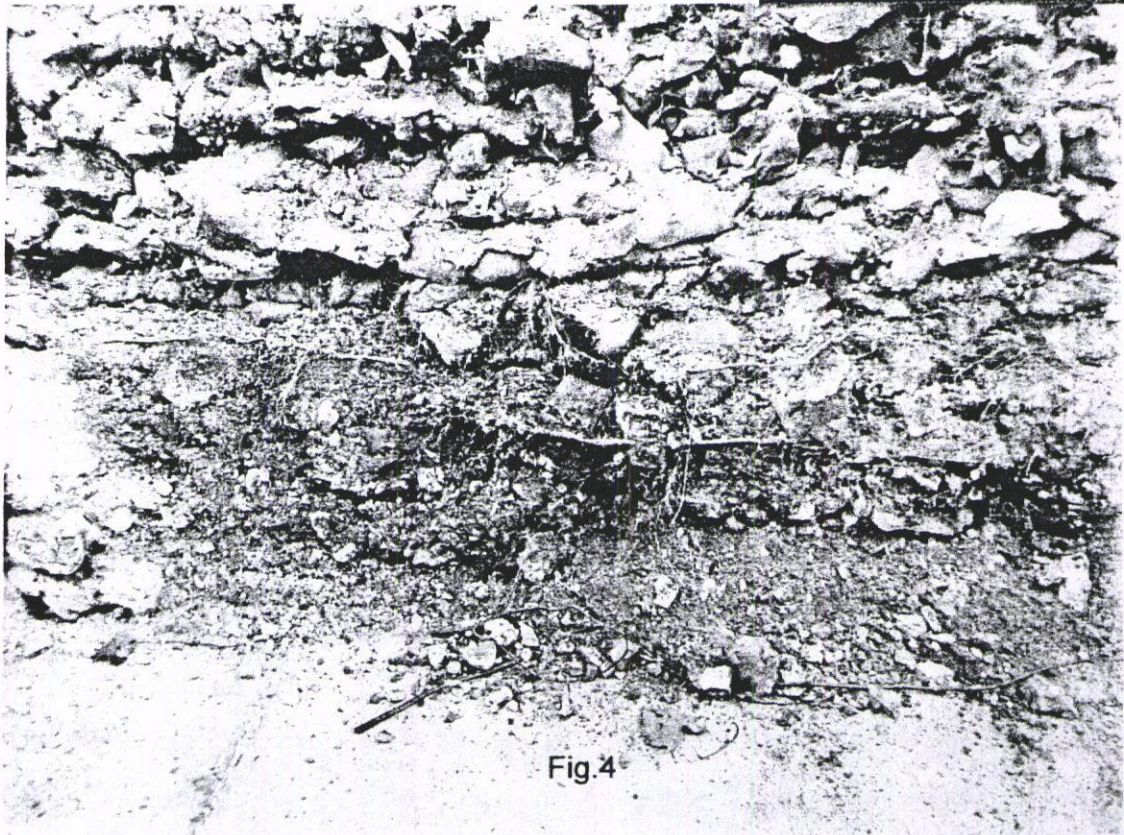
Fig.4

8.4 There were no major roots visible at any point in or along the line of the collapsed wall but some minor roots were present (**Fig. 4**).
