**FIRST STAGE APPRAISAL**

**86 WEST STREET  
HAVANT  
HAMPSHIRE  
PO9 1LN**

**Job No: 2844**

**Date: 6<sup>th</sup> August 2009**

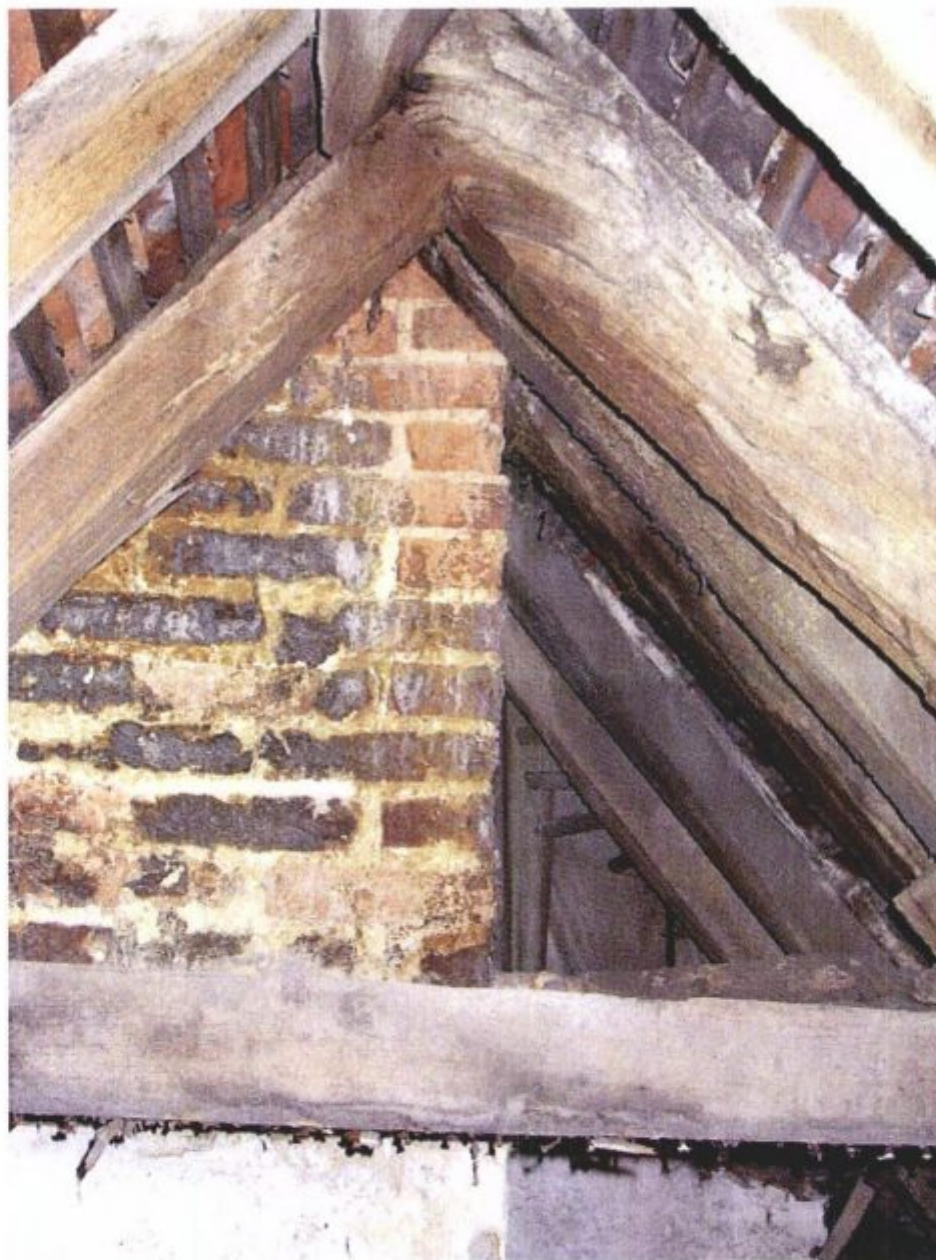
Photo 001 – Ridge at East Chimney Stack.

There is also an old ridge plate over the rafters at the rear pitch at this point (see Photo 001) and the rear rafters are bearing on it.

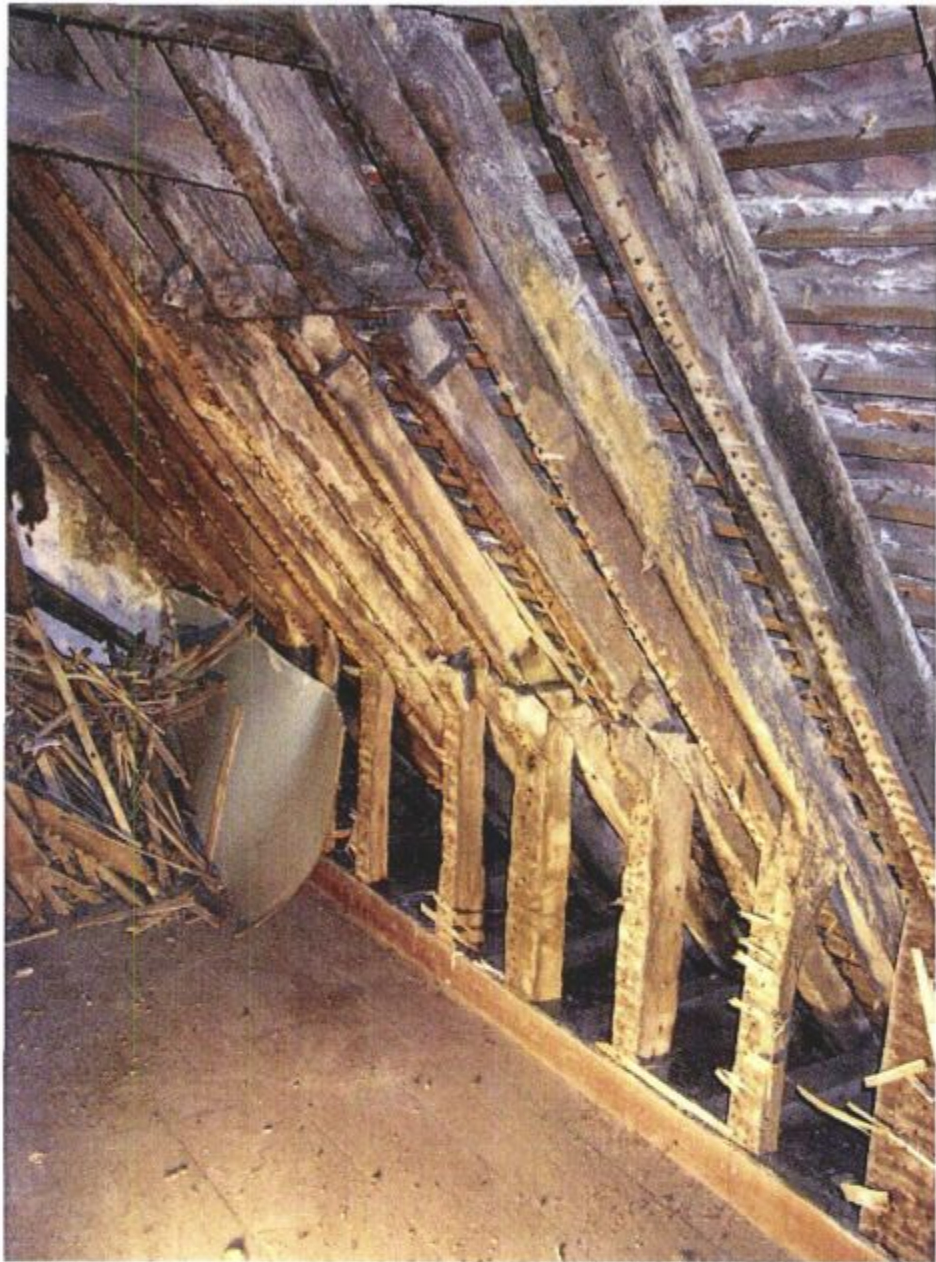
**Photo 003 – Roof Accommodation Area Front Pitch.**

- First 2 No. front rafters to West of stack are in extremely poor condition due to insect infestation and decay.

They have also been “furred out” in the past. (See Photo 003.)

The main rafters framing the original opening are showing signs of decay.

The opening has been infilled with 2 No. loose rafters, which are in poor condition. (See Photo 003.)

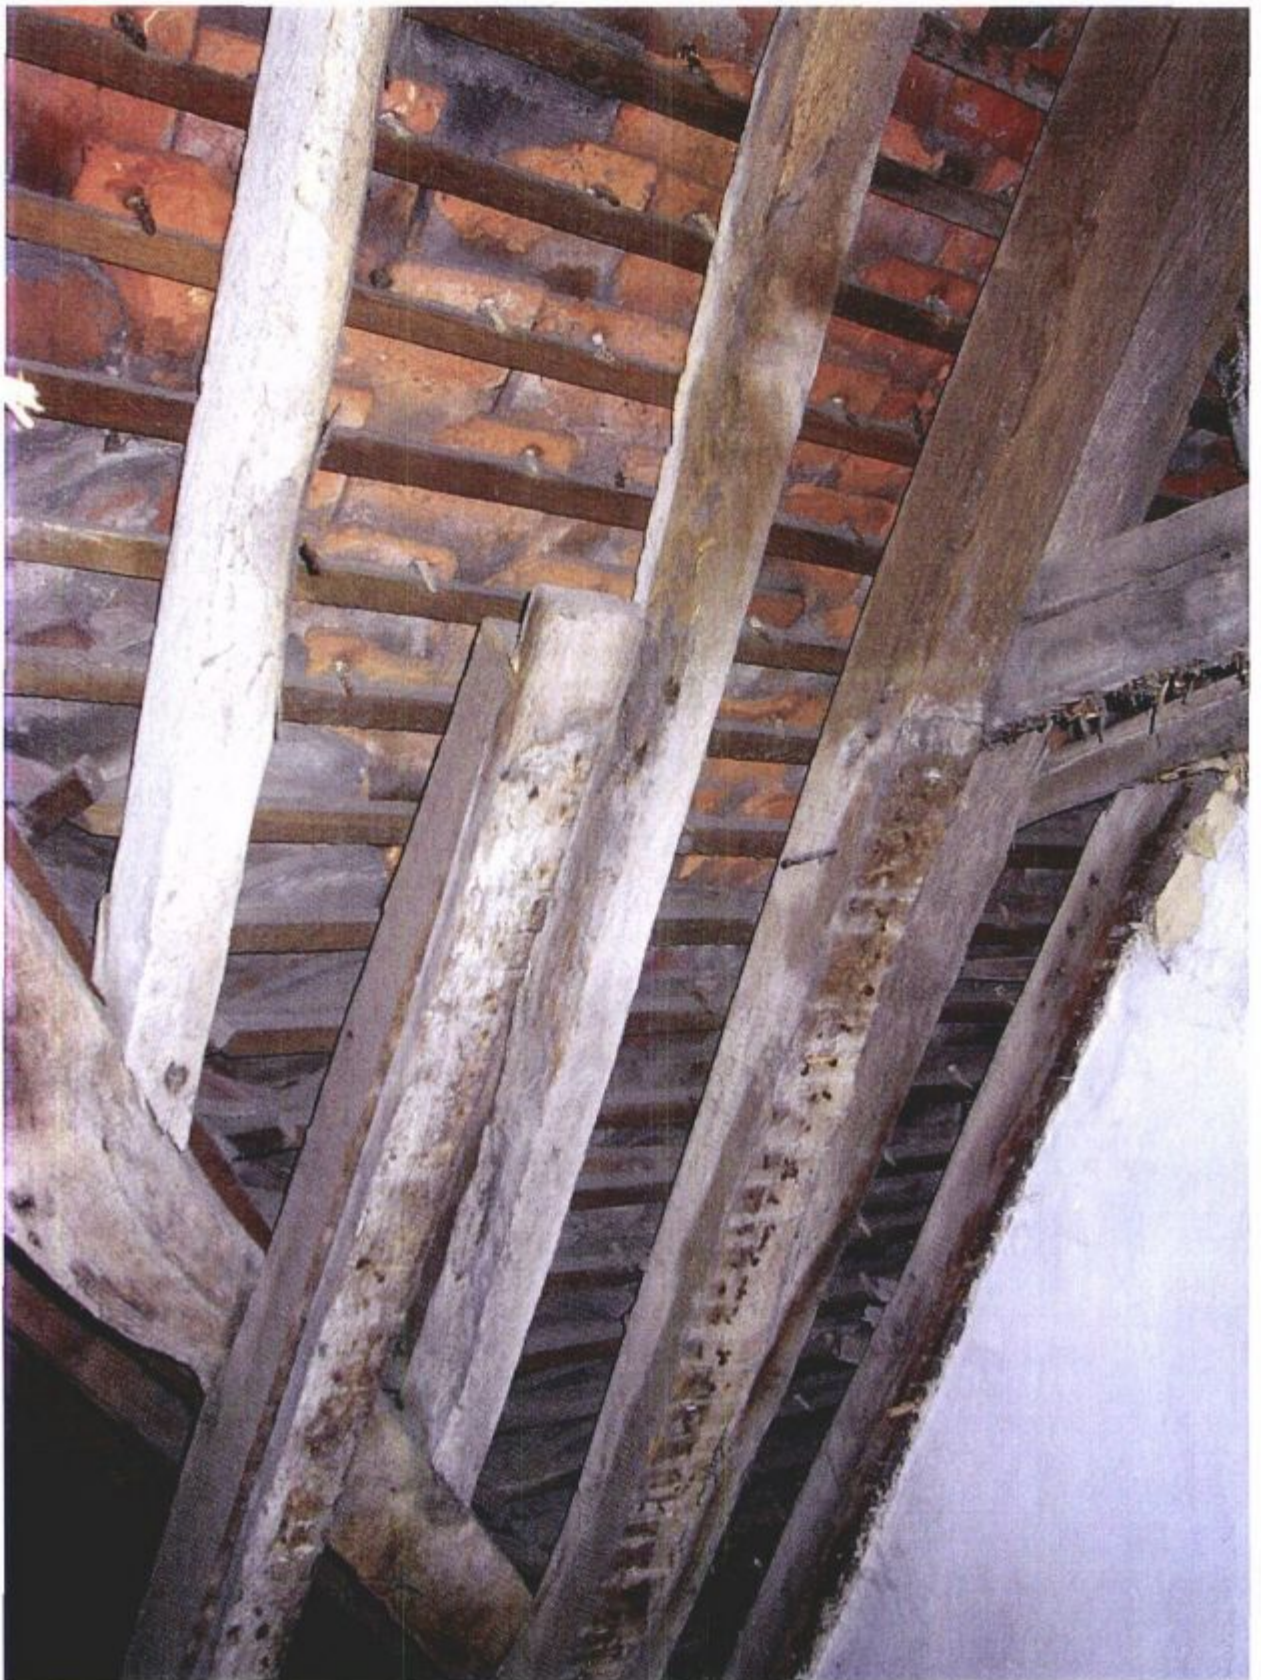
**Photo 004 – Roof Accommodation Area.  
Rear Pitch Northeast Layboard/Beam.**

- The rear pitch rafters from the Eastern stack are, generally, lacking any triangulation with the front pitch.

Few extend from the ridge to the loadbearing wall at floor level.

Many are cut into the lay-board forming the rear valley. (See Photos 004 & 005.)

Most sections are in average to poor condition and several have furrings on their top surface.

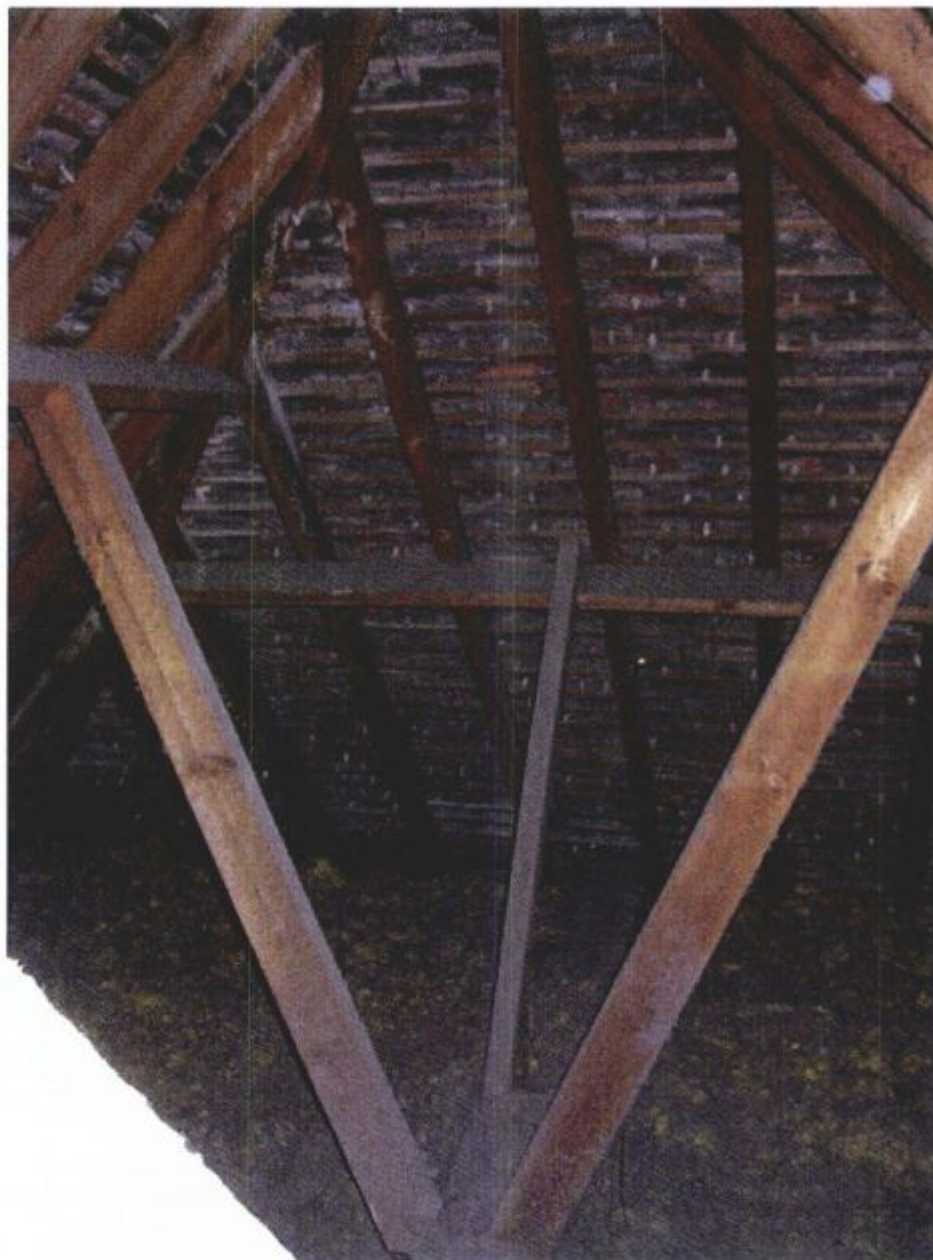
**Photo 006 – E-W Roof behind Roof Accommodation Area.**

- The roof is pitched East/West with a hipped end to the North. (See Photo 006.)

This roof has been totally replaced above ceiling joist level with softwood rafters over purlins at approx mid-pitch (see Photo 006).

These purlins have been struttled diagonally down onto the centre of the ceiling to what is considered to be a large timber carriage beam spanning North/South.

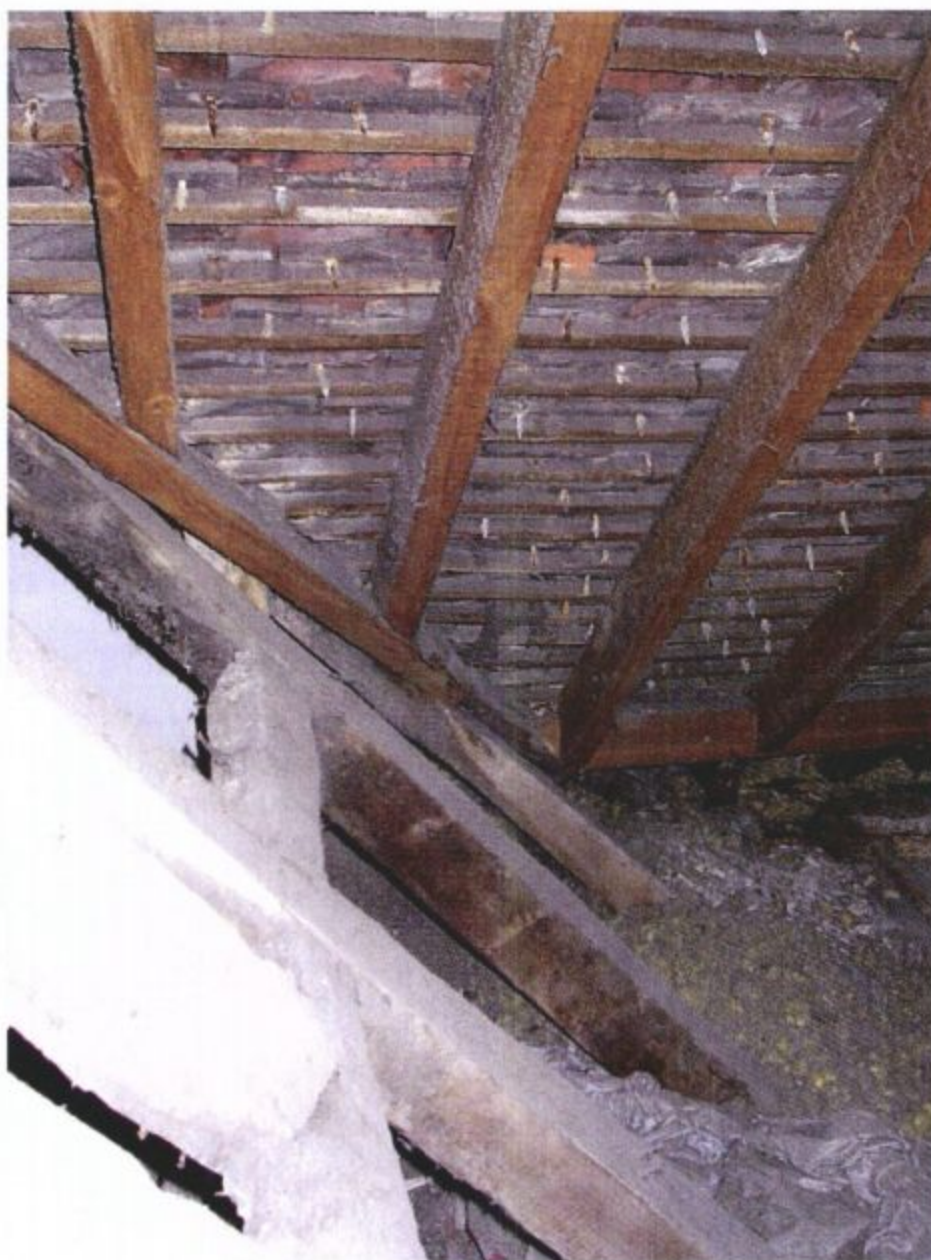
**Photo 007 – Rear West Pitch behind Roof Accommodation Area.**

The original ceiling joists are not readily visible due to the volume of insulation, but are believed to span East/West. (See Photo 007.)

**NB:-** The rafters are springing from a new timber plate bearing on the ceiling joists from the adjacent pitch to the West.

The roof is therefore not tied/restrained at eaves level.

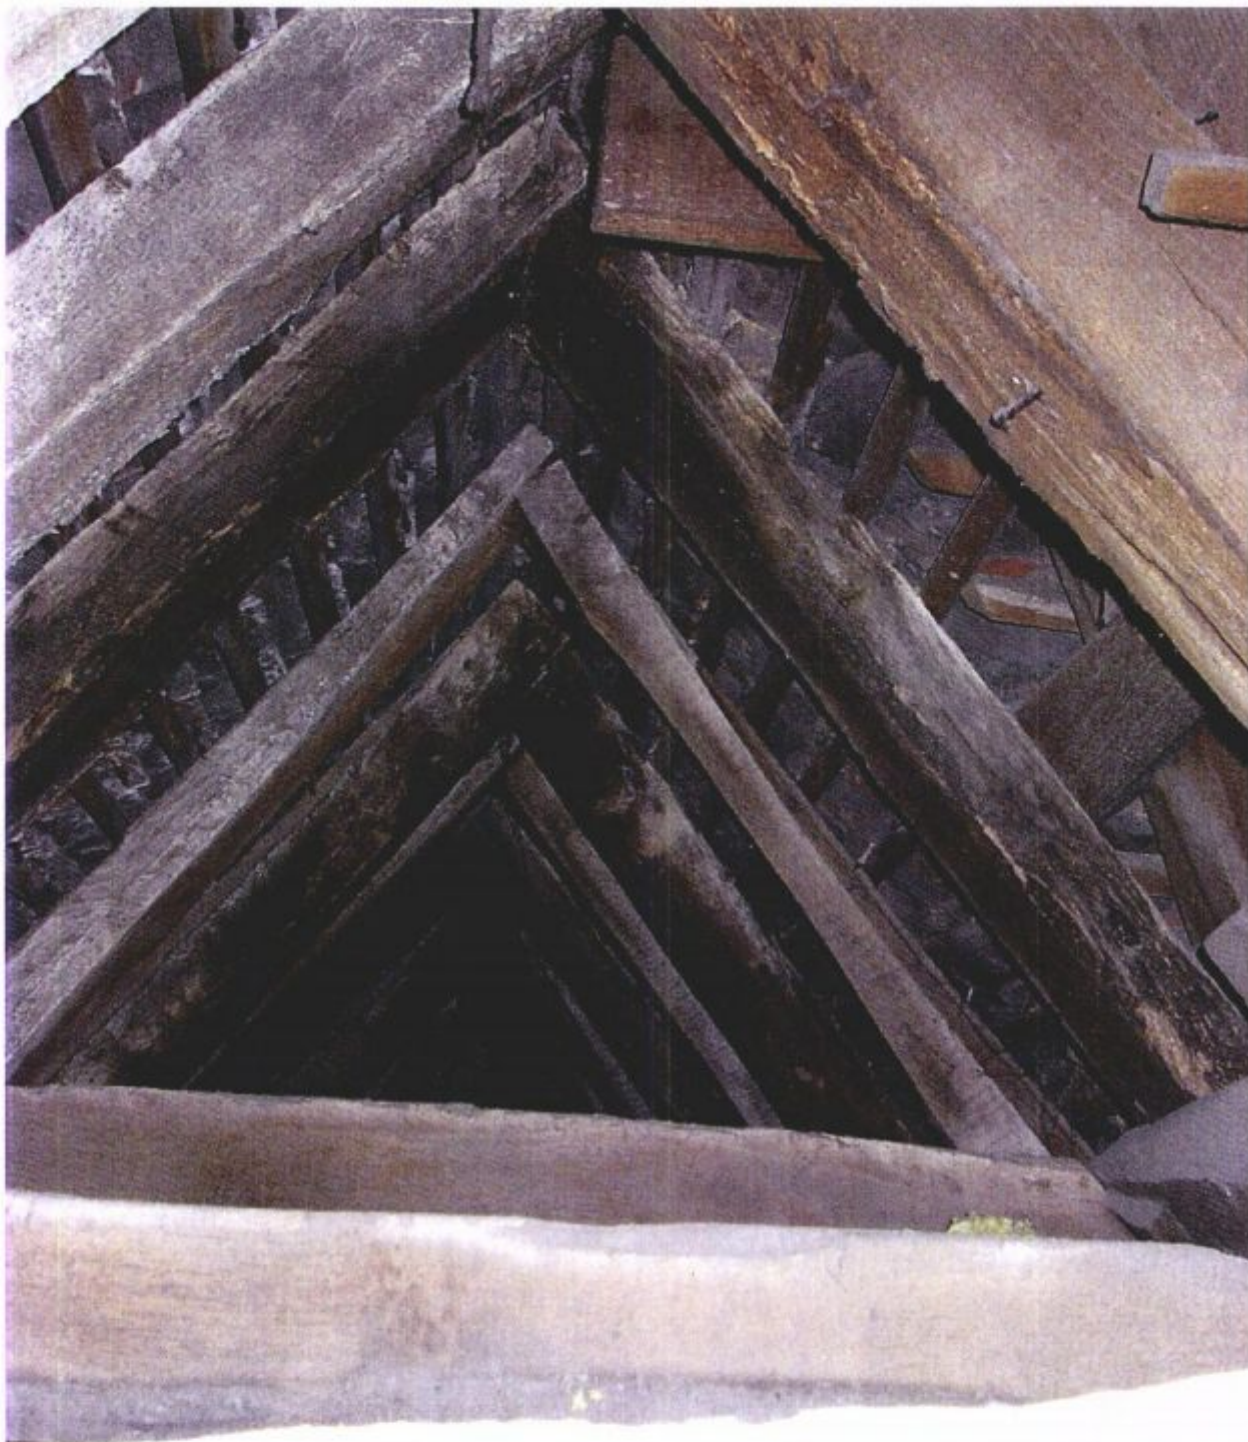
**Photo 008 – Ridge over Accommodation Area.  
Showing Ridge Board from Rear Pitch.**

- West of the incoming rear ridge-board, the rafters to the front and rear pitch, are aligned and are probably tenoned into one another, since there is no ridge board. (See Photo 008.)

Front pitch timbers West of the rear ridge beam appear in better condition, but have been previously “furred out” on their top face in order to remove some considerable deflection.

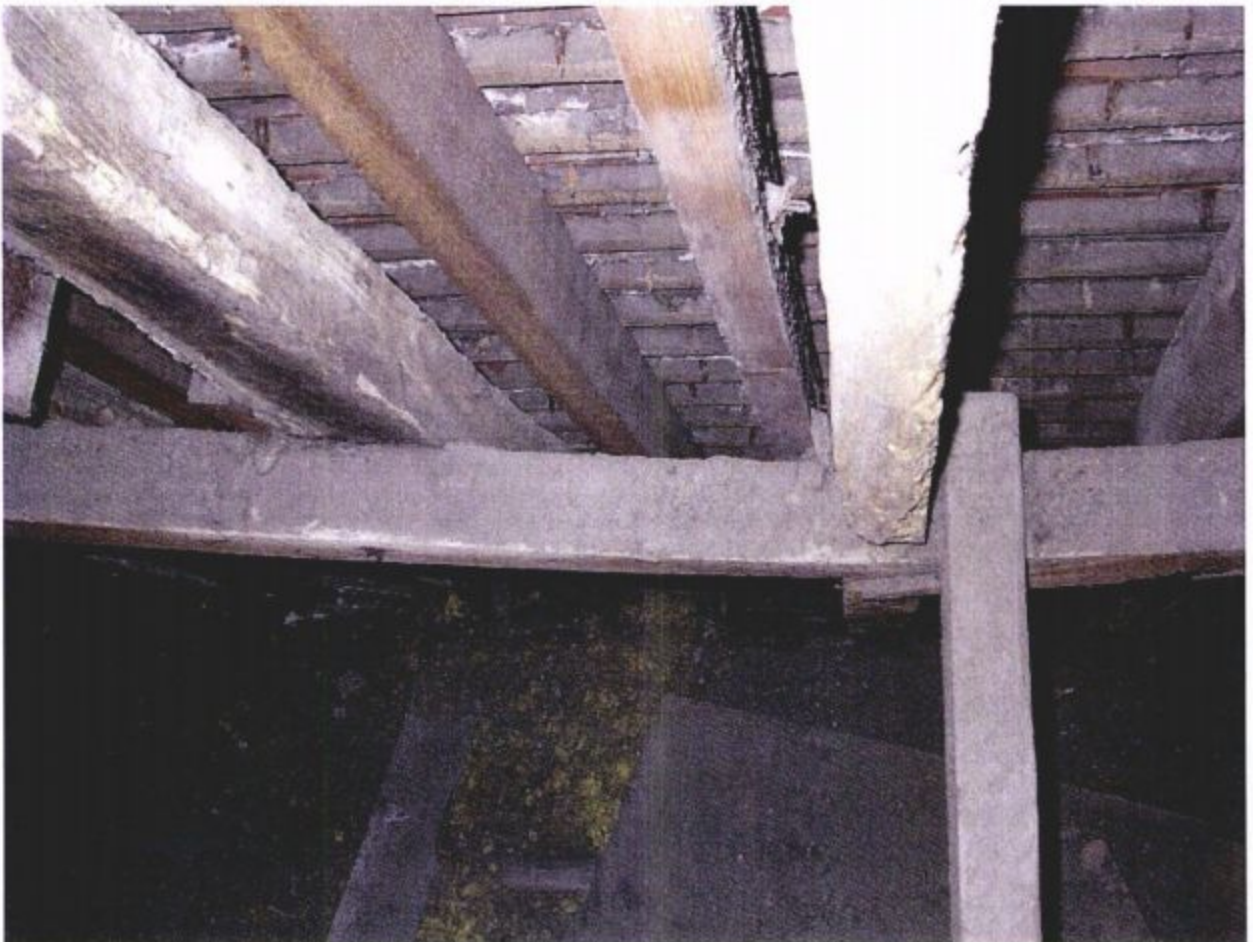
**Photo 012 – S.W. Roof Space. Front Pitch. Broken Purlin at Strut Position.**

Considerable deflection (approx 150mm) has been made good by overlaying with 50 x 100 softwood rafters. (See Photo 012.)

- The front purlin is broken at mid-span and has been diagonally struttled, although there appears to be no loadbearing element below the strut.
- The rear pitch has 2 No. intermediate purlins, both of which are broken at mid-span. (See Photos 014 & 017.)

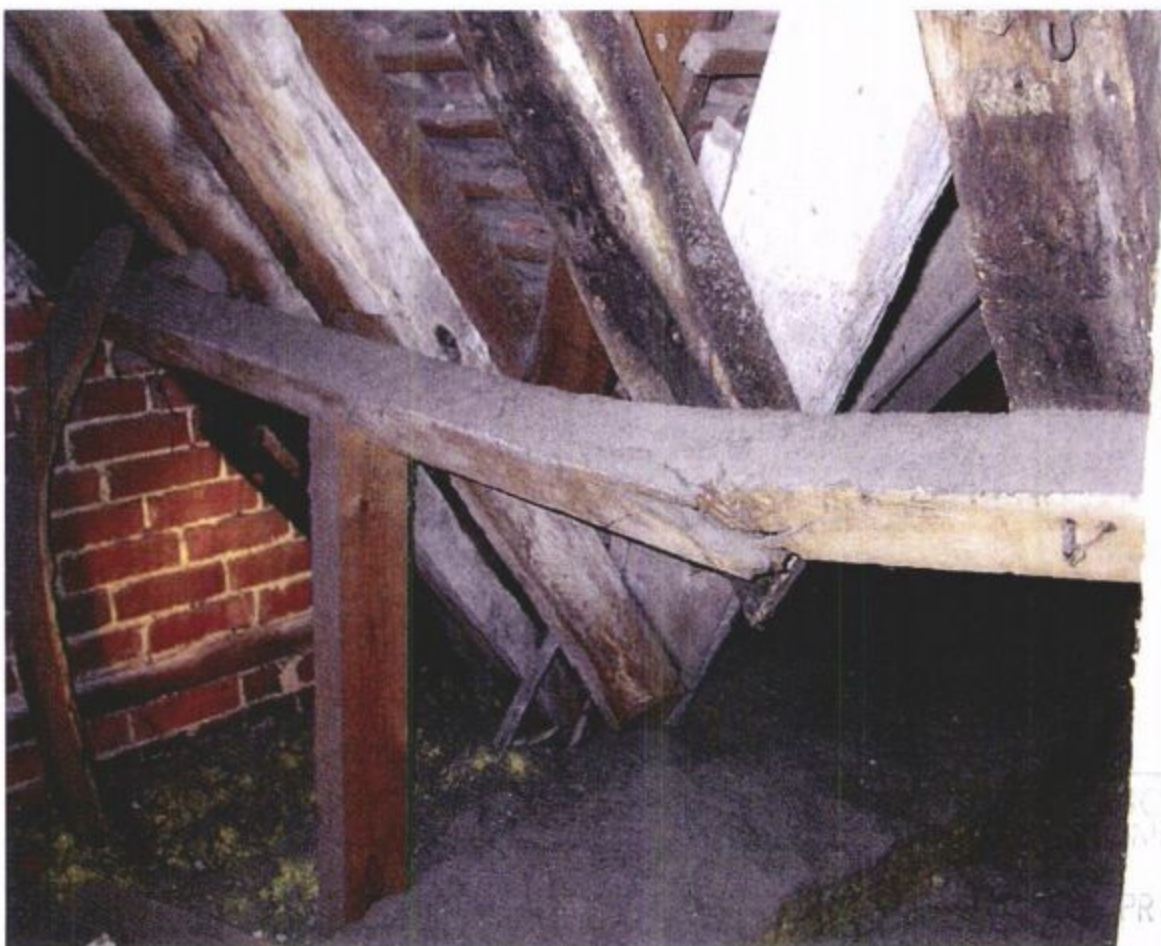
**Photo 017 – S.W. Roof Space. Rear Pitch. Broken Lower Purlin.**

The rear pitch rafters are trimmed into the lower purlin and valley lay-board and are inadequately supported causing the purlin failure. (See Photo 017.)

- The rear rafters have been “furred out” to compensate for the serious deflections evidenced. (See Photo 017.)
- The complete roof has been crudely and incorrectly strengthened in the past.

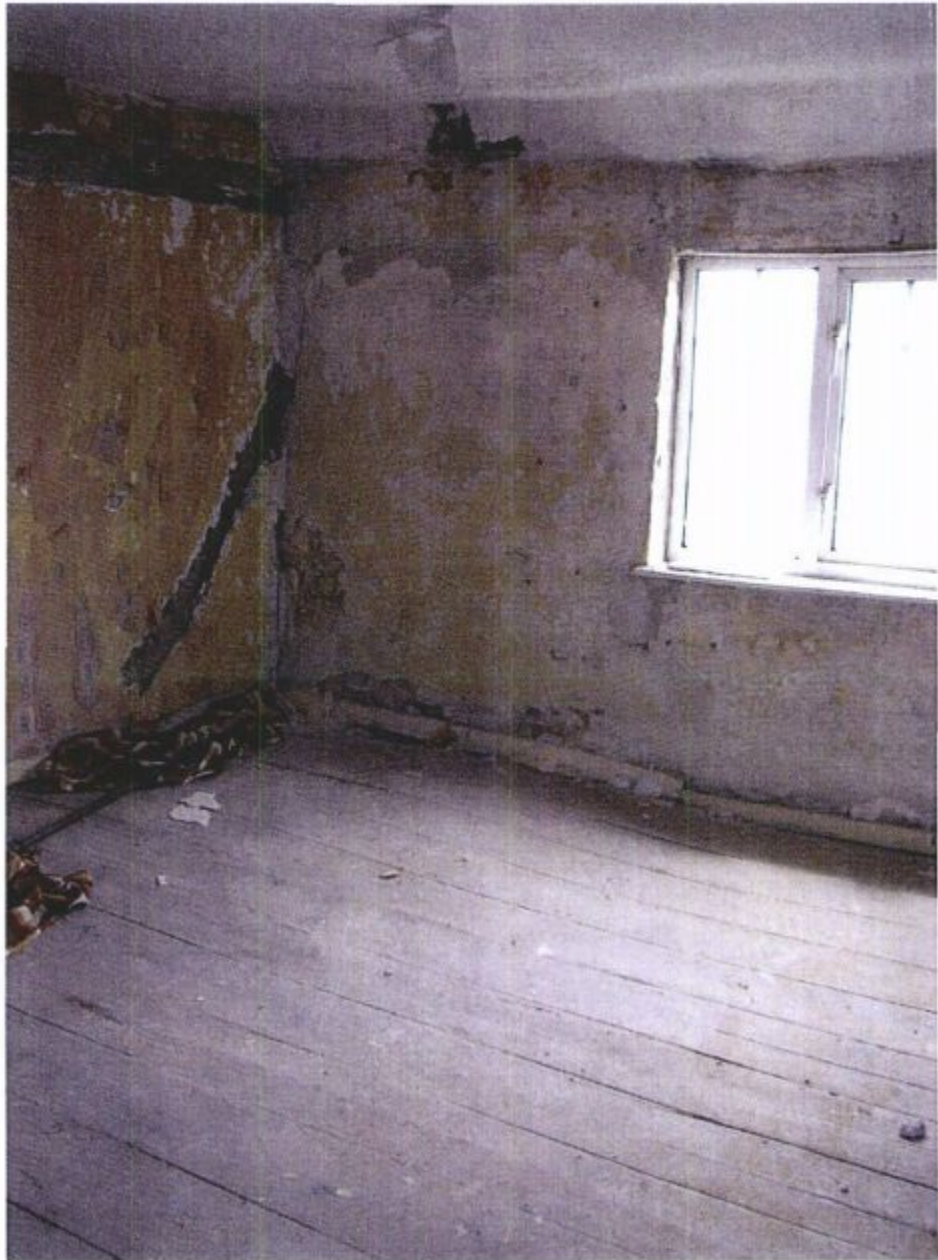
**Photo 018 – Bedroom 1. S.E. Corner.**

- Diagonal brace exposed in wall would be expected to be housed into a vertical post at the South, but none evidenced. (See **Photo 019.**)
- At the Southwest corner, the timber framed party wall is fractured and showing a separation from the front (South) wall. (See **Photo 023.**)
- The first floor shows considerable distortion on centre. (See **Photo 018.**)

The floor has been “over-boarded” East/West indicating the original North/South boarding to have decayed.

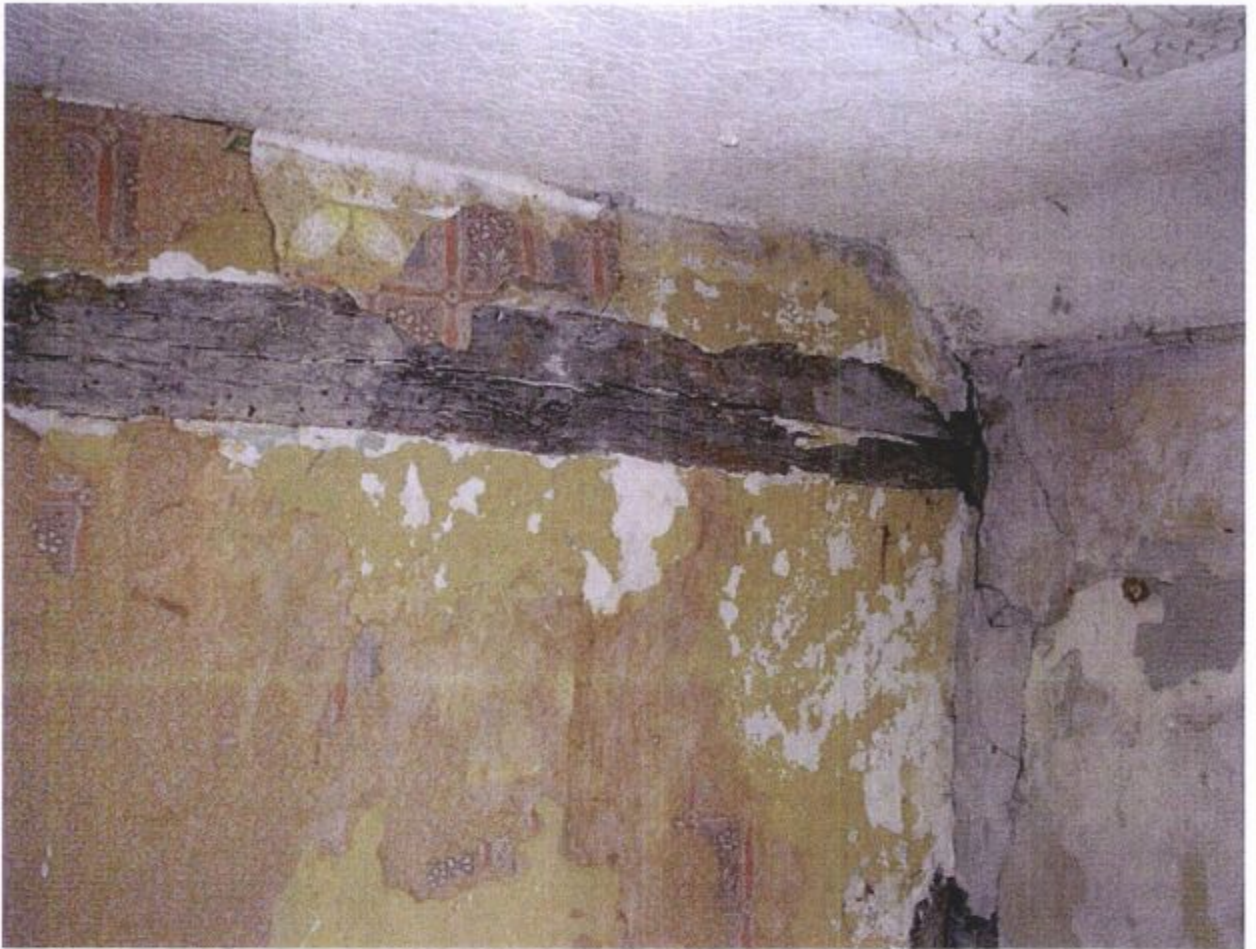
**Photo 021 – Bedroom 1. S.E. Corner. Partition Junction with South Wall at Frame Head.**

- Front (South) wall bowing outwards on centre, particularly at the eaves.
- Front (South) wall separating approx 50mm from loadbearing timber framed partition to Bedroom 2. (See Photos 018 & 019.)
- Partition formed in timber frame with brick infill. (See Photo 022.)
- Head plate showing separation at South and considerable splitting and insect infestation. (See Photo 021.)

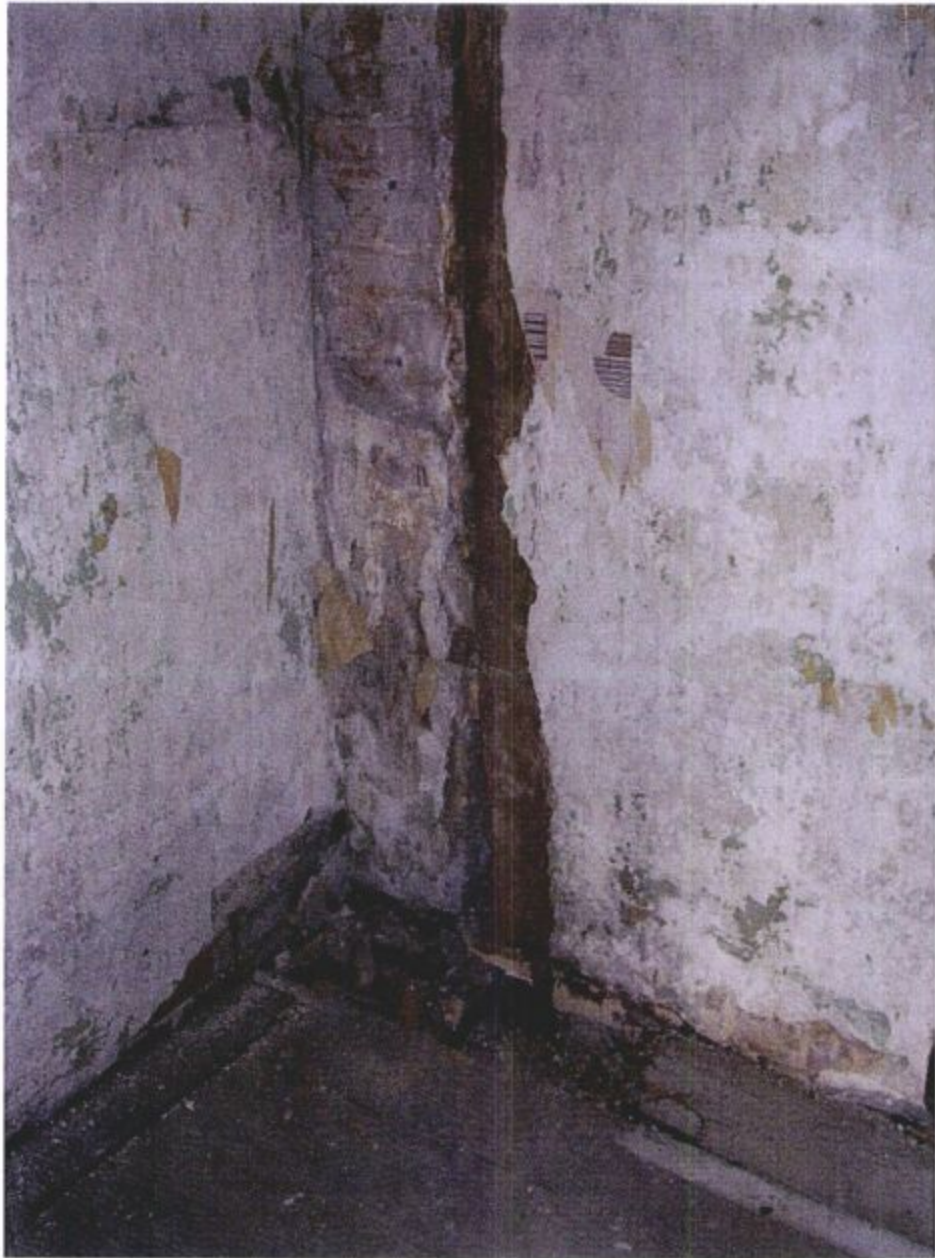
**Photo 024 – Corridor.  
West Party Wall Junction with Loadbearing Timber Framed Bathroom Wall.**

- The corridor/Bathroom partition is timber framed with brick infill and is expected to be supported on a beam over the Kitchen.
- The floor is over-boarded and there is evidence of decay in the lower boarding. (See **Photo 024.**)
- Originally, a stair from the ground floor passageway exited through this corridor at first floor, but has now been infilled. (See **Photo 025.**)

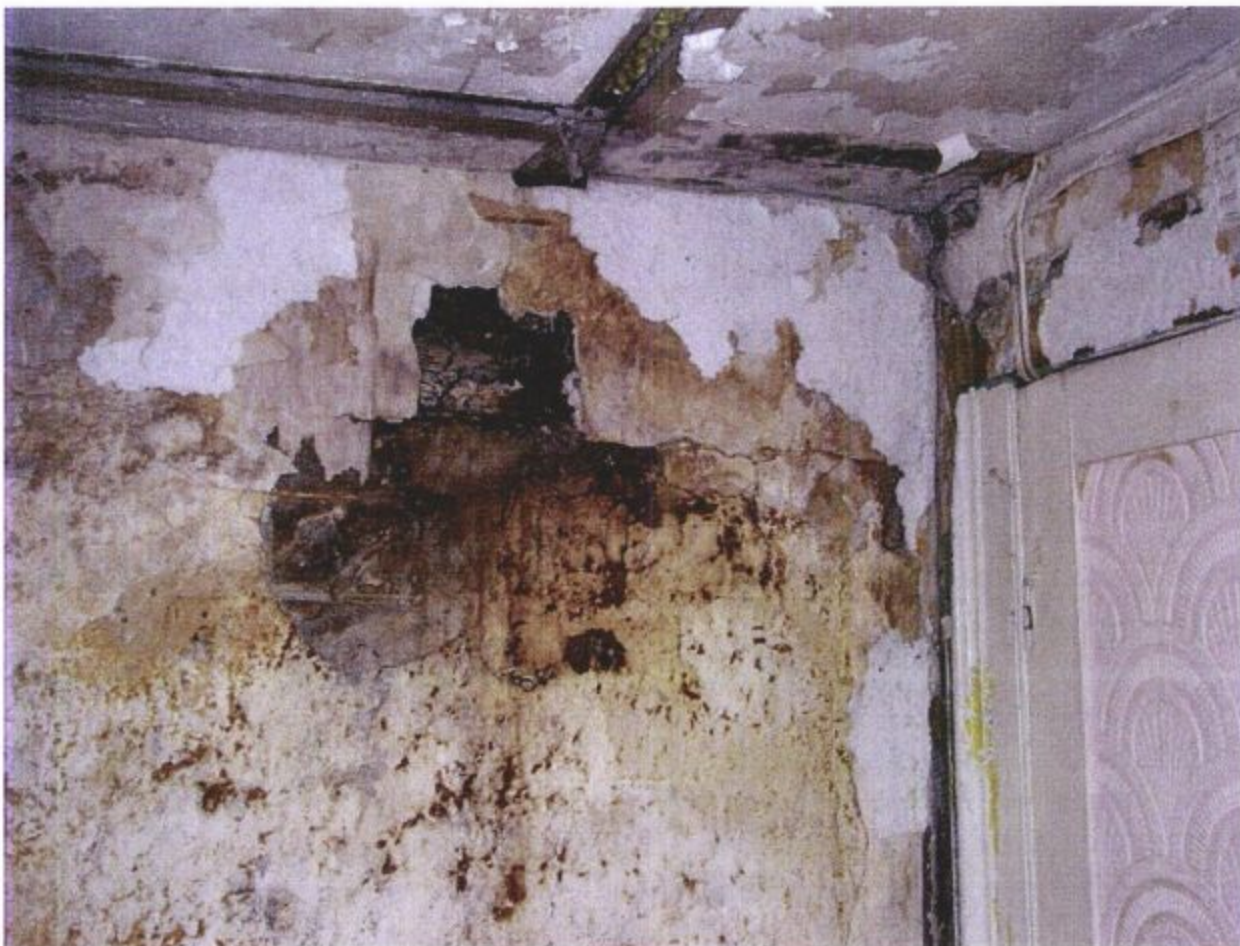
**Photo 026 – Bathroom S.W. Corner.  
Bedroom 3 Partition. Timber Frame Decay.**

- 75mm Step up into Bathroom from corridor.
- First floor boarding running East/West and if not over-boarded, suggests floor joists span North/South.
- Timber framed loadbearing partition with Bedroom 3 at East, shows severely decayed head plate at Southeast corner. (See Photo 026.)

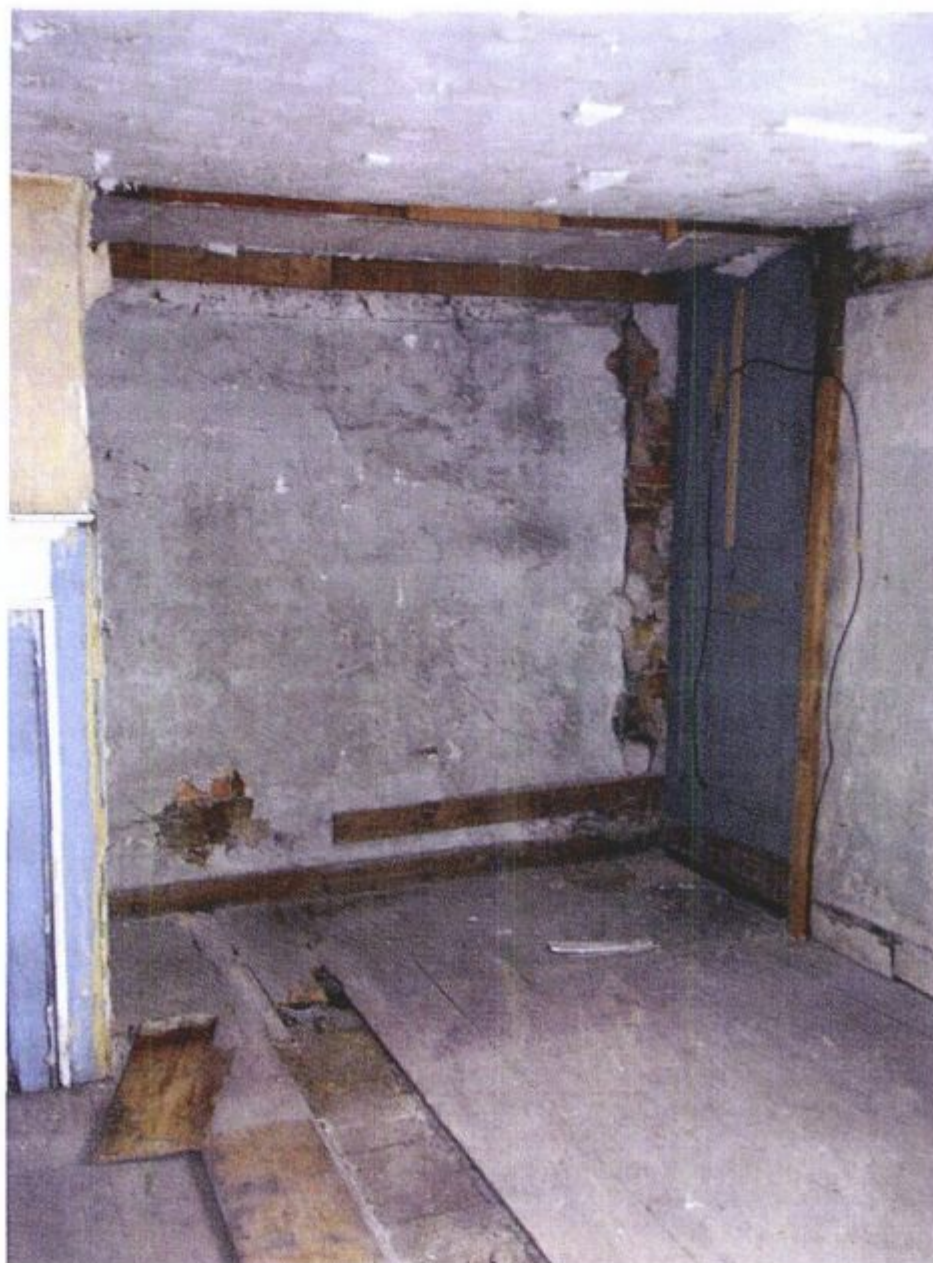
Photo 028 – Bedroom 2. S.E. Corner. Showing East Party Wall.

- Outward lean in front elevation at eaves, but not as pronounced as at Bedroom 1.
- Separation at first floor with junction at front wall, becoming worse towards Bedroom 1.
- Vertical separation of Bedroom 1 / 2 partition to front wall.
- A vertical joint at brick pier in East party wall at junction with front wall. (See Photo 027.)
- Evidence of timber framing to party wall at East. (See Photo 028.)

Considerable cracking evident in plasterwork.

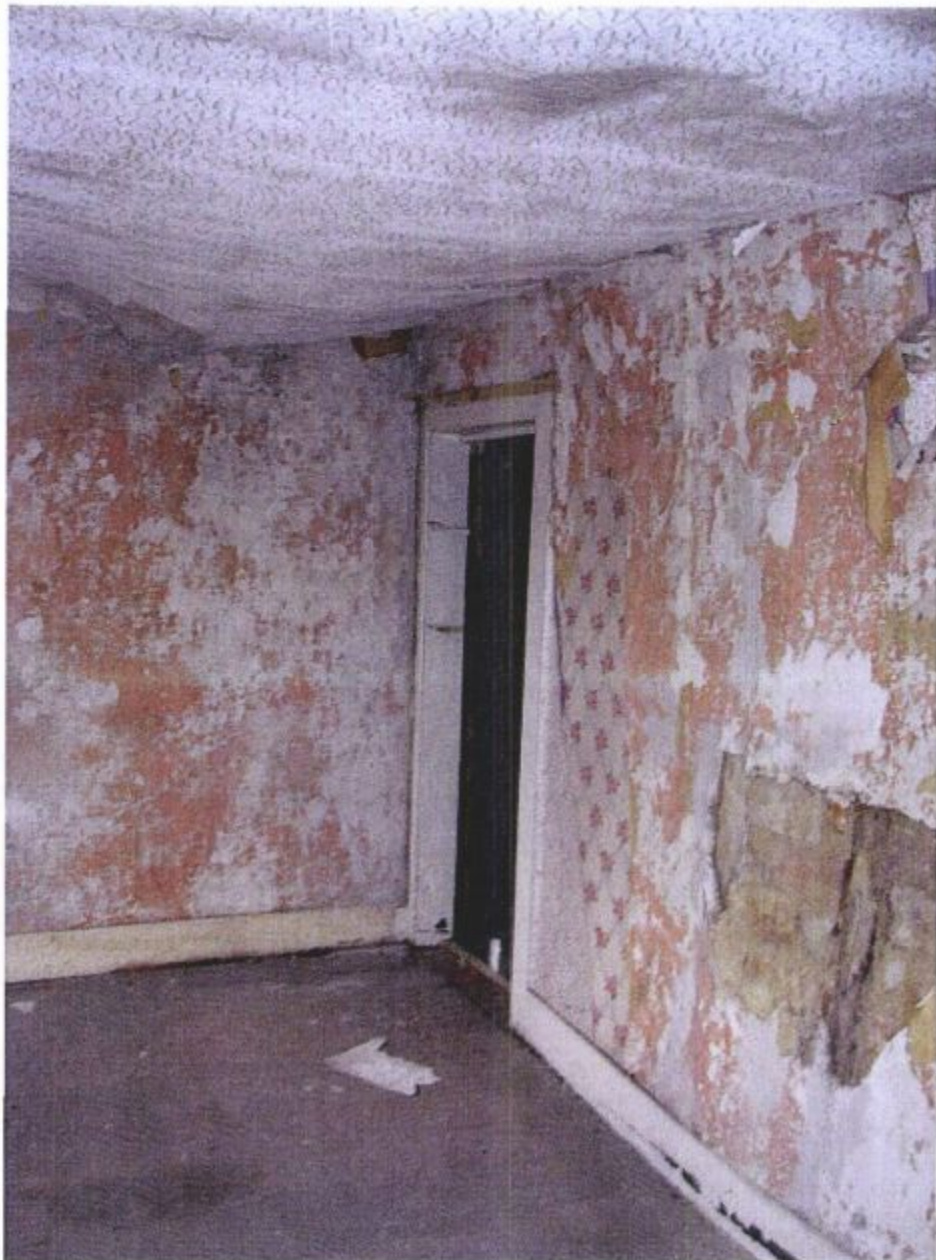
Photo 032 – Bedroom 3. S.E. Corner. East Party Wall/Stair Wall Junction.

- Internal loadbearing Bedroom 3 / Stair partition is timber framed with brick infill. The wall is very distorted on centre.

The exposed timber framing is in poor condition.

There is a drop in the floor at this point. (See Photo 032.)

This may relate to decay in the carriage beam bearing below.

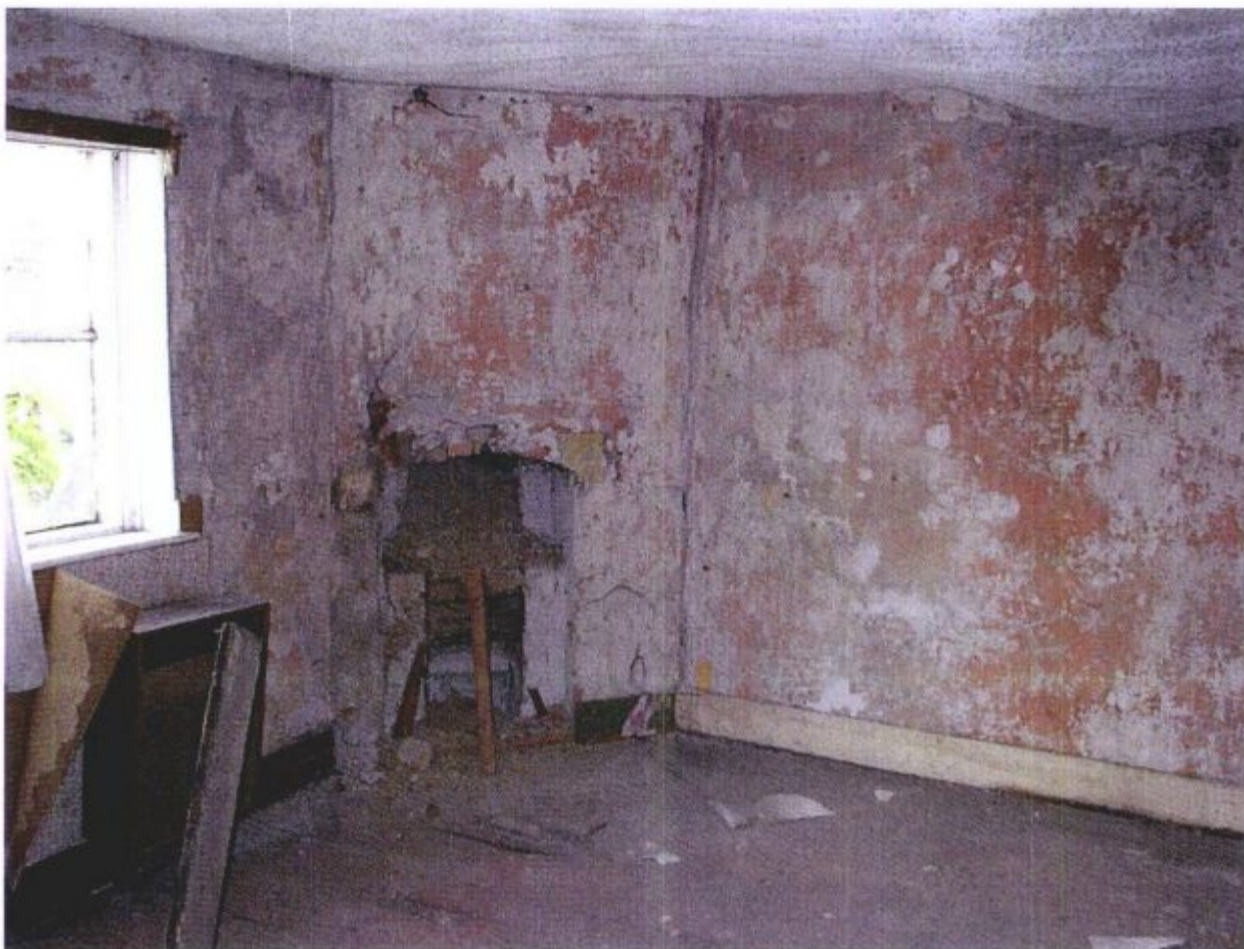
**Photo 034 – Bedroom 3. N.E. Corner.**

- There is slight horizontal bow in the external rear (North) wall on centre.
- There is a pronounced bulge in the ceiling against the East party wall indicating failure of joisting over, or of the roof supports. (See Photo 034.)
