**SECOND STAGE APPRAISAL**

**ADDENDUM TO FIRST STAGE APPRAISAL 2844**

**86 WEST STREET**

**Job No: 2844**  
**Dated: 5<sup>th</sup> November 2009**  
**Revised: 30<sup>th</sup> November 2009**

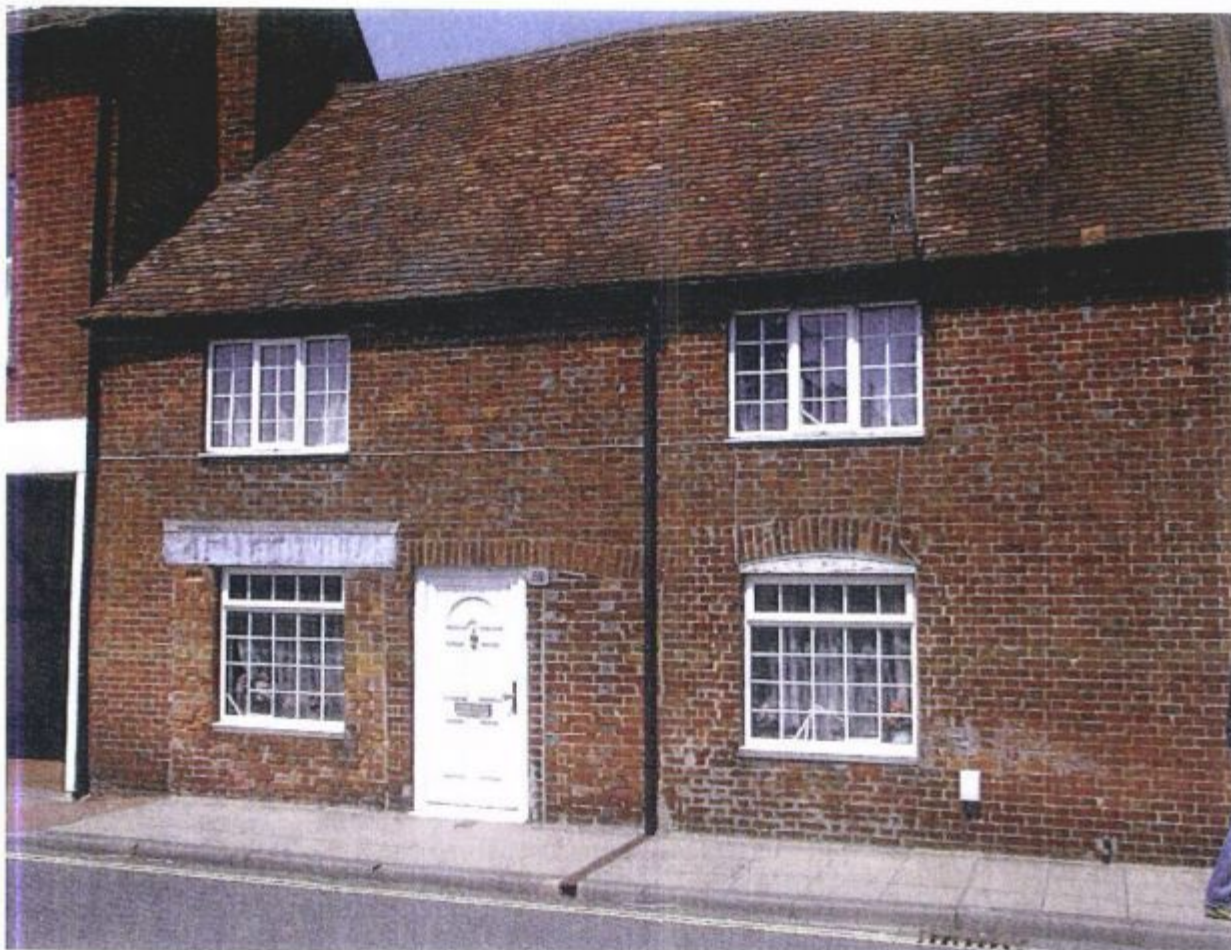
Photo No. 5 (June)

- Straight vertical joints evident either side of the front window indicating an earlier, wider opening. (See Photo No. June 005 and September 051.)
- North wall shows a straight vertical joint at the junction with the Party Wall and a 25 thick horizontal plate at approx mid-height.

- The proposed conversion of the building back to 2 No. dwellings, dictates the re-opening of a former infilled doorway adjacent to the existing entrance. (See Photo No. 06/005.)

Front (South) Elevation

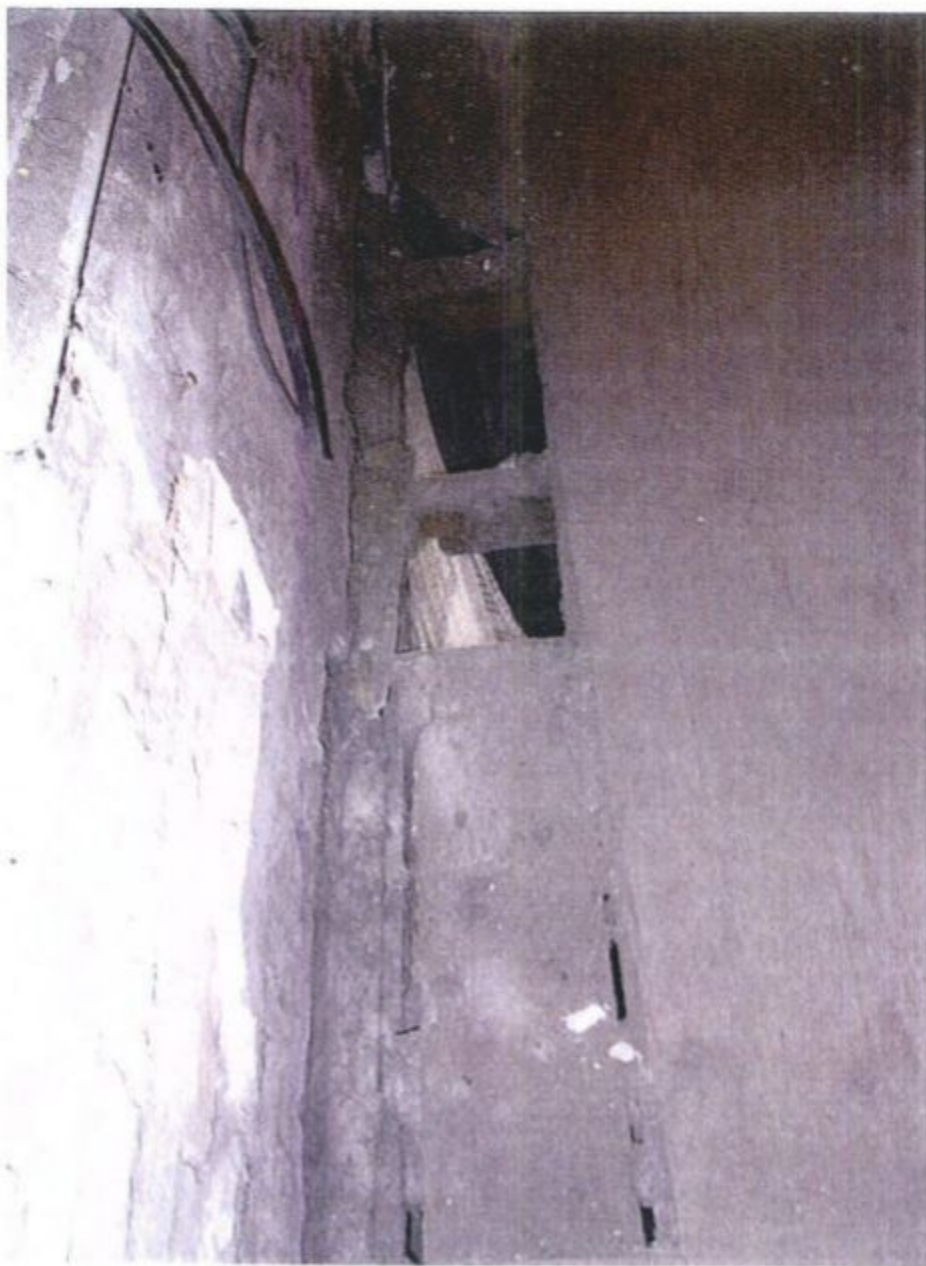
Photo No. 28

- First floor has been over-boarded (east/west) in the same direction as the original decayed boarding beneath.
- The floor joists are now exposed within the Study below and span north/south from the front (south) wall to the 230 x 200 wide carriage beam towards the rear of the Study.
- The floor joists are broken/decayed and crudely repaired and no longer have a bearing on the front wall. (See Photo Nos. 28, 47, 48, 49 & 51.)

Temporary propping has been introduced to provide a bearing at the south end of this floor.

Bedroom 1.  
1<sup>st</sup> Floor Junction with Front Wall

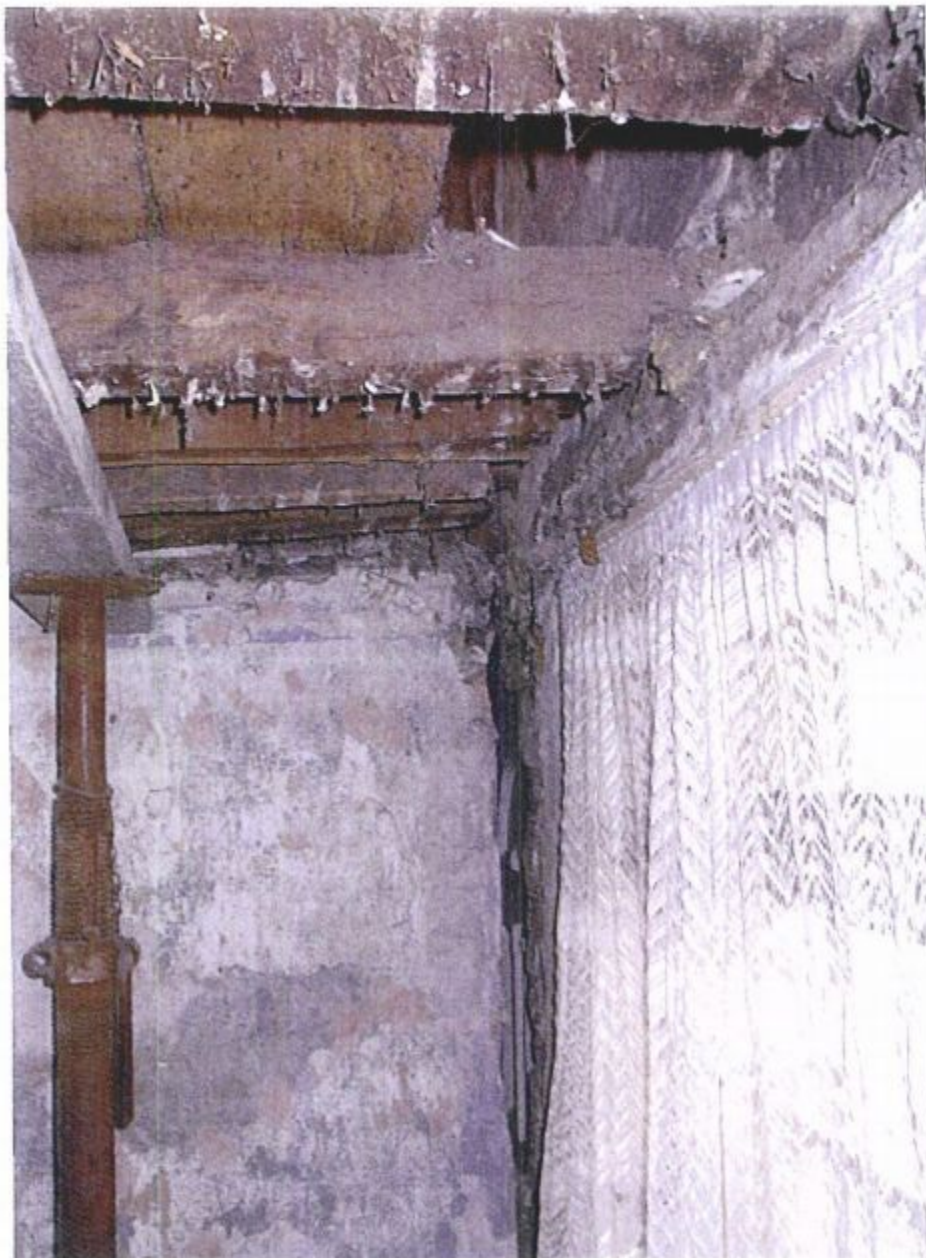
Photo No. 47

- Severe vertical separation of the Party Wall and Corridor wall with south wall is evident.

First floor unsupported at south and structurally unsound.

Study:- 1<sup>st</sup> Floor Junction with Front Wall.  
Separation in Study/Corridor Wall.

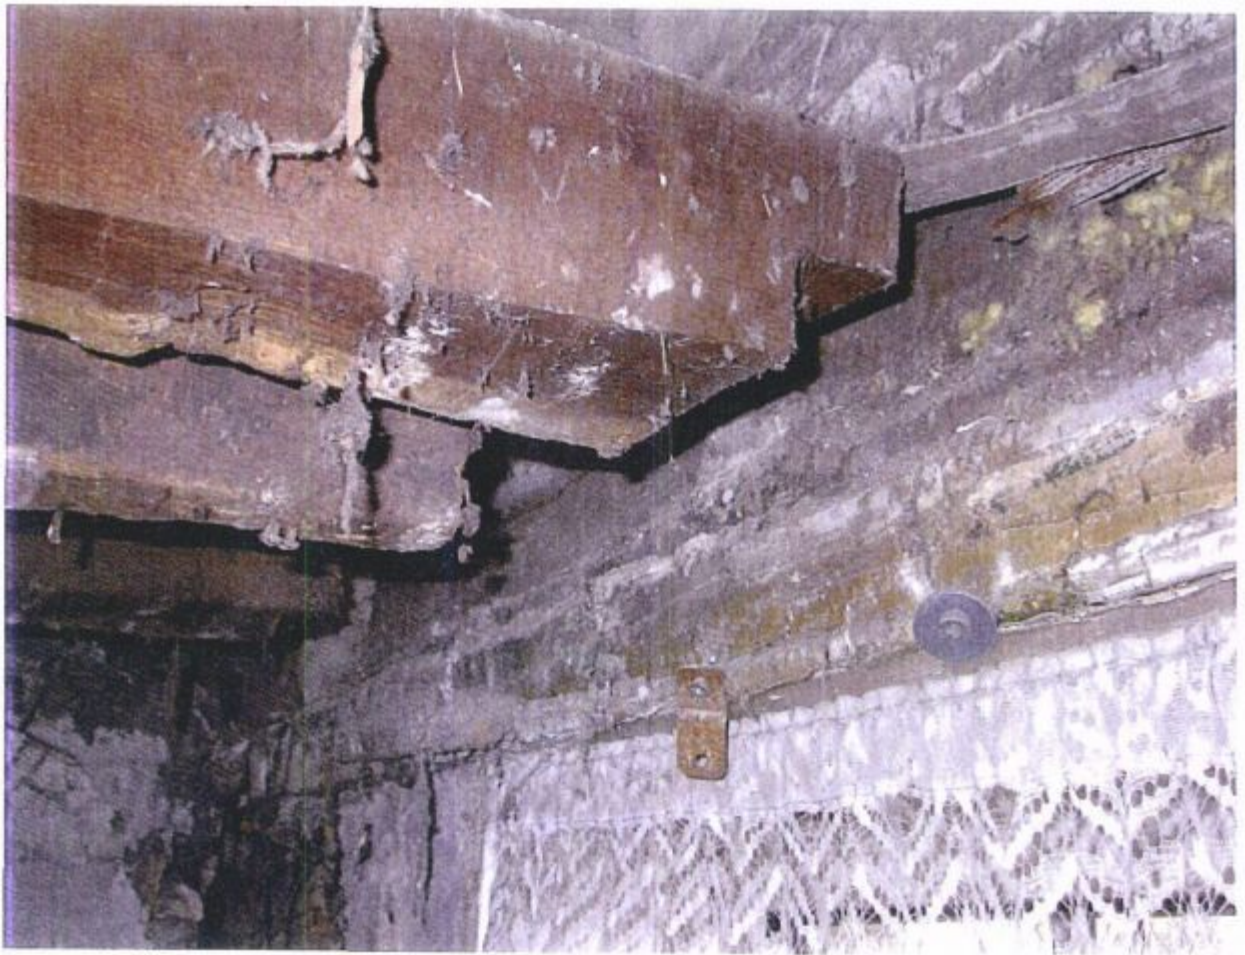
Photo No. 48

Study:- 1<sup>st</sup> Floor Junction with Front Wall.

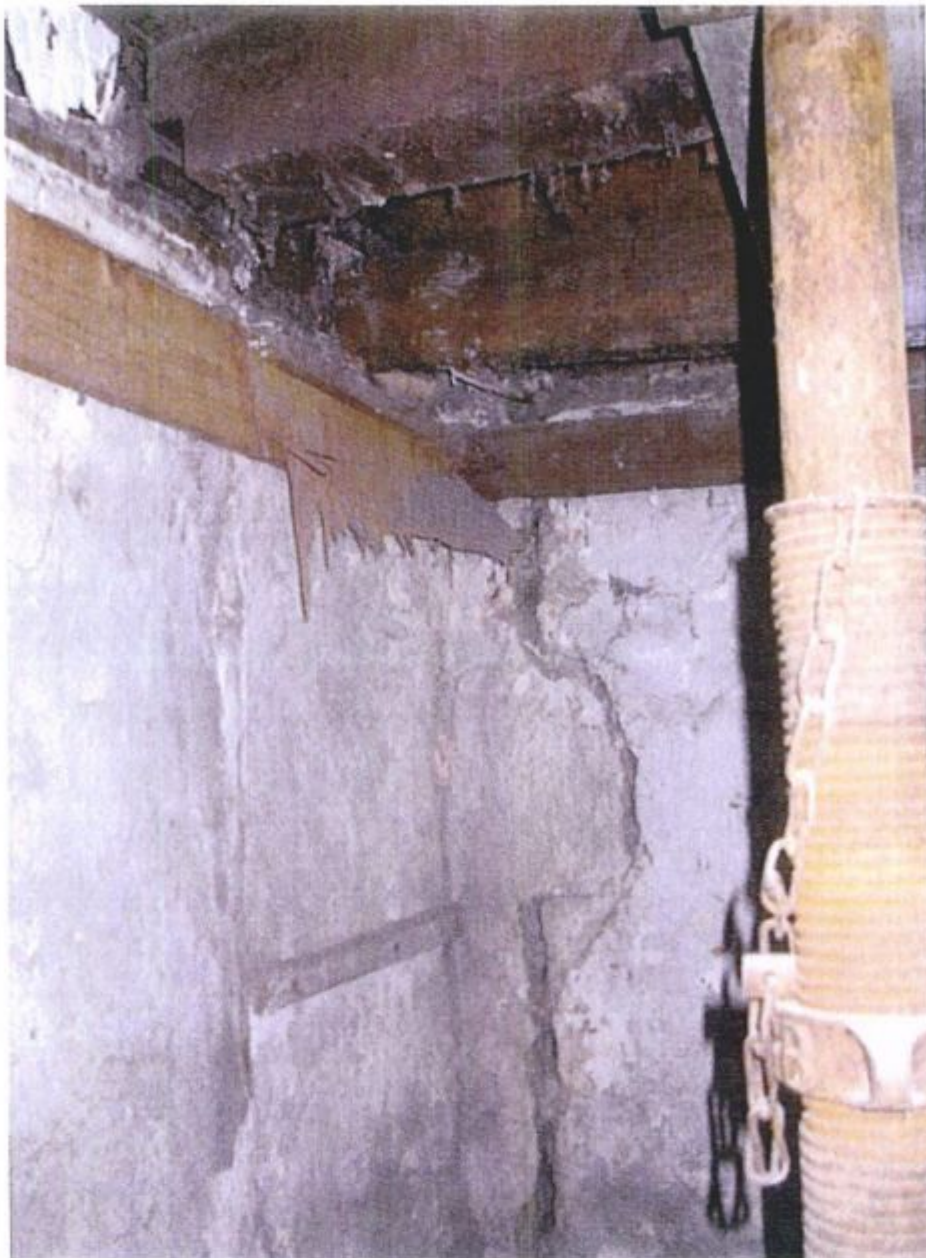
Photo No. 49

Study:- 1<sup>st</sup> Floor Junction with Front Wall.  
Separation in Party Wall.

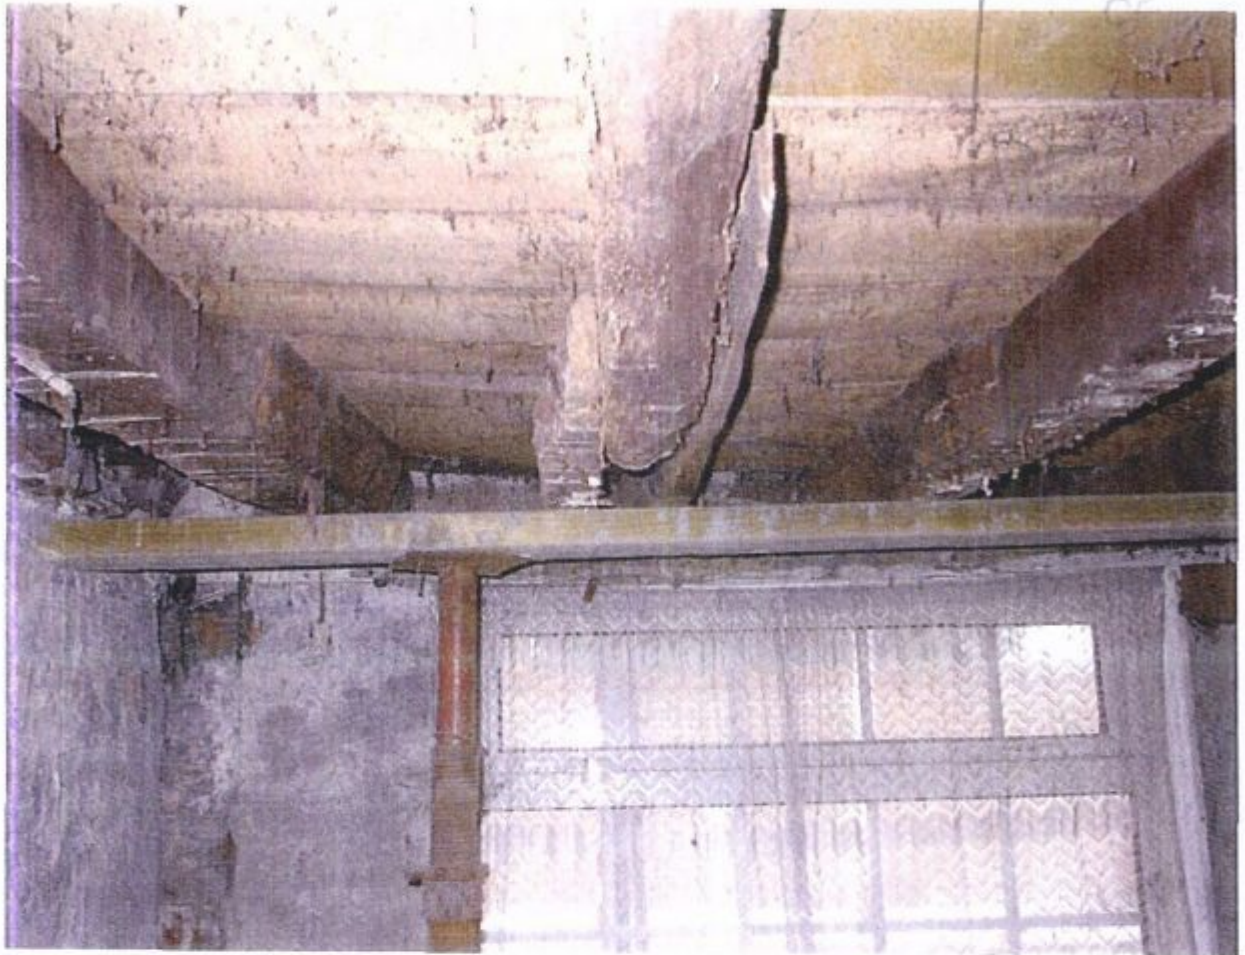
Photo No. 51 – Study:- 1<sup>st</sup> Floor Joists.

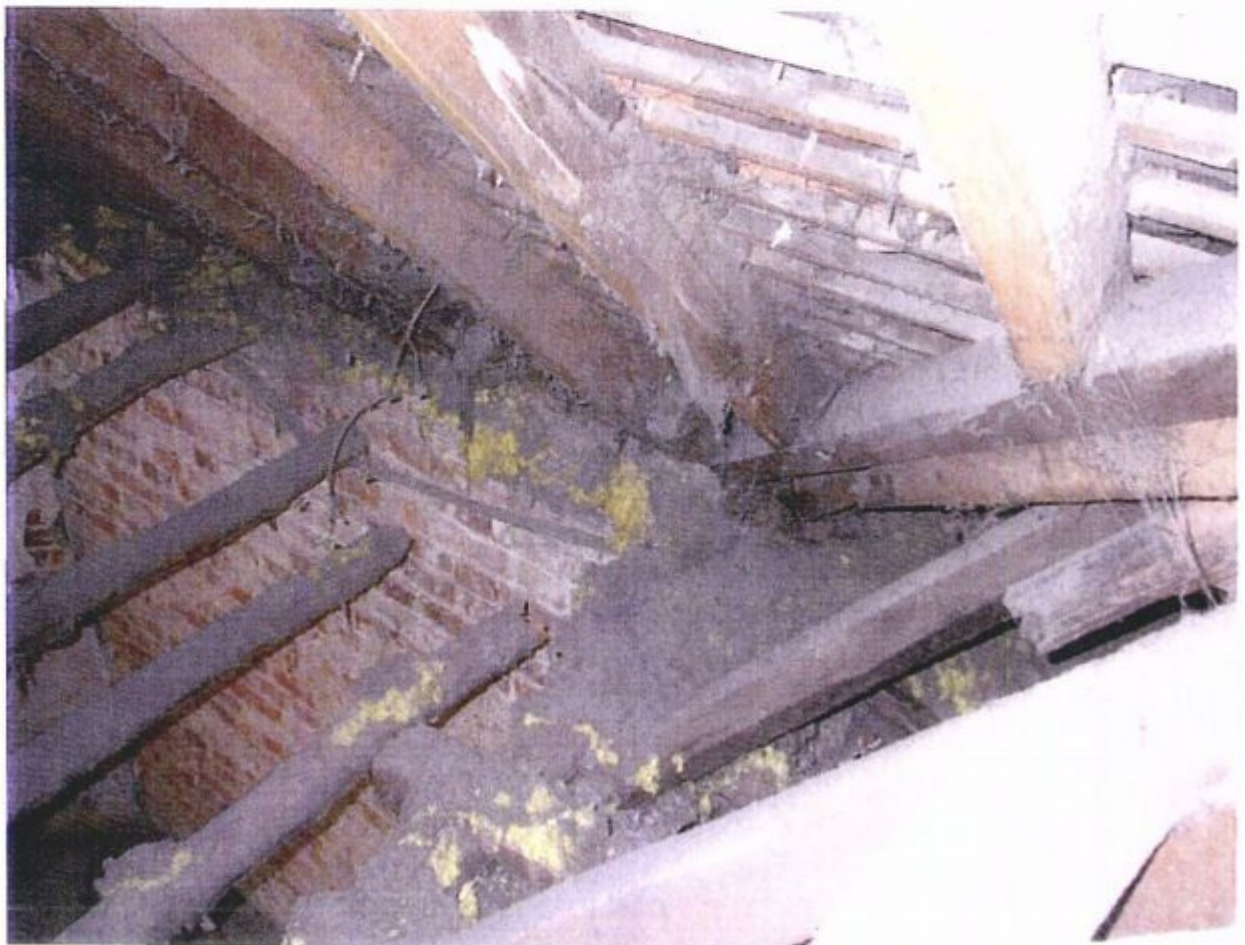
The joists are in very poor condition and have fallen away from the bearings in many instances.

This explains the previous bulge in the ceiling at the east. (See Photo No 11.)

Photo No. 11 – Bedroom 3. East Ceiling Joists at Junction with Rafters.

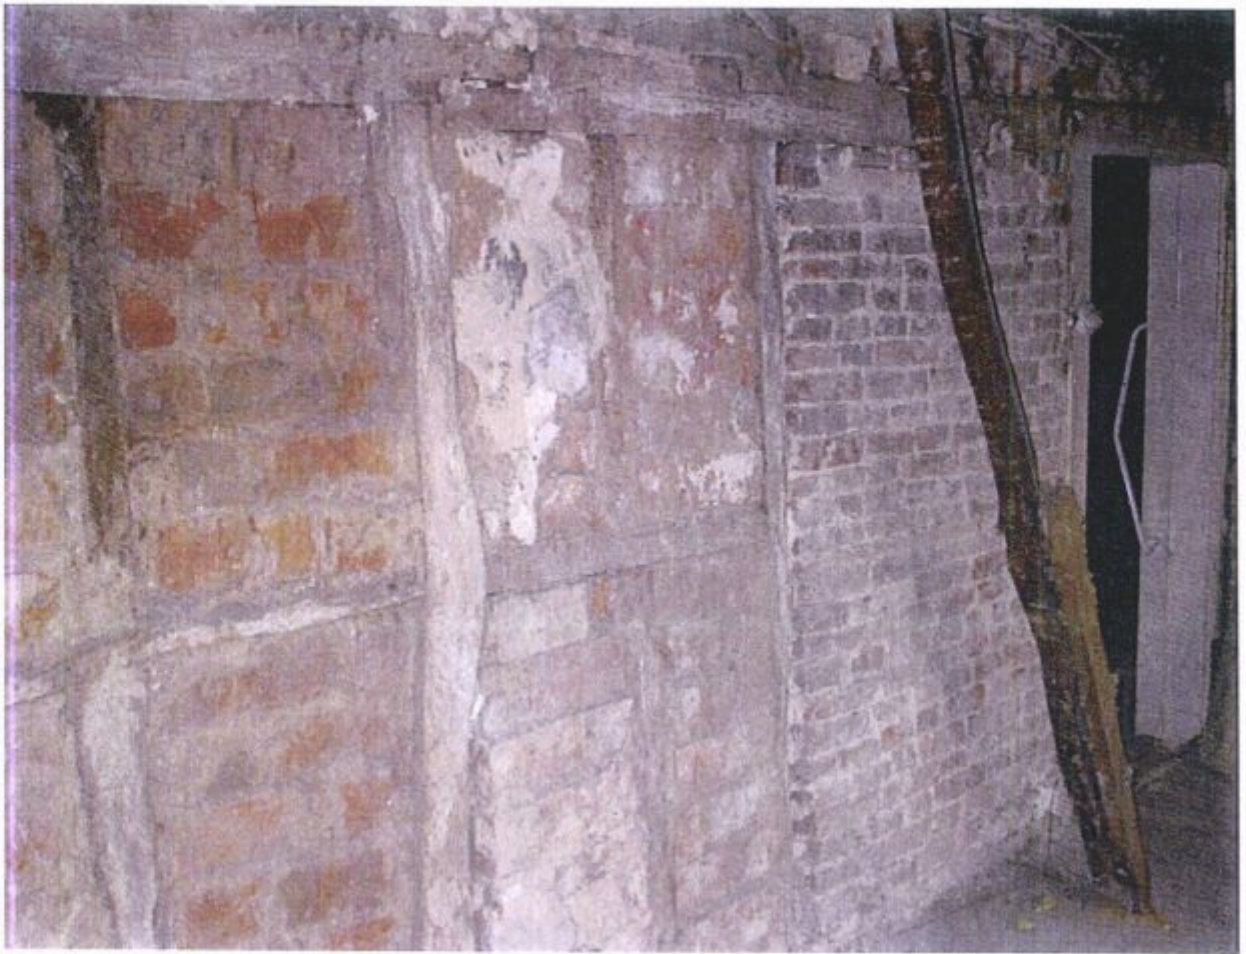
Photo No. 41

The load bearing wall between the Stair and Bedroom 3 is early timber frame with brick infill and the timbers show evidence of insect infestation and decay.

The bulge in the infill brickwork is indicative of the distress in the timber studs. (See Photo No. 41.)

Bedroom 3/Stair Load Bearing Wall.

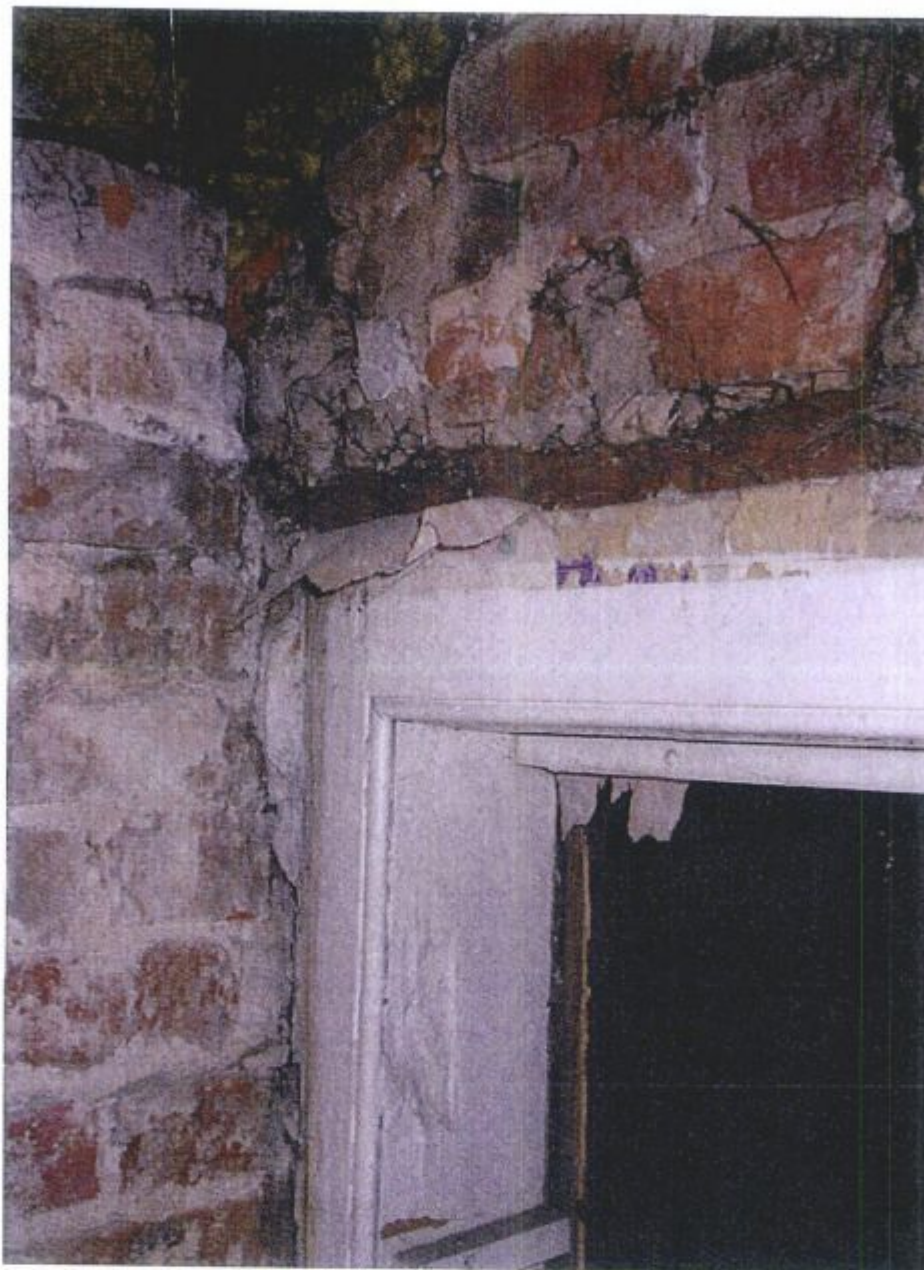
Photo No. 38

There is a vertical separation at the junction with the east Party Wall and the internal Stair wall where a cupboard doorway exists.

The timber lintel over the doorway appears to be an extension of the head plate in the wall and is showing considerable decay. (See Photo No. 38.)

Bedroom 3.

Internal Load Bearing Wall Junction with Party Wall at Cupboard Doorway.

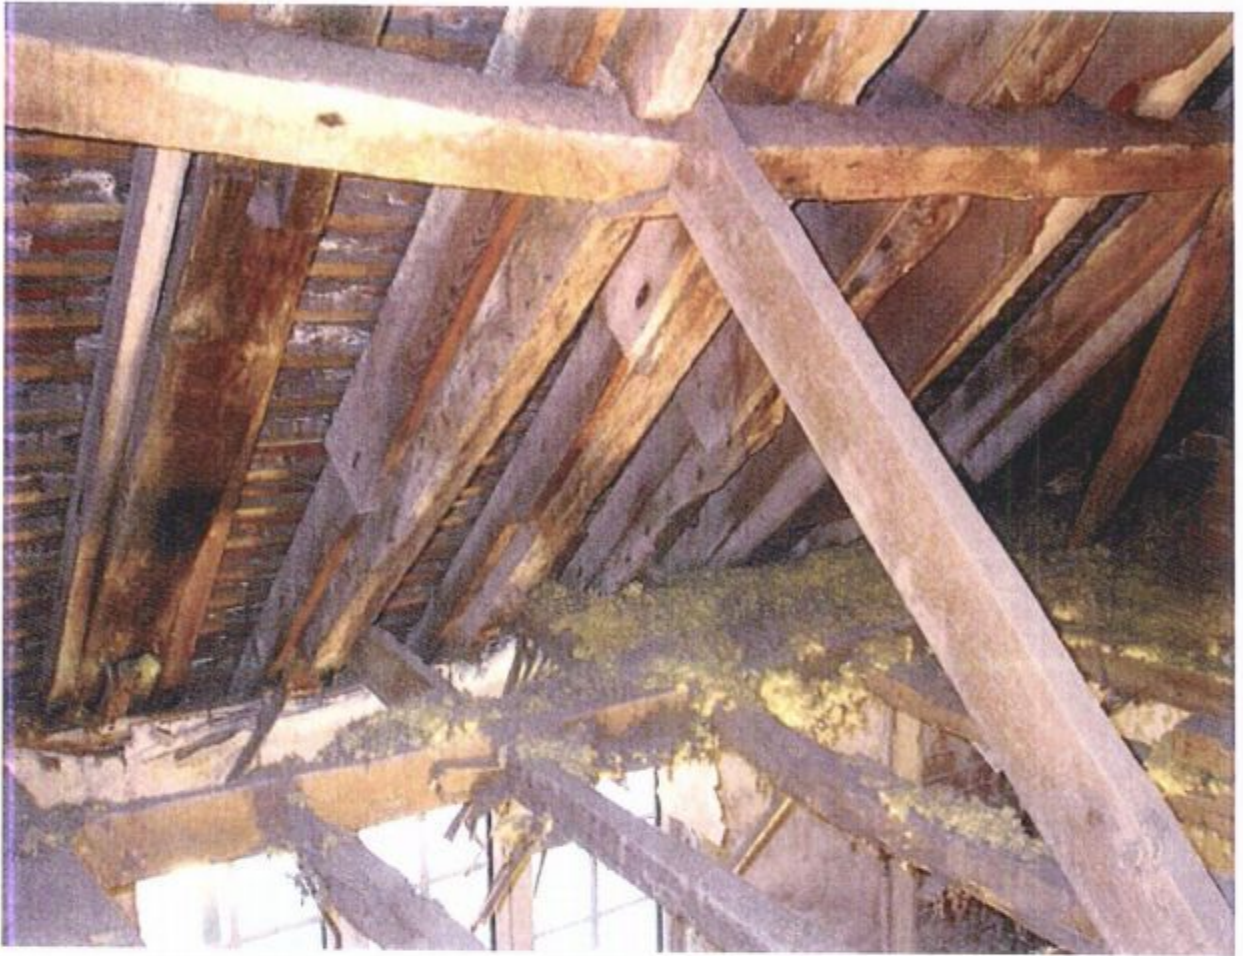
Photo No. 12

The roofs to the front pitches are in very poor condition, particularly that to the southwest, which is seriously distressed and lacks effective ceiling ties. (See Photo No. 012.)

Front Pitch over Bedroom 1.

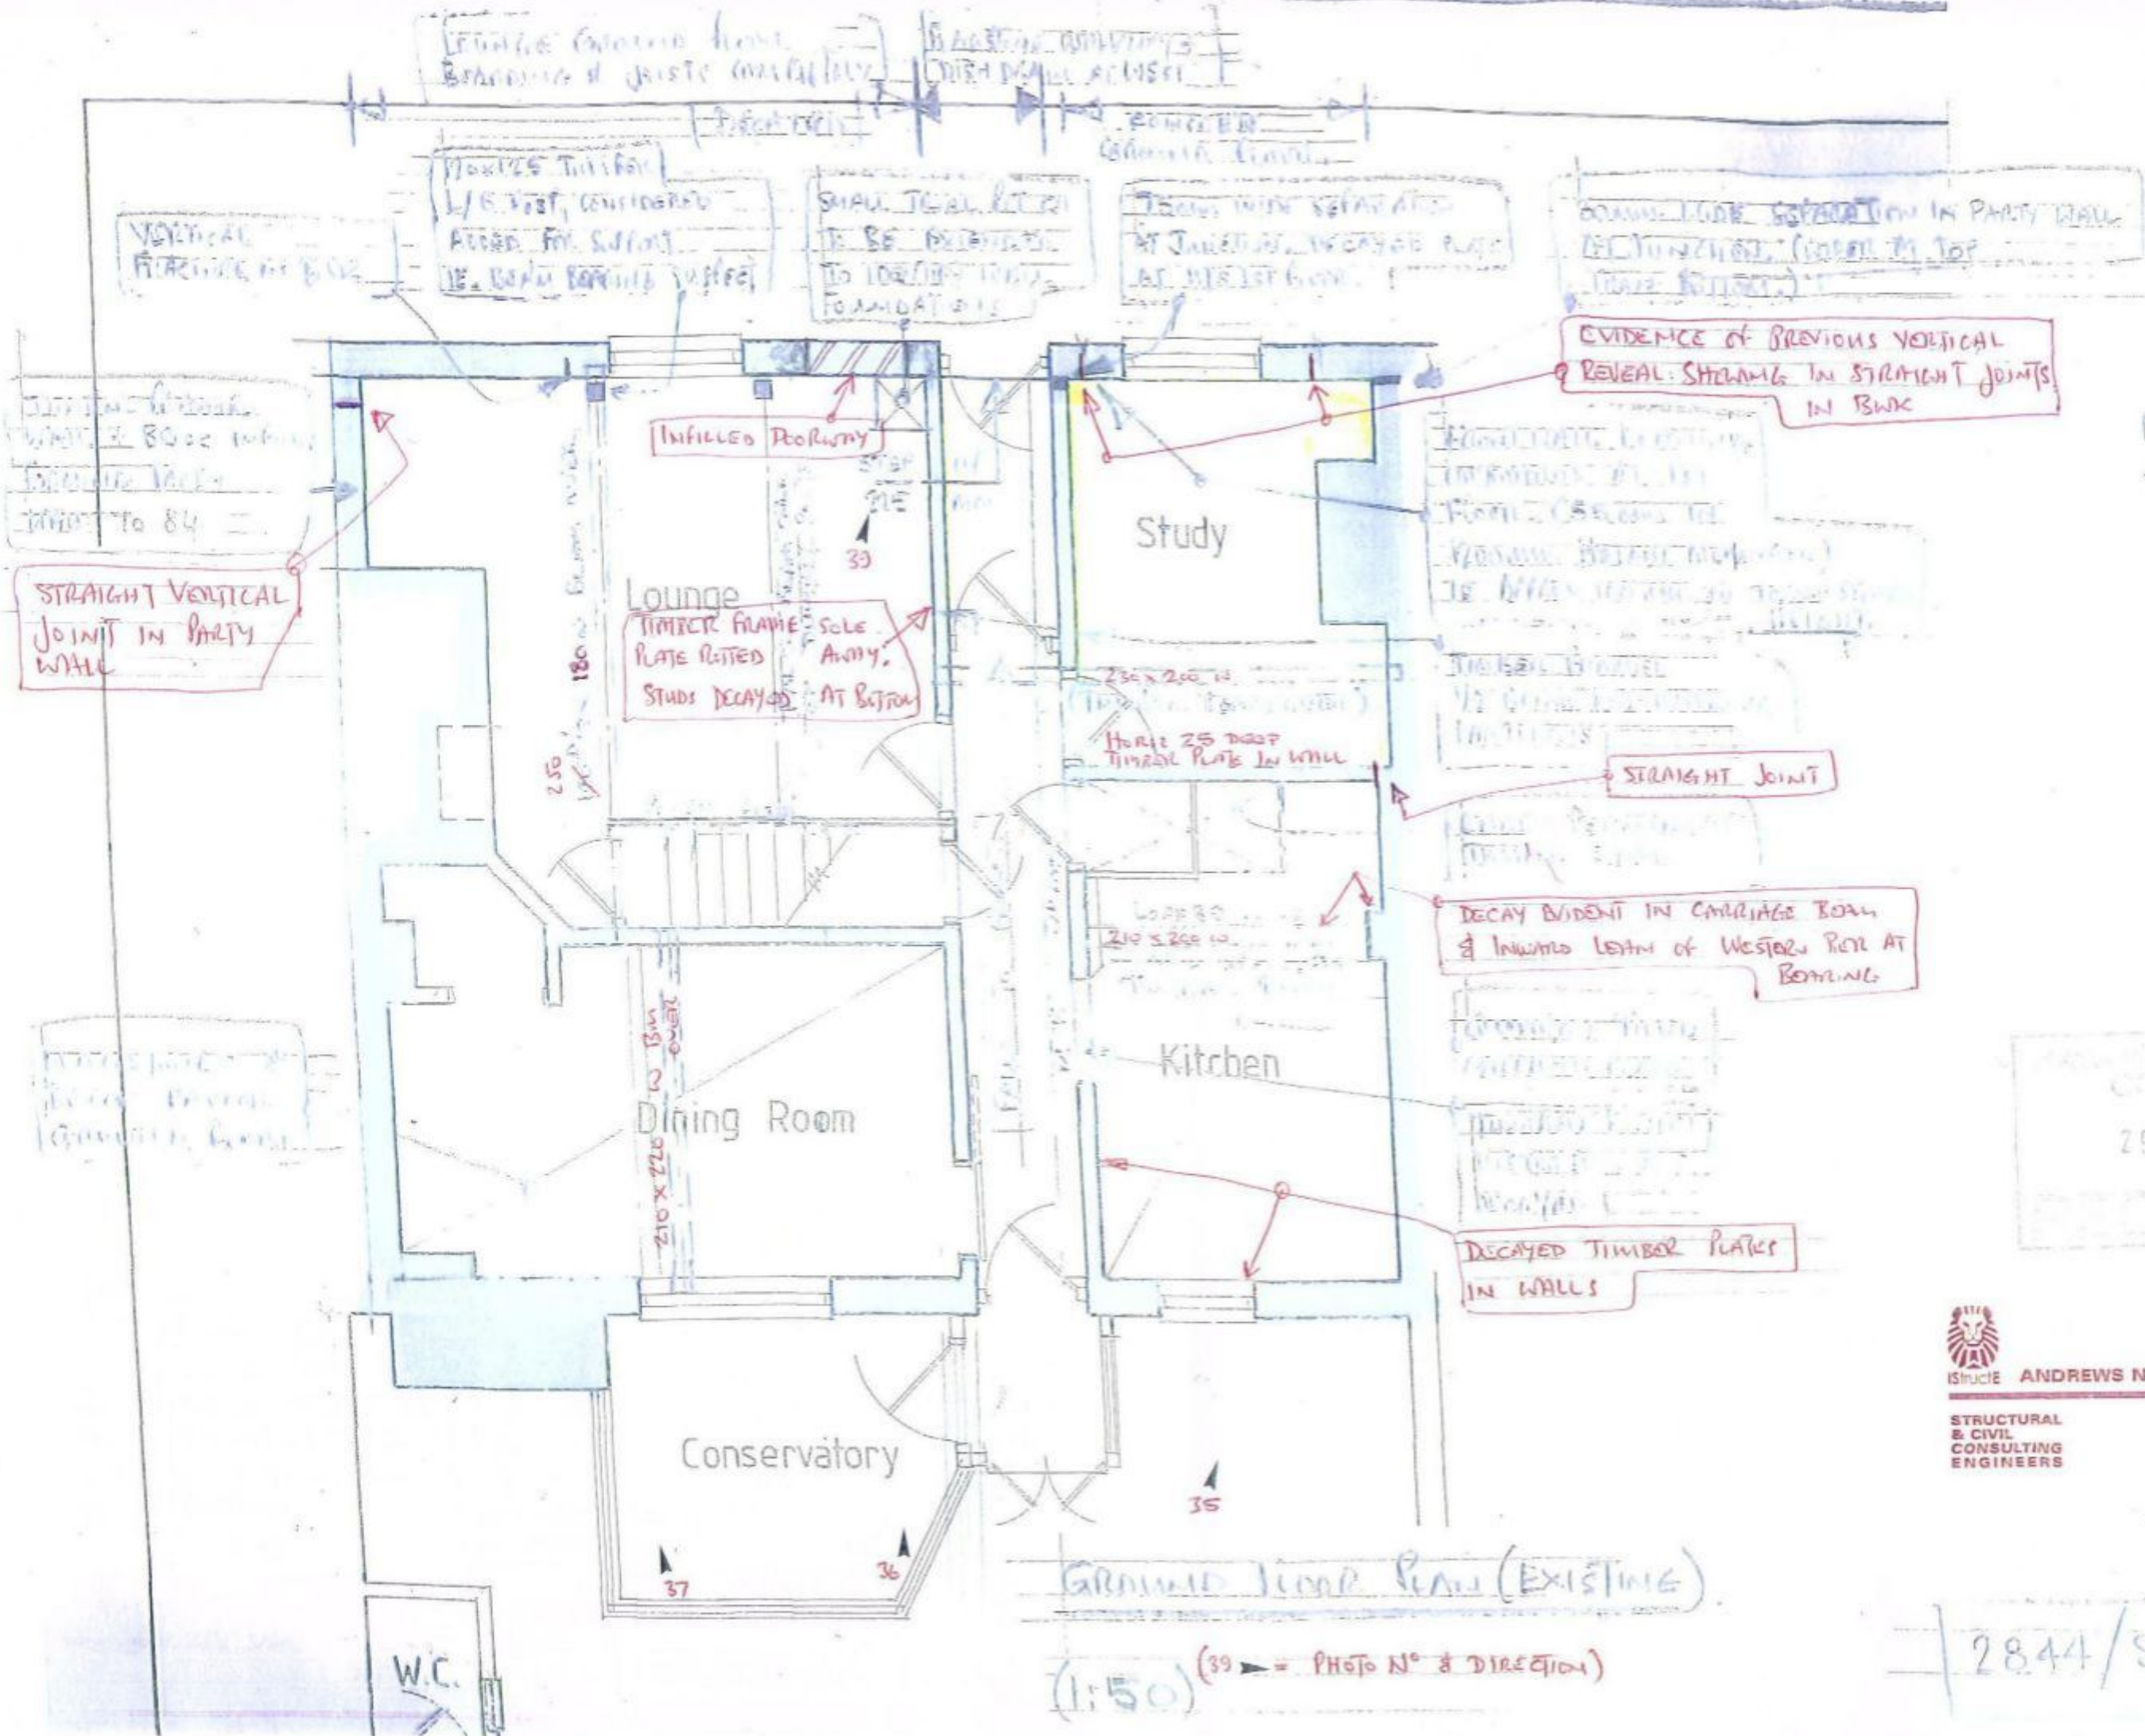
2844/SK/01/A

NOTE: - PARALLEL 1ST FLOOR JOISTS & SEPARATION OF CREEK WALLS  
WITH FRONT ELEVATION INDICATES NO LATERAL RESTRAINT  
AT THIS LEVEL

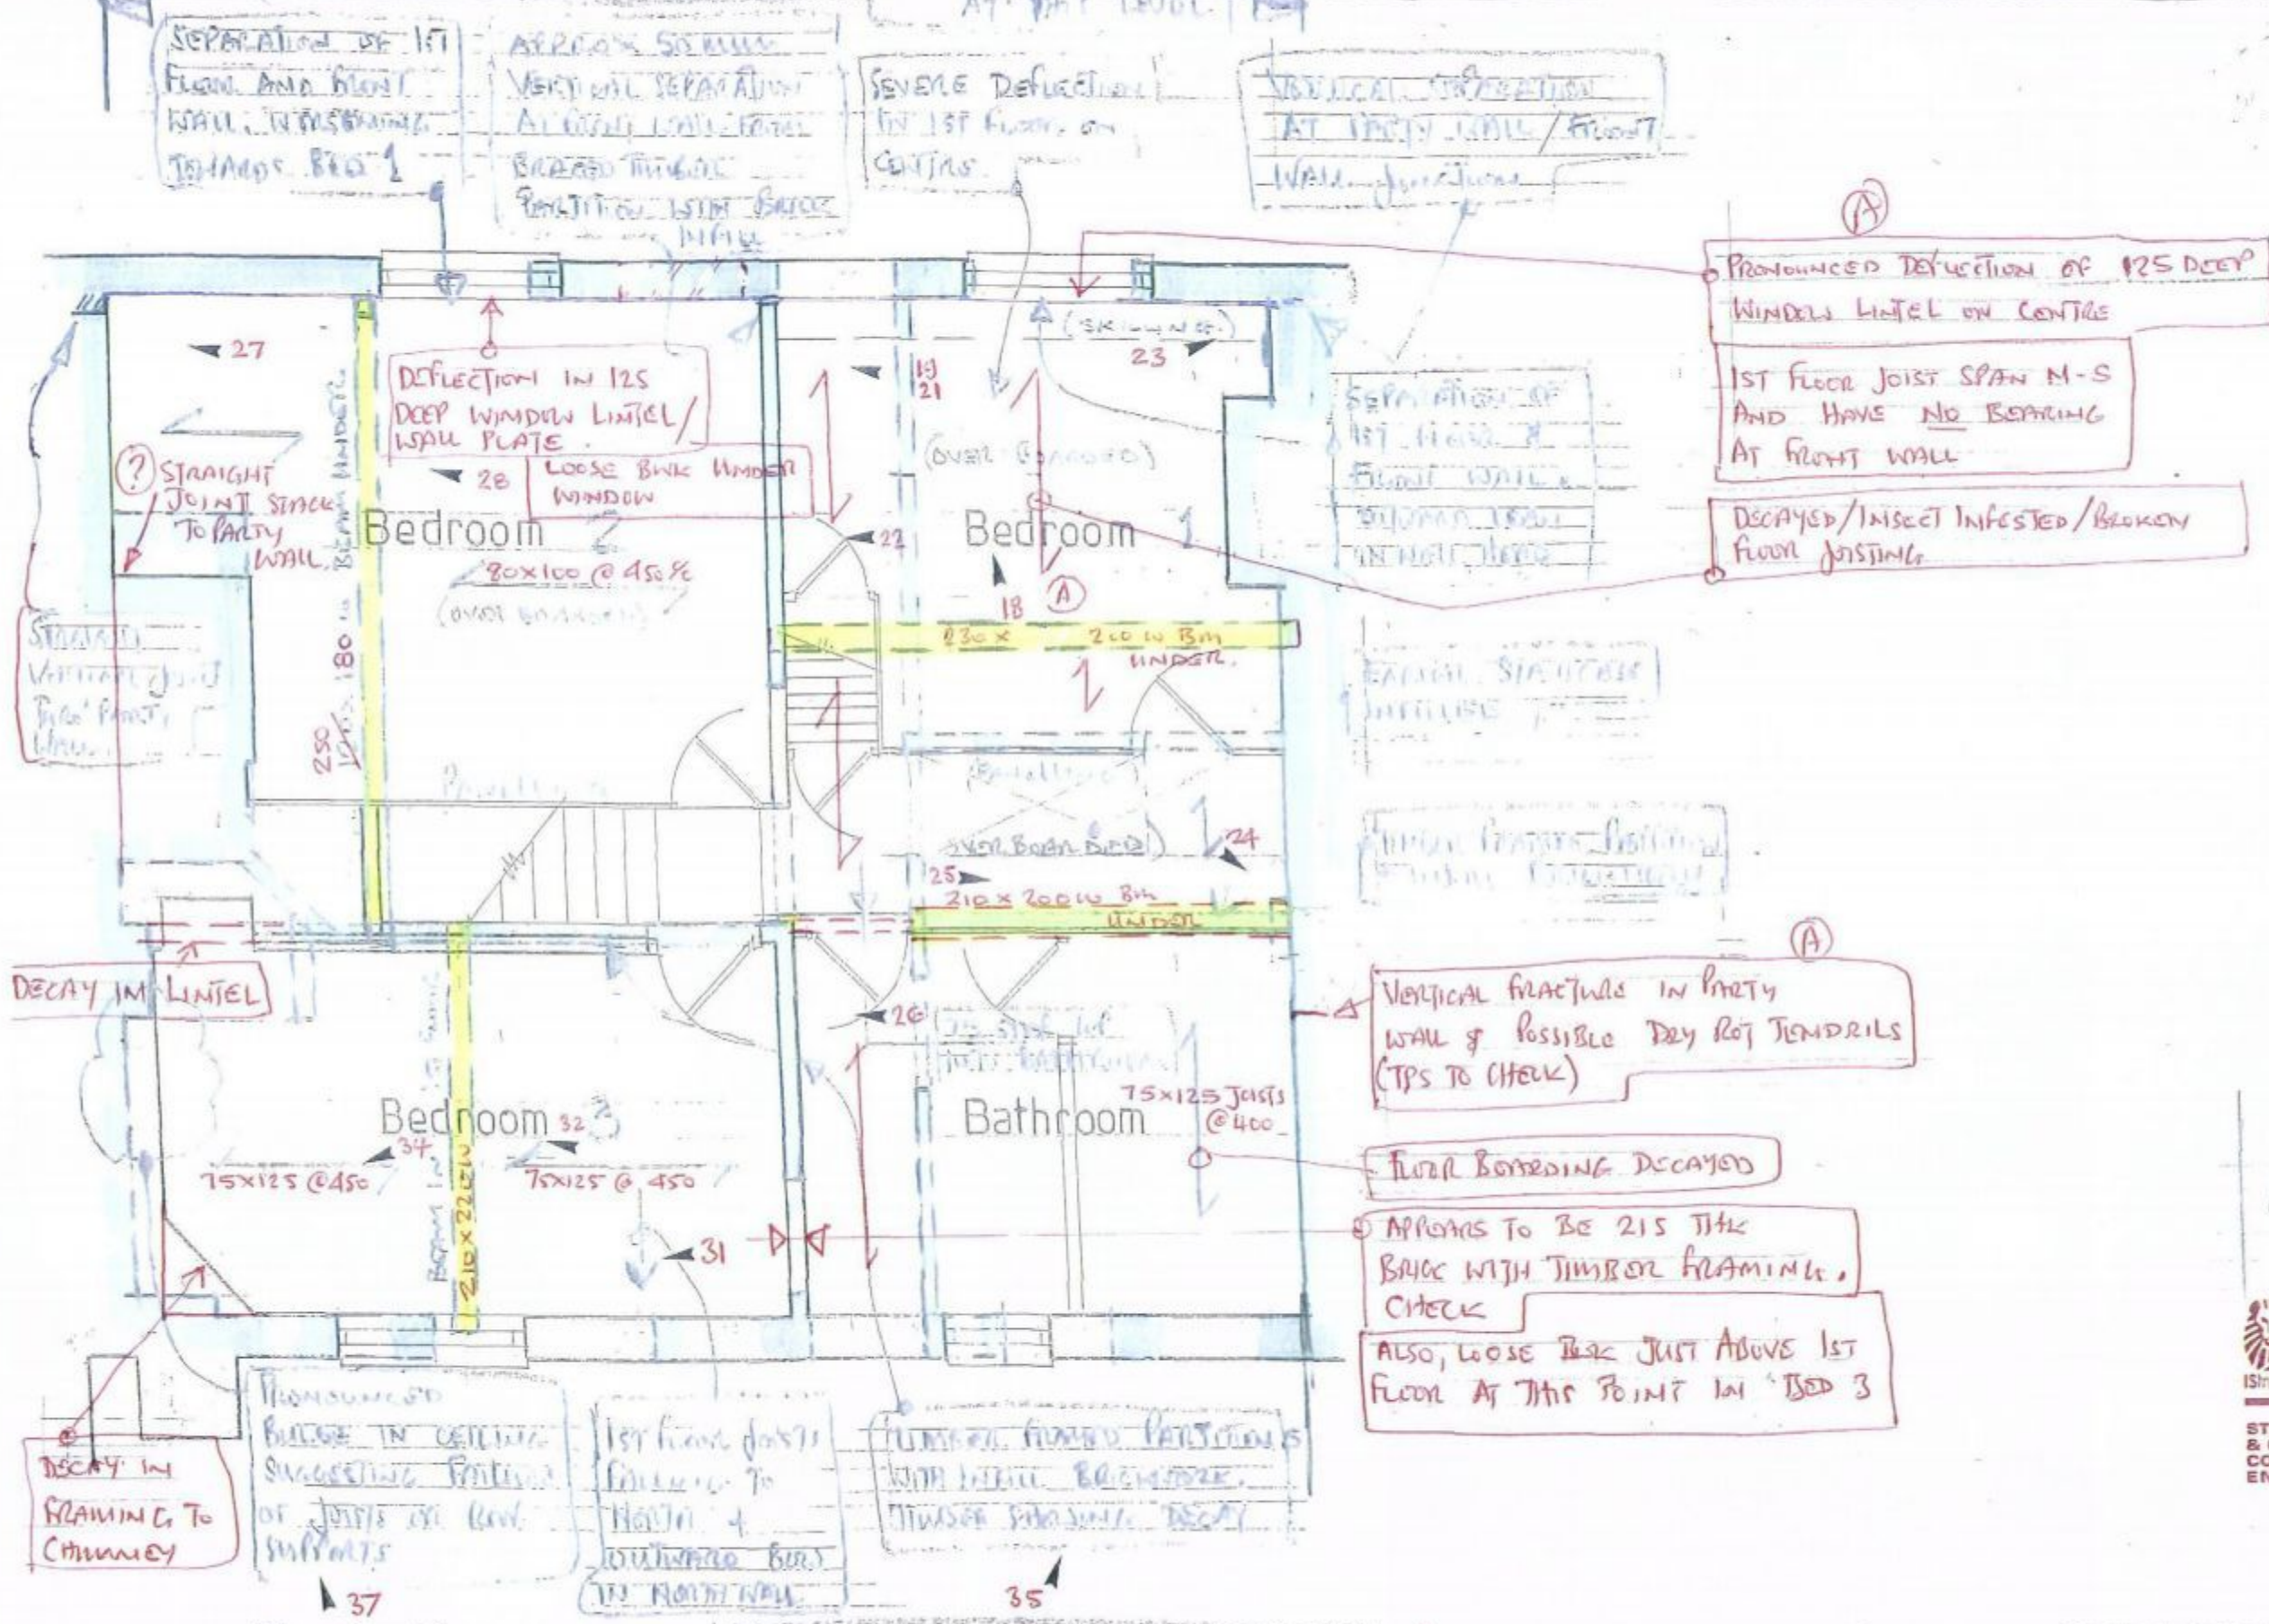
2844/SK/02 A

SEVERE DEFLECTION  
IN 1ST FLOOR ON  
CORNER

VERTICAL SEPARATION  
AT 1ST FLOOR / FRONT  
WALL

Pronounced Deflection of 125 DEEP  
WINDOW LINTEL ON CENTRE

1ST FLOOR JOIST SPAN M-S  
AND HAVE NO BEARING  
AT FRONT WALL

DECAYED / INSECT INFESTED / BROKEN  
FLOOR JOISTING

VERTICAL FRACTURE IN PARTY  
WALL & POSSIBLE DRY ROT TENDRILS  
(TPS TO CHECK)

FLOOR BOARDING DECAYED

ALSO, LOOSE BRK JUST ABOVE 1ST  
FLOOR AT THE POINT IN BED 3
