**SECOND STAGE APPRAISAL**

**ADDENDUM TO FIRST STAGE APPRAISAL 2844**

**86 WEST STREET**

**Job No: 2844**  
**Dated: 5<sup>th</sup> November 2009**  
**Revised: 30<sup>th</sup> November 2009**

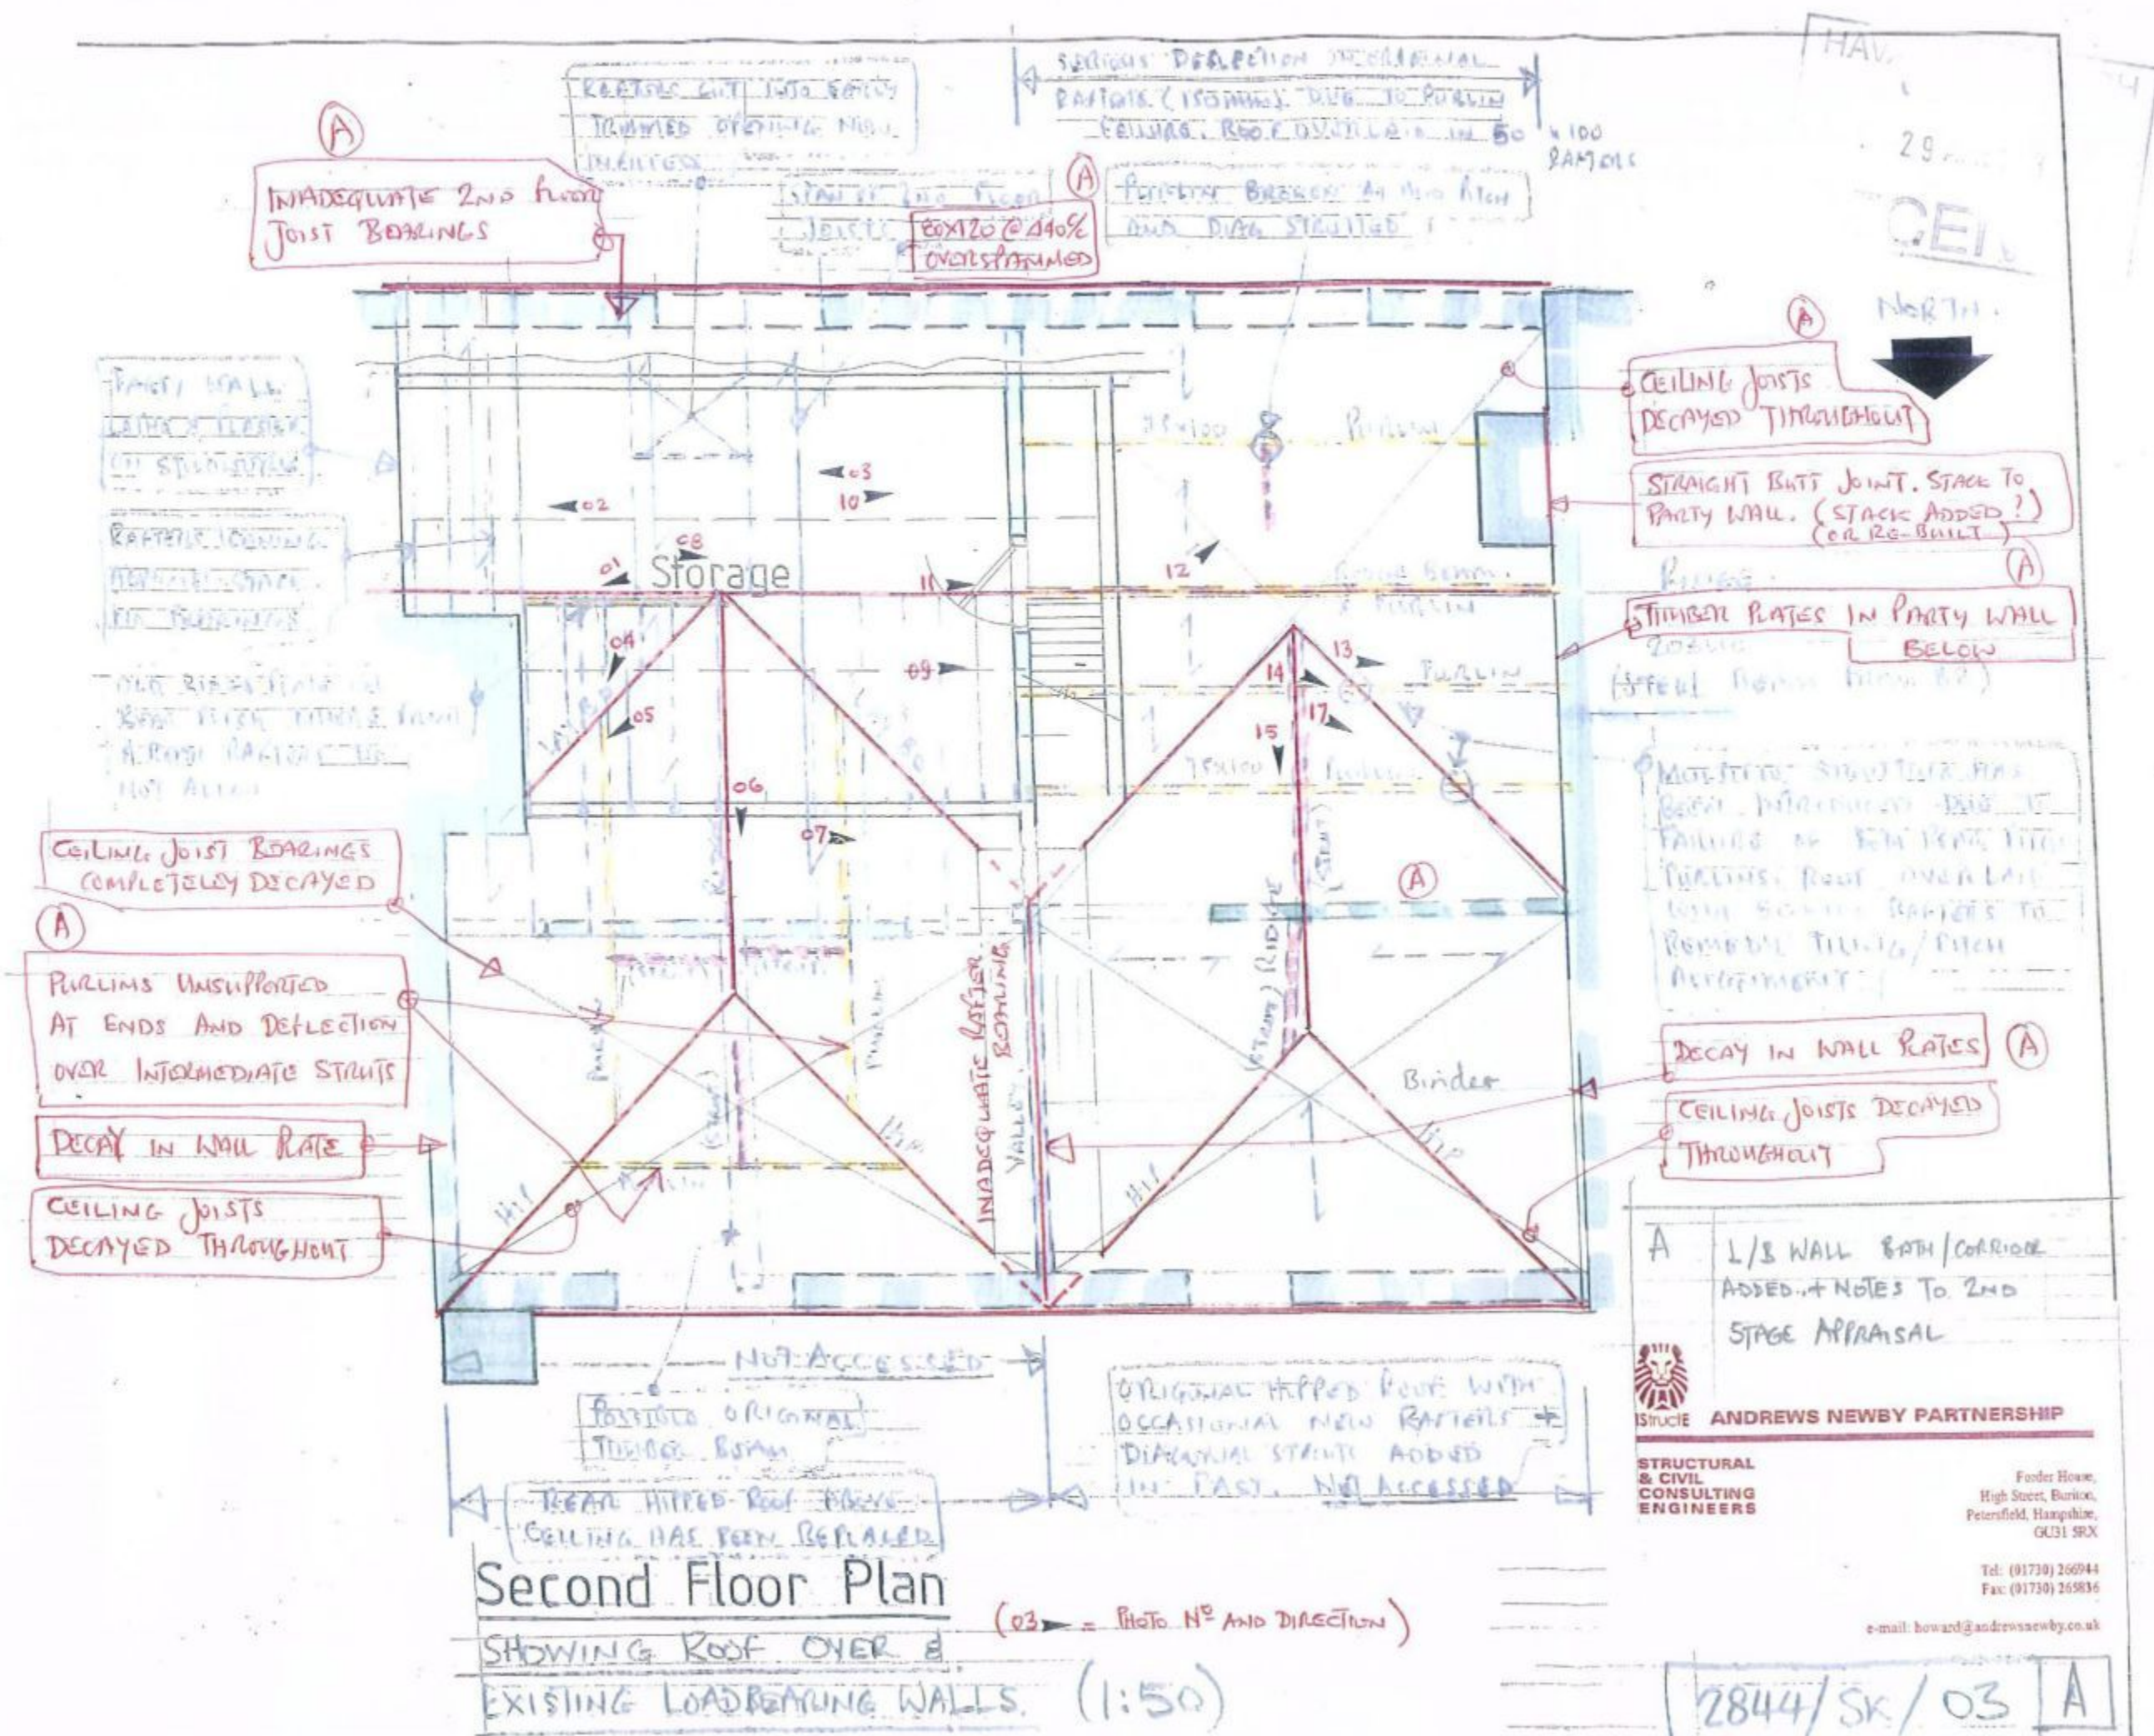
2844/SK/03 A

(A) INADEQUATE 2ND FLOOR JOIST BEARINGS

(A) BOX JOIST @ 440% OVERSTRESS

(A) CEILING JOISTS DECAYED THROUGHOUT

(A) MODIFIED STRUCTURE HAS BEEN INTRODUCED DUE TO FAILURE OF SOME ROOF TRUSSES. ROOF OVER LANE WITH SOME BARRIERS TO REMOVE TILING/FLOOR AS NECESSARY

(A) DECAY IN WALL RATES
