# **APPENDIX 3**

## ***Inspection Report***

**REPORT ON INPECTION OF  
15 NILE STREET  
EMSWORTH  
HAMPSHIRE**

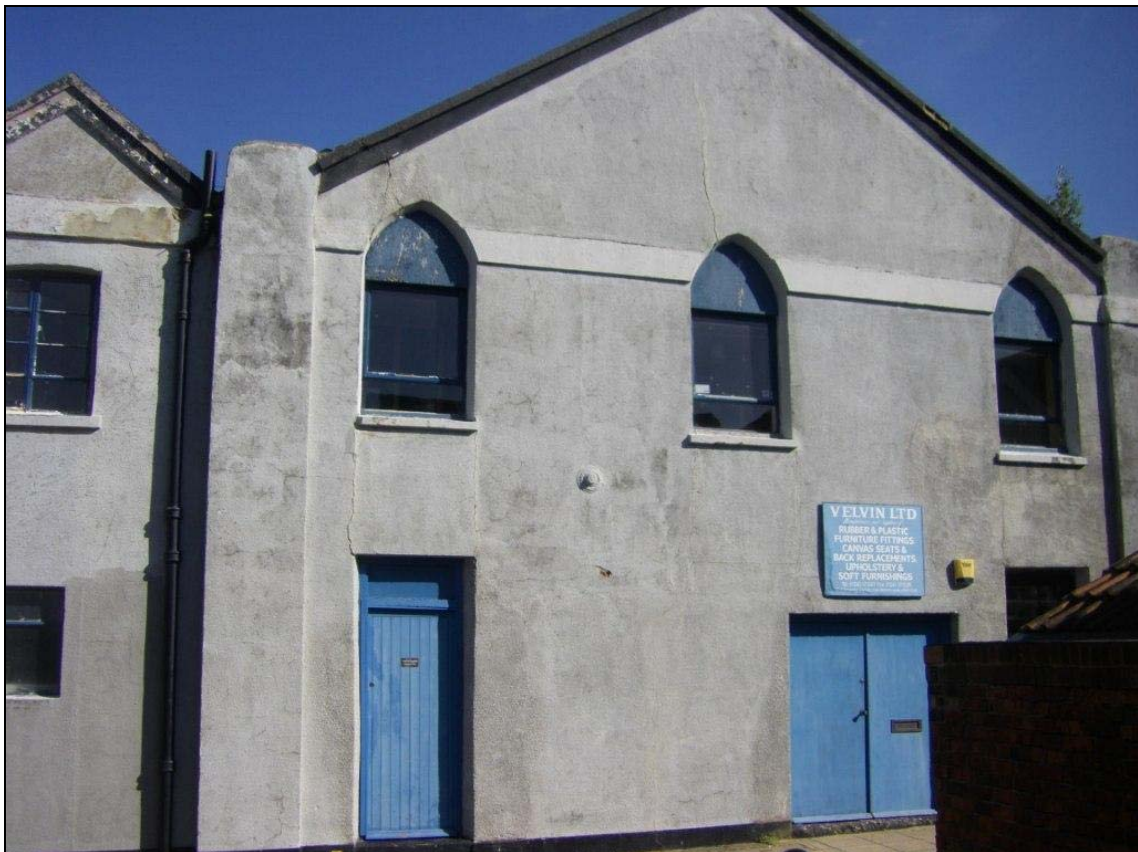
**Photo 1: Front elevation, cracking on wall visible**

The tyrollean is cracked in numerous places with a horizontal crack at the base of the gable wall, we cannot confirm that this goes through into the masonry, internally although there are numerous cracks we cannot be certain that they reflect the external cracks. We can see that there have been brickwork infills particularly under the windows. There is a cast iron downpipe and soil vent pipe on the front as well.

The repaired wall and infills are not bonded to the original brickwork leaving a wall that is not uniform over the entire elevation. It would be more economical to demolish the existing than carry out the necessary repairs.

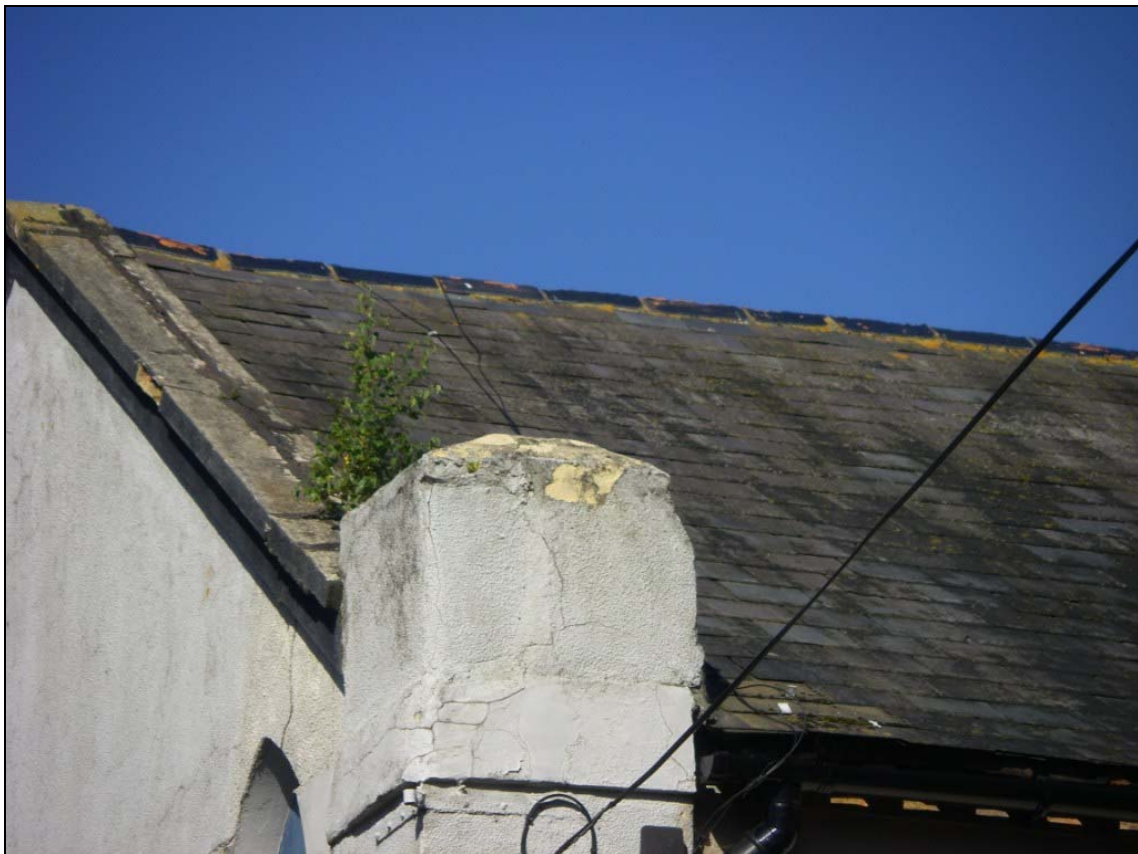
**Photo 2: East pitch of the roof with capped gable upstand wall and vegetative growth. The slates are in a poor condition. There is no underfelt or insulation.**

The roof is in poor condition with numerous slipped and damaged slates, the middle section of the roof was not wholly visible from ground level. Internally the length of rafter between supports e.g. purlins is excessive by today's standard, there was no underfelt and that sections of the rafters and joisting have evidence of decay. There is no evidence of lateral restraint to the gable walls. There is a half-round plastic gutter which appears to be a recent installation, it was not raining at the time of inspection so we cannot comment on the effectiveness of the rainwater goods.

- The existing building would require a totally new roof including joists, insulation, under felt and ventilation.
- From the condition of the gable walls the original lateral restraint achieved by the joists has failed and is no longer effective and we would therefore anticipate the renewal of the joisting at first floor level and the introduction of effective lateral restraint.

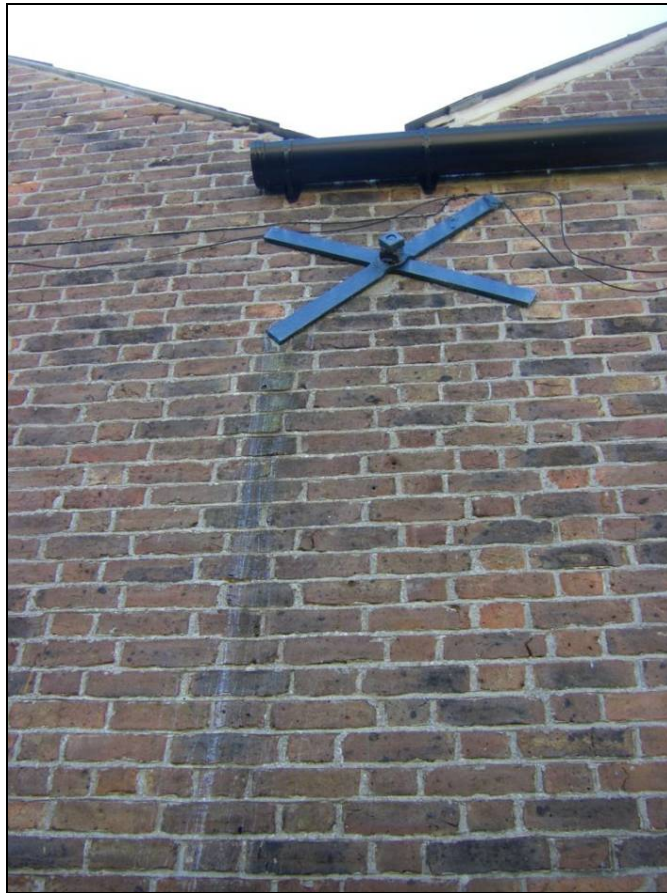
The larger gable wall bulges out considerably and this is in all probability due to a lack of internal lateral restraint. The retro fitted ties bars may have partly stabilised the wall but without monitoring the wall we cannot be sure that the movement in this wall is historic or progressive. Due to the condition of the wall it is our opinion that the wall will have to be taken down to below the level where it is bulged and then rebuilt.

**Photo 3: North elevation at junction of the two pitched roofs. The pattrress plate attached to the tie bar is clearly visible.**

The brickwork has been repointed; however this has been poorly executed and would require raking out and repointing.

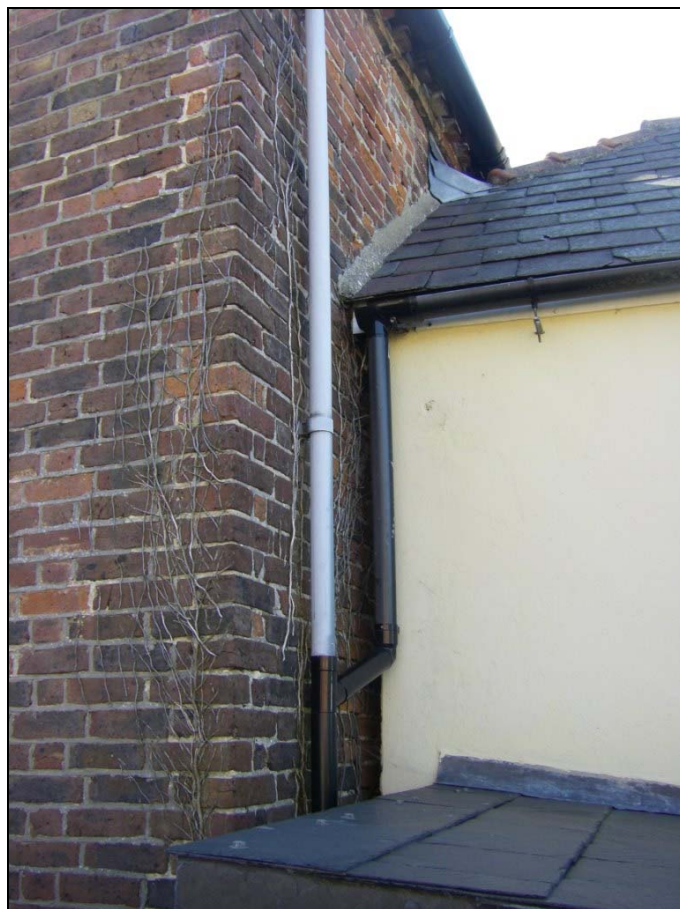
From our limited views this wall did not have externally any noticeable defects albeit it does require re-pointing.

**Photo 4: Abutment of adjoining property and the west elevation.**

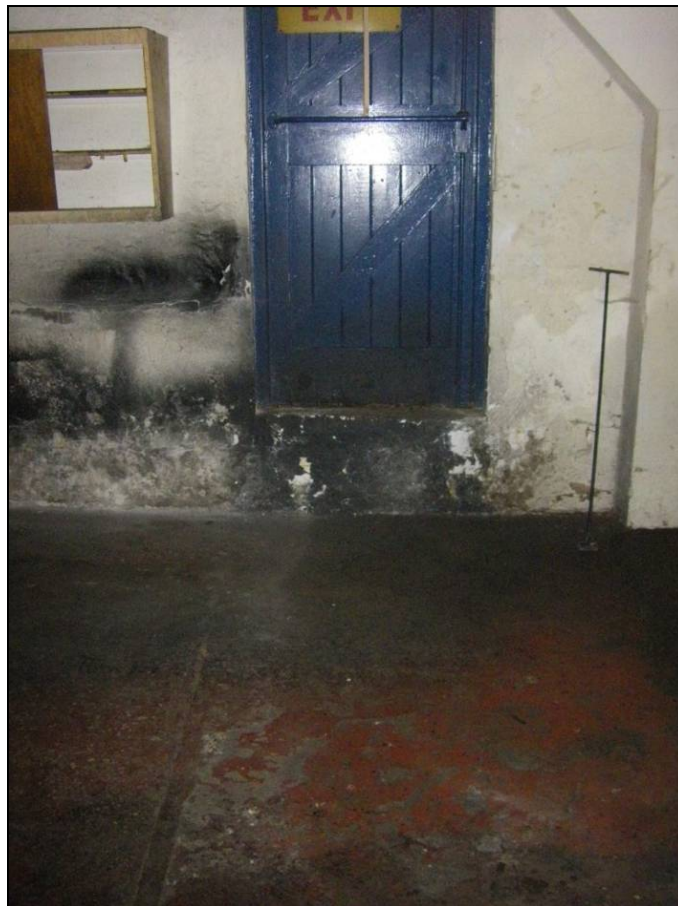
The ground floor external walls have considerable dampness at low level with large patches of damp staining on the ground bearing concrete floor slab. The north elevation is some 400mm lower internally than ground level externally; in the west section the floor is even lower. This is not ideal and the floor levels would have to be carefully considered if the building was to be refurbished. There will be considerable work to be undertaken to bring this in line with current regulations. While we appreciate that there are systems on the market that would allow the damp walls to be over boarded, which would also allowing moisture to drain away in our opinion the cost would be excessive to achieve a satisfactory finish.

**Photo 5: The external ground level is at the bottom of the door. There is dampness both on the walls and floor.**

The dampness in this building is visible to the solid walls including the internal walls, there are various causes of this dampness: rising damp, penetrative dampness and condensation, however to ascertain the extent of the dampness and eradicate the causes in our opinion would take a considerable time and expense.

finish vary, additionally due to the age of the unit we presume that there is no damp proof membrane and insulation. In our opinion the removal of the slab completely would be the most economic way to achieve a floor that meets current standards.

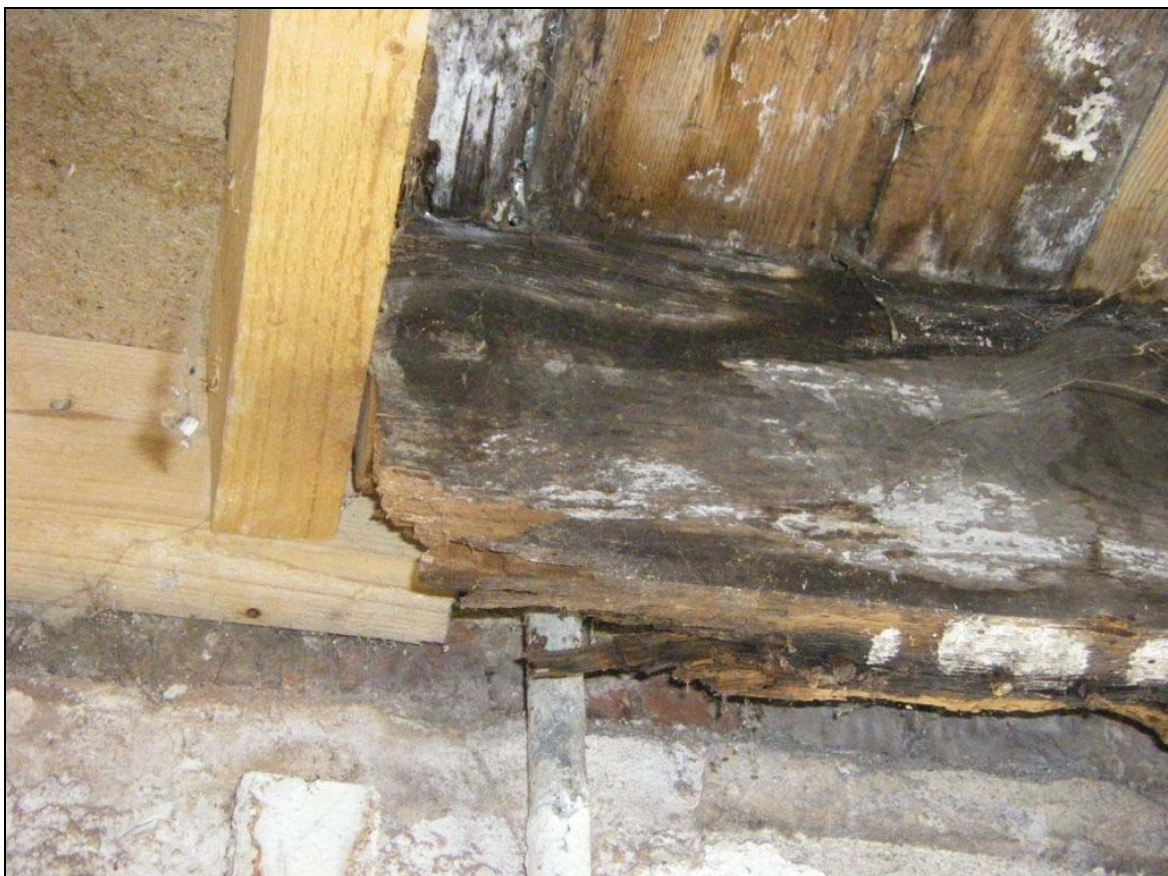
In the ground floor toilets a section of ceiling is exposed and we can see where a repair has been carried out to decayed timbers. This is perhaps indicative of the possible state of timbers elsewhere but concealed from view. It may also be that the size of the joists would be inadequate for current span and therefore would require renewal.

**Photo 6: Repair to first floor joist, decayed timber still visible.**

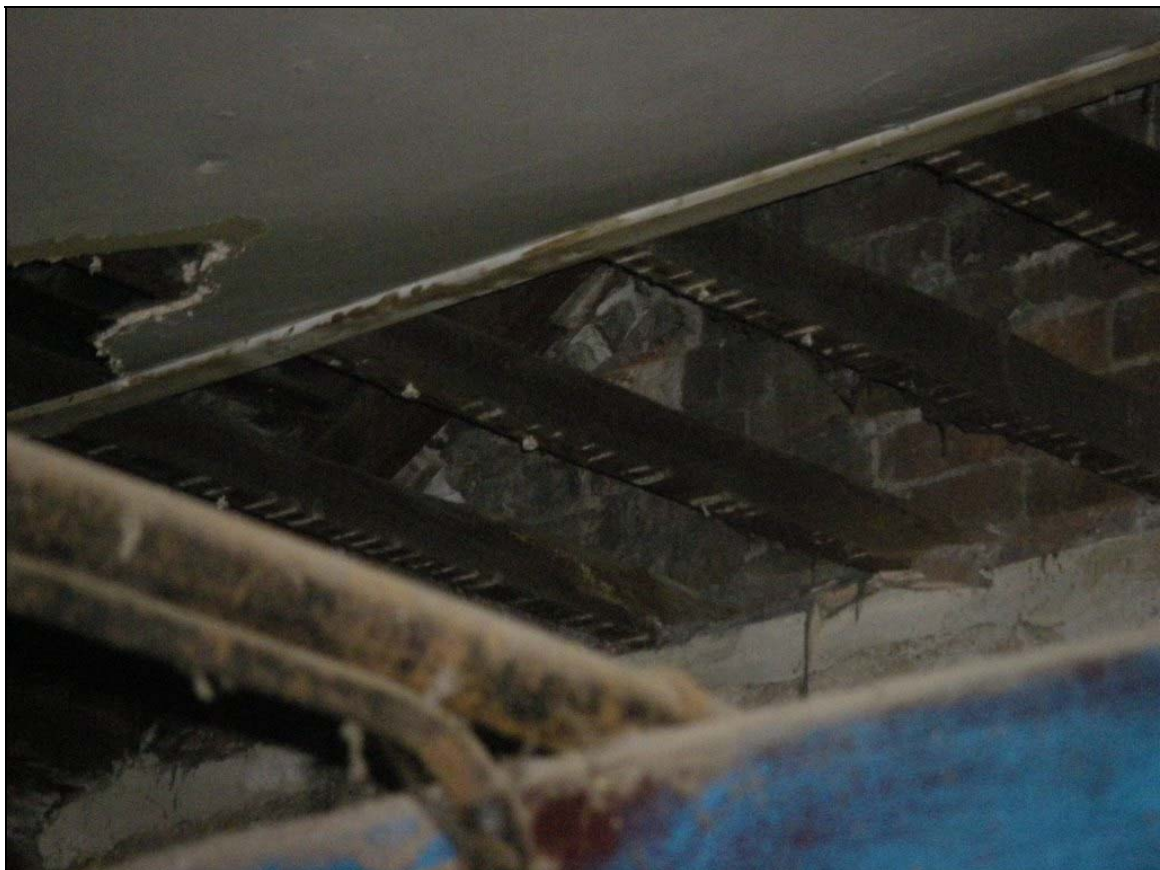
On first floor level there are some redundant offices that would all be removed. External walls where exposed the plaster is in a very poor condition.

**Photo 7: Lath and plaster missing from ceiling joist on first floor. The ceiling joist where supported by a wall can provide lateral restraint however if the timber decays the effectiveness of the lateral restraint will be compromised.**

As previously stated lateral restraint would need to be added and the wall built up on the north wall. The partition between the two separate sections of the building is a mixture of masonry and timber studwork.
