# **APPENDIX 3**

## ***Inspection Report***

**REPORT ON INPECTION OF  
15 NILE STREET  
EMSWORTH  
HAMPSHIRE**

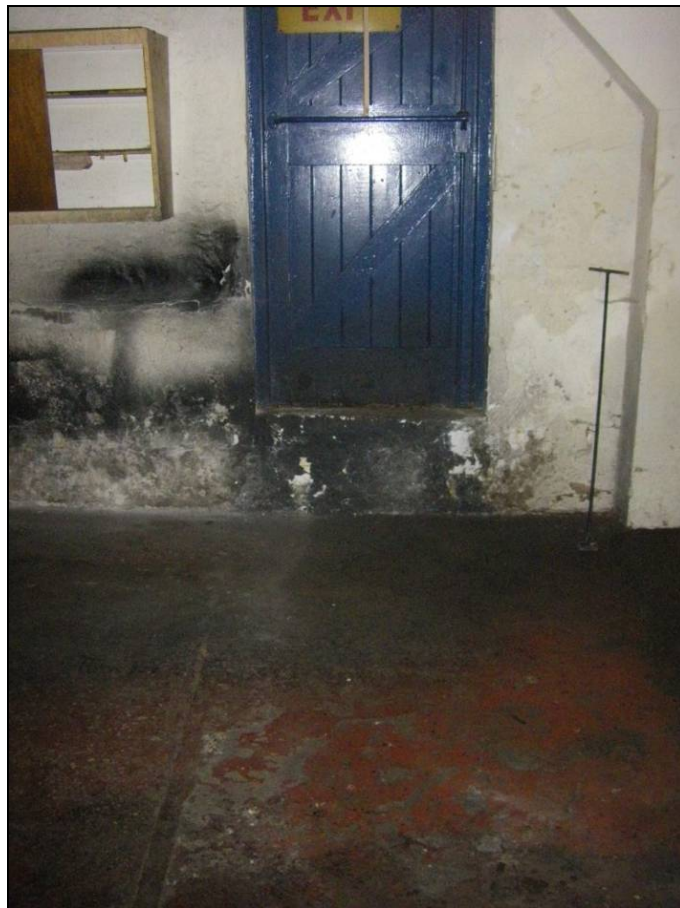
The ground floor external walls have considerable dampness at low level with large patches of damp staining on the ground bearing concrete floor slab. The north elevation is some 400mm lower internally than ground level externally; in the west section the floor is even lower. This is not ideal and the floor levels would have to be carefully considered if the building was to be refurbished. There will be considerable work to be undertaken to bring this in line with current regulations. While we appreciate that there are systems on the market that would allow the damp walls to be over boarded, which would also allowing moisture to drain away in our opinion the cost would be excessive to achieve a satisfactory finish.

**Photo 5: The external ground level is at the bottom of the door. There is dampness both on the walls and floor.**

finish vary, additionally due to the age of the unit we presume that there is no damp proof membrane and insulation. In our opinion the removal of the slab completely would be the most economic way to achieve a floor that meets current standards.
