## ***Inspection Report***

**REPORT ON INSPECTION OF  
15 NILE STREET  
EMSWORTH  
HAMPSHIRE**

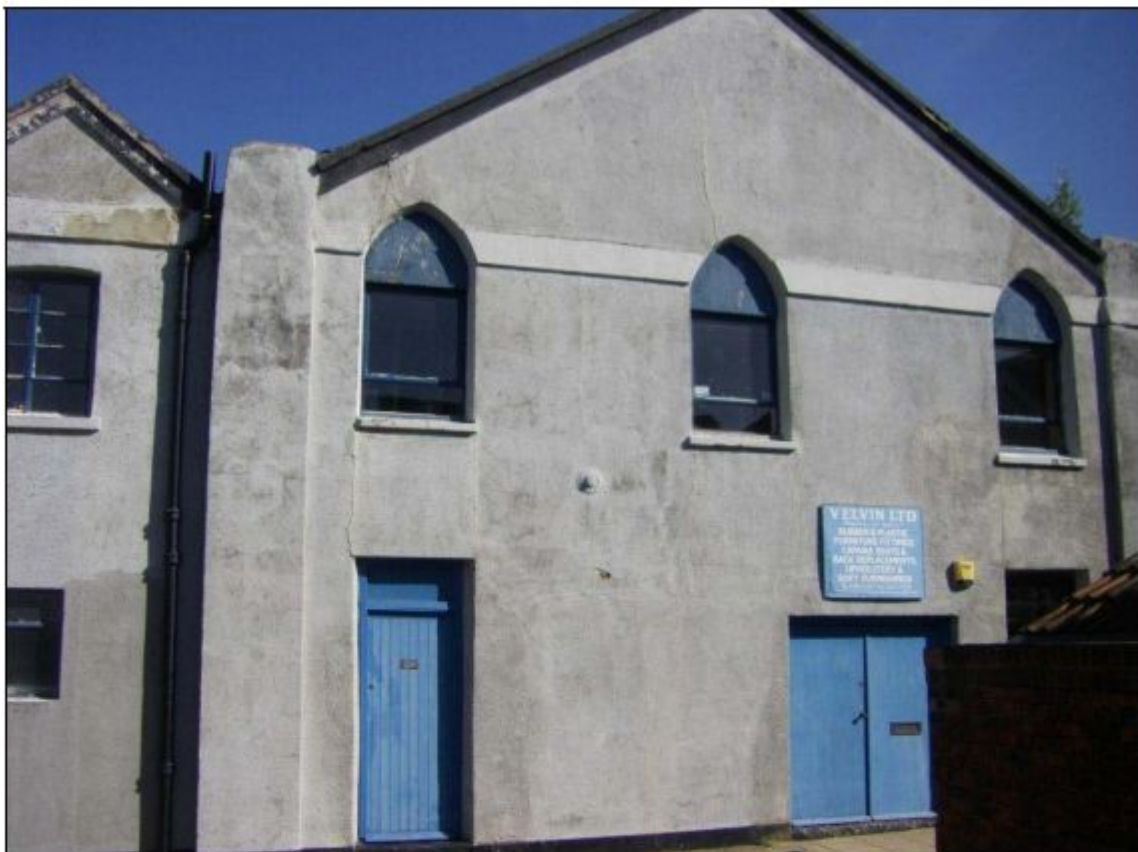
**Photo 1: Front elevation, cracking on wall visible**

The tyrollean is cracked in numerous places with a horizontal crack at the base of the gable wall, we cannot confirm that this goes through into the masonry, internally although there are numerous cracks we cannot be certain that they reflect the external cracks. We can see that there have been brickwork infills particularly under the windows. There is a cast iron downpipe and soil vent pipe on the front as well.

The repaired wall and infills are not bonded to the original brickwork leaving a wall that is not uniform over the entire elevation. It would be more economical to demolish the existing than carry out the necessary repairs.

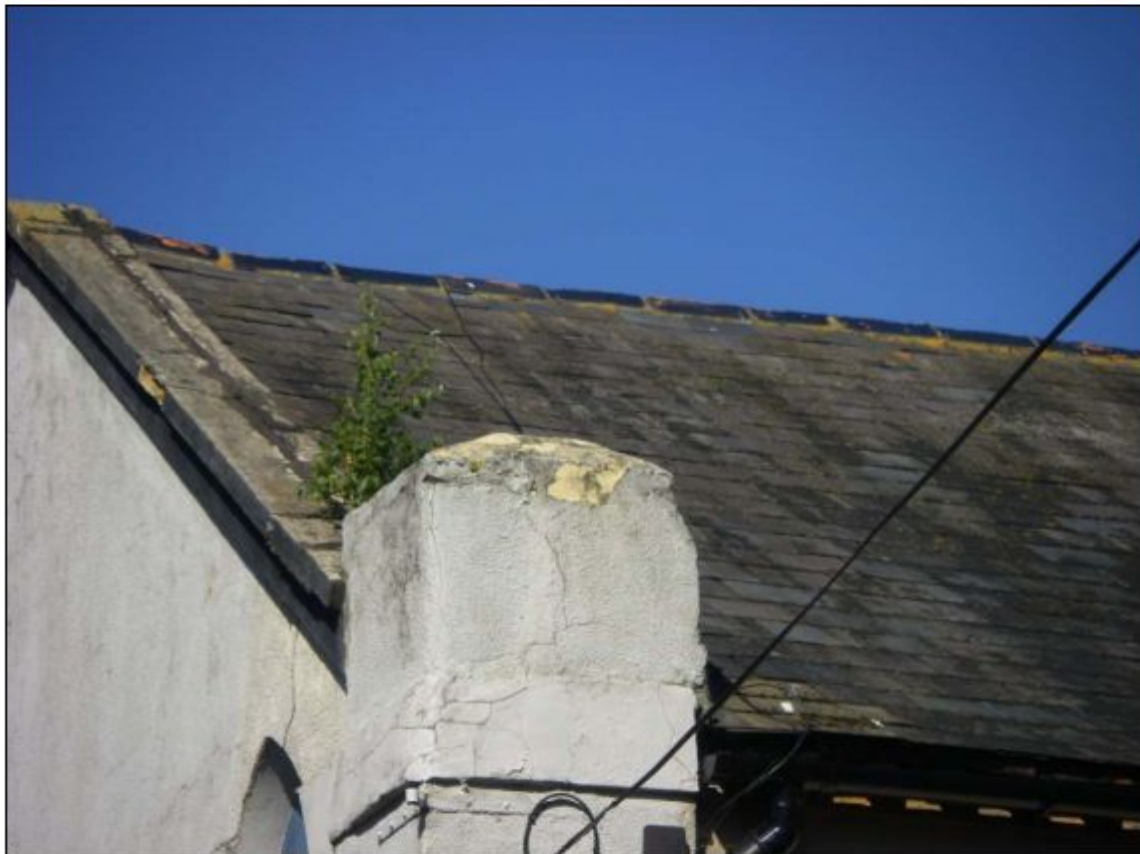
**Photo 2: East pitch of the roof with capped gable upstand wall and vegetative growth. The slates are in a poor condition. There is no underfelt or insulation.**

The roof is in poor condition with numerous slipped and damaged slates, the middle section of the roof was not wholly visible from ground level. Internally the length of rafter between supports e.g. purlins is excessive by today's standard, there was no underfelt and that sections of the rafters and joisting have evidence of decay. There is no evidence of lateral restraint to the gable walls. There is a half-round plastic gutter which appears to be a recent installation, it was not raining at the time of inspection so we cannot comment on the effectiveness of the rainwater goods.

- The existing building would require a totally new roof including joists, insulation, under felt and ventilation.
- From the condition of the gable walls the original lateral restraint achieved by the joists has failed and is no longer effective and we would therefore anticipate the renewal of the joisting at first floor level and the introduction of effective lateral restraint.

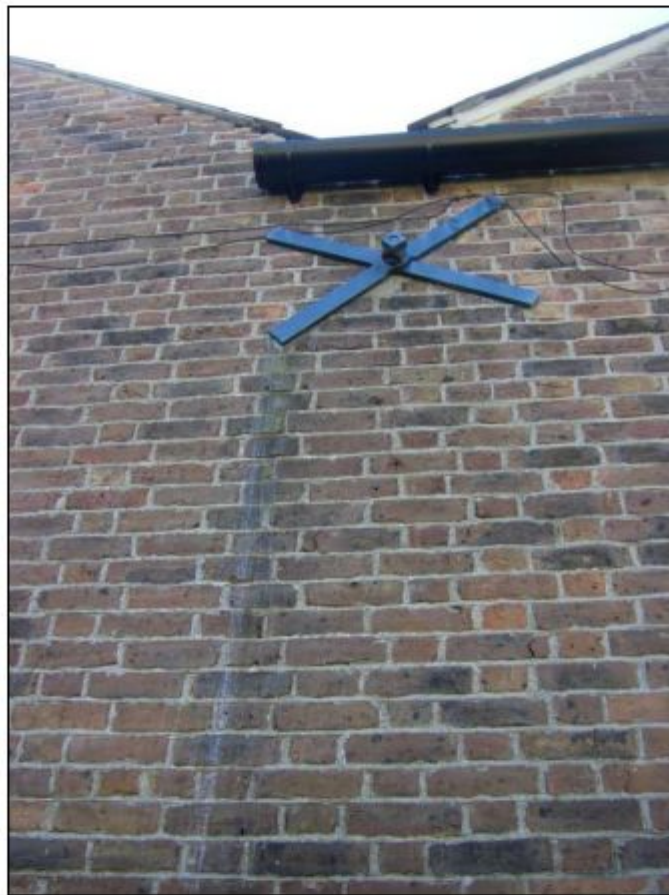
The larger gable wall bulges out considerably and this is in all probability due to a lack of internal lateral restraint. The retro fitted ties bars may have partly stabilised the wall but without monitoring the wall we cannot be sure that the movement in this wall is historic or progressive. Due to the condition of the wall it is our opinion that the wall will have to be taken down to below the level where it is bulged and then rebuilt.

**Photo 3: North elevation at junction of the two pitched roofs. The pattern plate attached to the tie bar is clearly visible.**

The brickwork has been repointed; however this has been poorly executed and would require raking out and repointing.

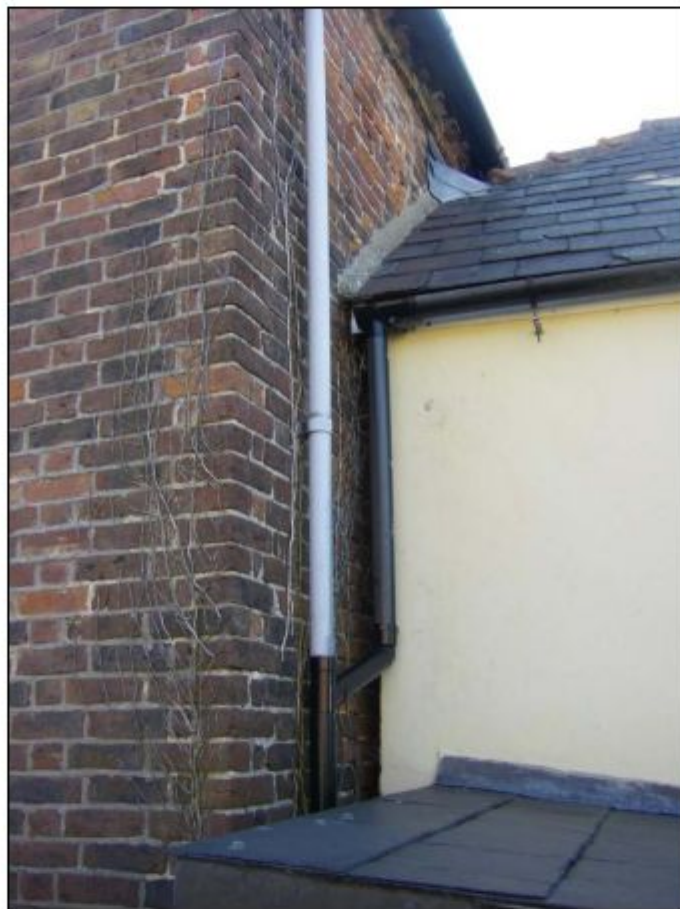
From our limited views this wall did not have externally any noticeable defects albeit it does require re-pointing.

**Photo 4: Abutment of adjoining property and the west elevation.**

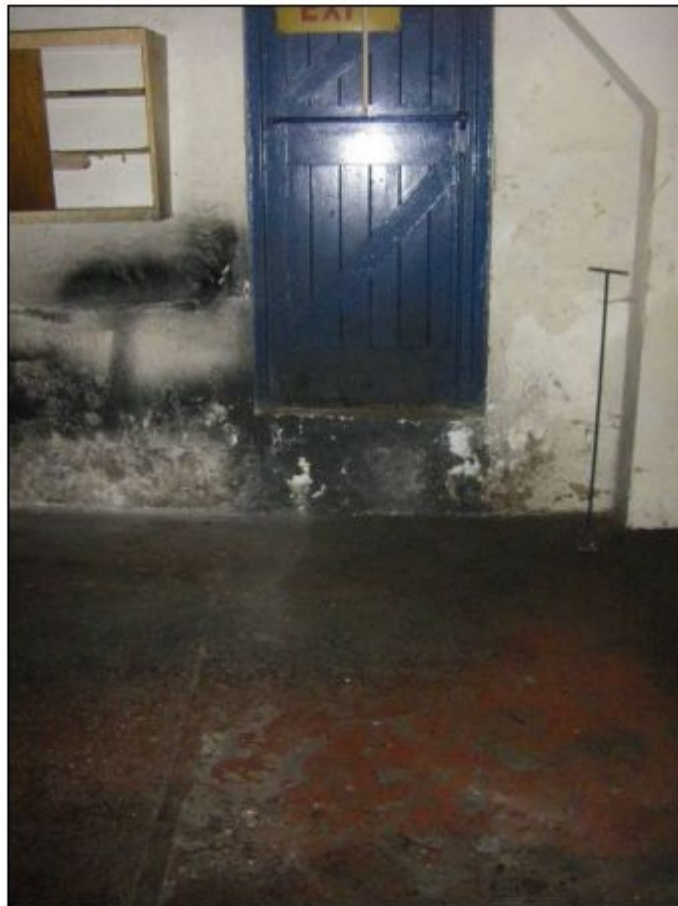
The ground floor external walls have considerable dampness at low level with large patches of damp staining on the ground bearing concrete floor slab. The north elevation is some 400mm lower internally than ground level externally; in the west section the floor is even lower. This is not ideal and the floor levels would have to be carefully considered if the building was to be refurbished. There will be considerable work to be undertaken to bring this in line with current regulations. While we appreciate that there are systems on the market that would allow the damp walls to be over boarded, which would also allowing moisture to drain away in our opinion the cost would be excessive to achieve a satisfactory finish.

**Photo 5: The external ground level is at the bottom of the door. There is dampness both on the walls and floor.**

finish vary, additionally due to the age of the unit we presume that there is no damp proof membrane and insulation. In our opinion the removal of the slab completely would be the most economic way to achieve a floor that meets current standards.

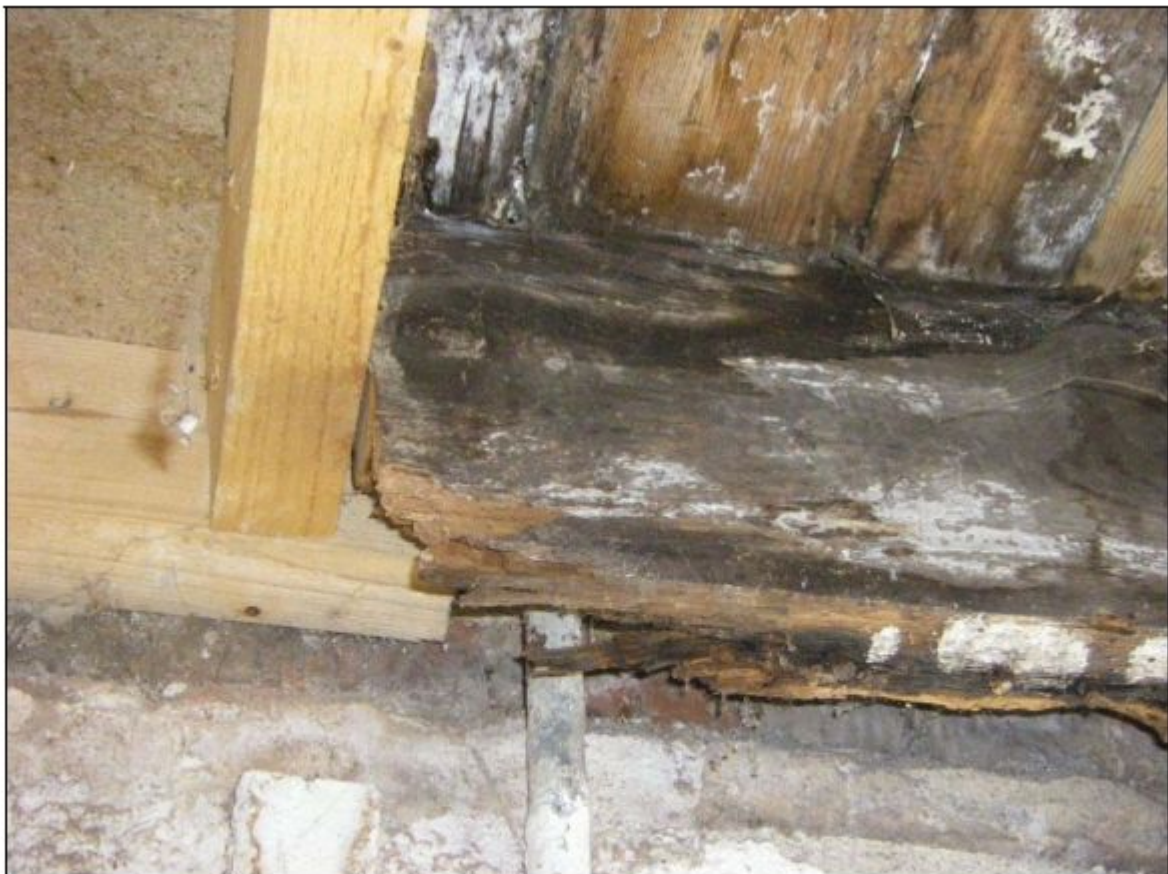
In the ground floor toilets a section of ceiling is exposed and we can see where a repair has been carried out to decayed timbers. This is perhaps indicative of the possible state of timbers elsewhere but concealed from view. It may also be that the size of the joists would be inadequate for current span and therefore would require renewal.

**Photo 6: Repair to first floor joist, decayed timber still visible.**

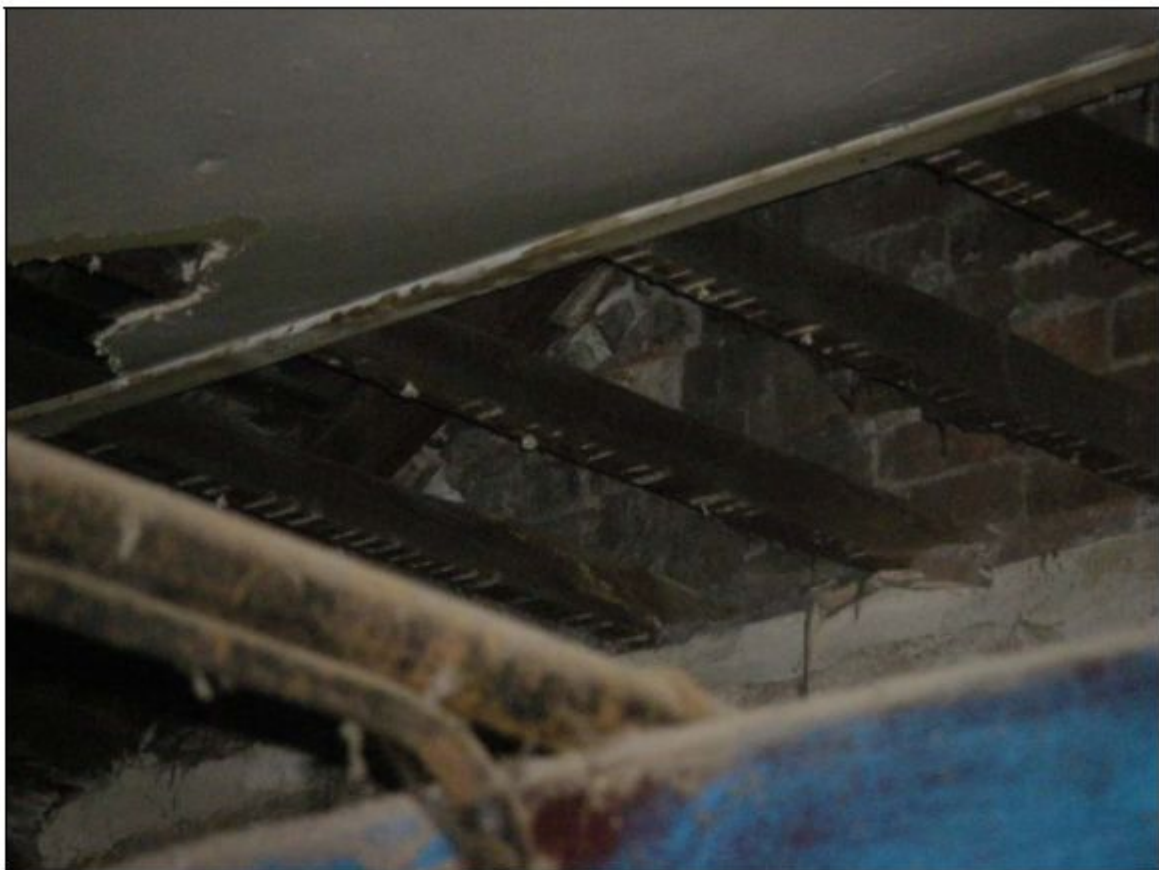
**Photo 7: Lath and plaster missing from ceiling joist on first floor. The ceiling joist where supported by a wall can provide lateral restraint however if the timber decays the effectiveness of the lateral restraint will be compromised.**

As previously stated lateral restraint would need to be added and the wall built up on the north wall. The partition between the two separate sections of the building is a mixture of masonry and timber studwork.
