# 39 SEAFRONT, HAYLING ISLAND.

## RECOMMENDED 'LISTED BUILDING' WORKS FOLLOWING VISUAL SURVEY CARRIED OUT IN SEPTEMBER 2012

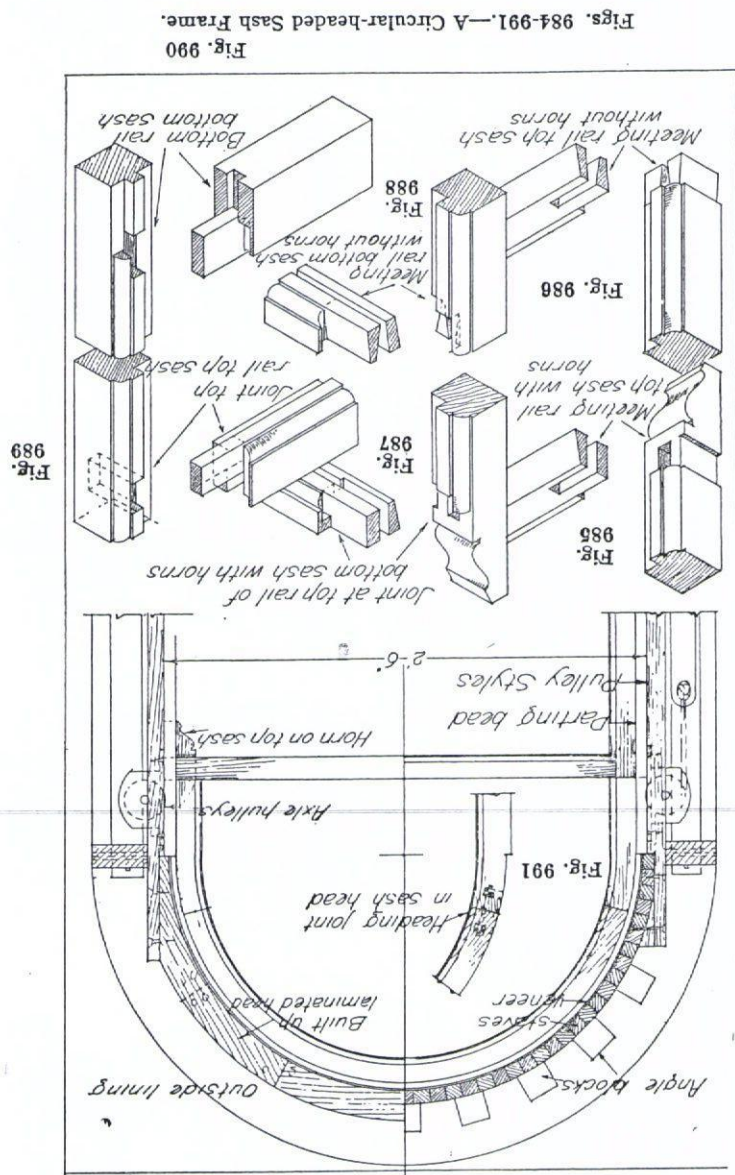
FIGURE 58

| DESCRIPTION | EXISTING CONSTRUCTION | PROPOSED REPLACEMENT / WORKS |
|---|---|---|
| | 3 <sup>rd</sup> Floor - Dormer windows in replacement double glazed PVCu Nos. 1, 2 & 3 [ 4127.11.6 ] | Take out and replace with softwood single glazed vertical sliding sash windows as per Detail "A" |
