Meadowsweet Grant  
Application  
(Original)

1st March 2012

Meadowsweet comprises two separate buildings, joined together at one corner for internal access. The older cottage shown on the left in Fig 1, is located adjacent to St Peters Road and is believed to date from AD 1530. The newer 'added-on' cottage on the right in Fig. 1 is partly constructed in a 'Mock Tudor' type style; it is located adjacent to Clovelly Road and dates from AD1920. This application concerns changes to the older cottage, (i) renovation of the southern and western elevations and (ii) installation of stainless steel liners inside the chimney stacks.

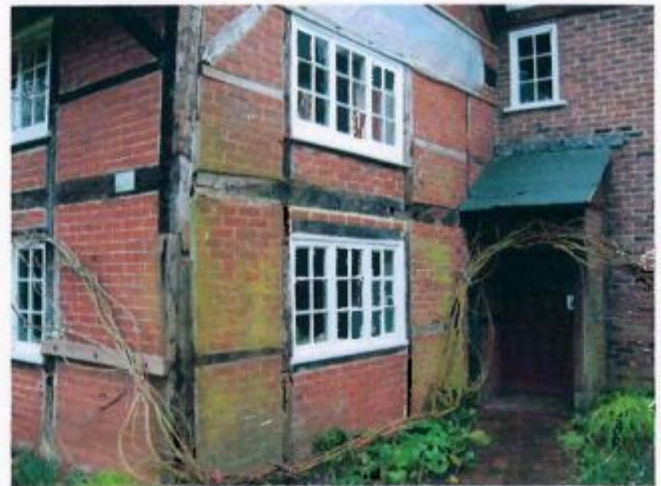
Fig 2: SW Elevations

The wall shown in Fig 2 is in presently in a very precarious state, with some loose brickwork panels in danger of falling outwards, potentially endangering people who pass below. The oak frame has lost its structural integrity, due to serious decay and attack by wood-boring beetles. Both horizontal tie beams are badly affected by this, and have become disjointed from the upright corner post. Many of the smaller beams are not keyed into the surrounding wood frame, thus further destabilising the wall and its individual masonry panels. The lower part of the vertical corner post was replaced using soft wood some time ago, and the resulting joint between these sections has caused the corner to buckle outwards; see Fig 2. In turn, this movement has caused the lower two brick panels on the west-facing corner wall to buckle inwards.

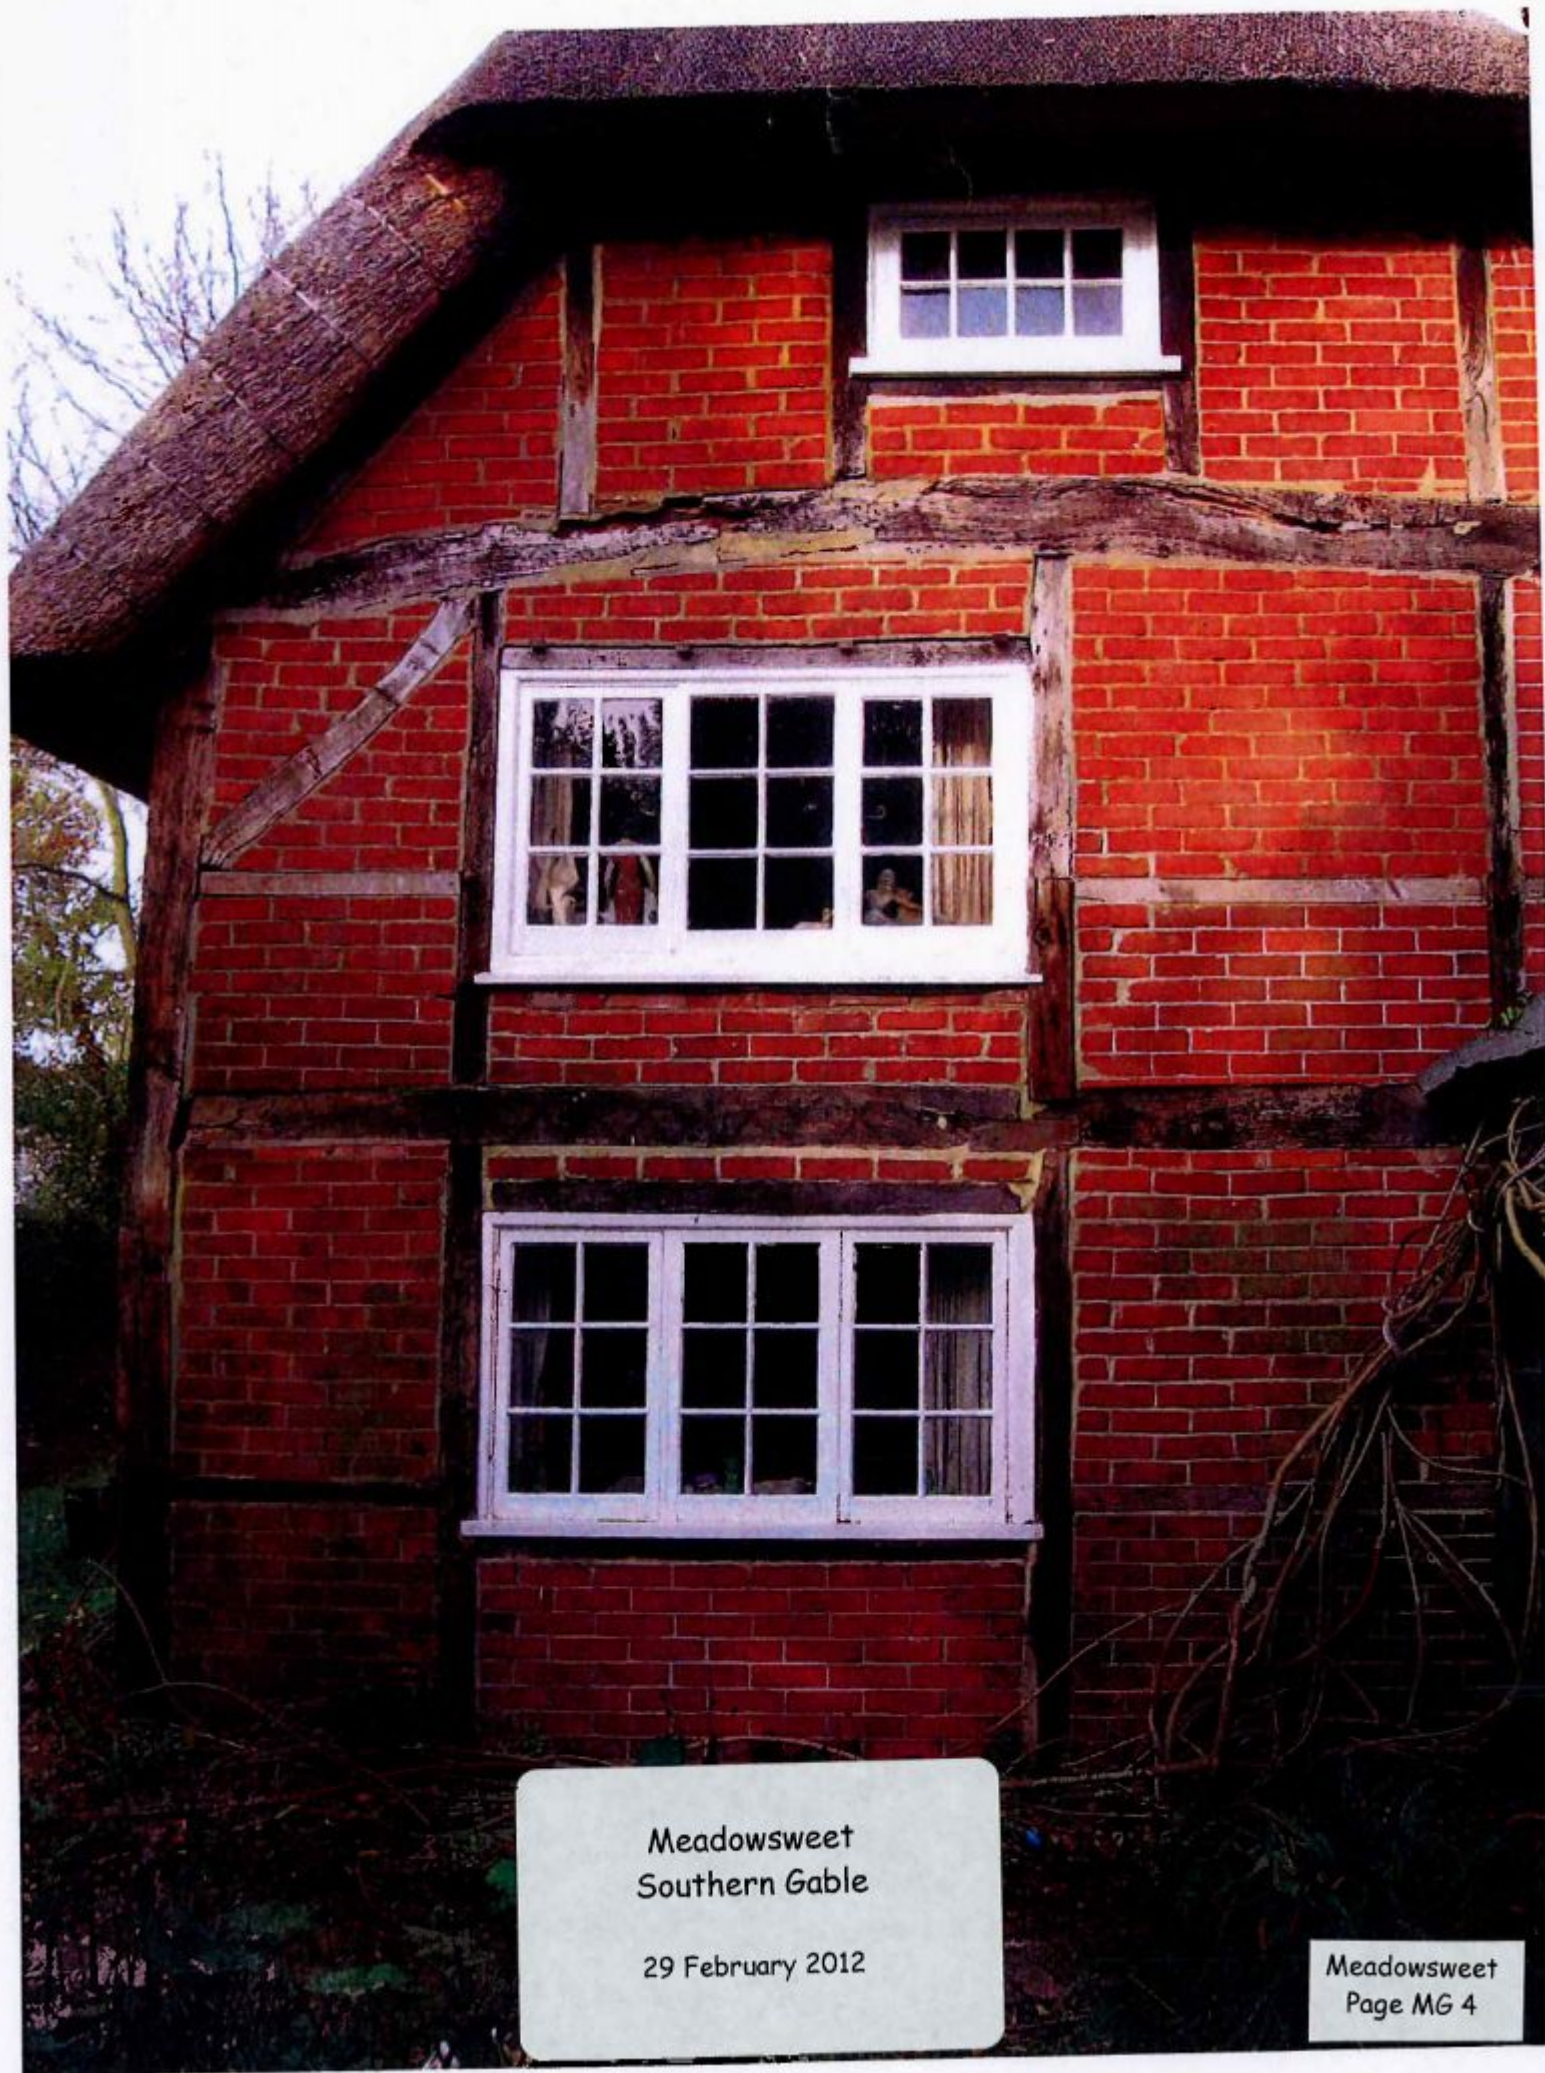
Meadowsweet  
Southern Gable

1. Severe deathwatch beetle and decay to the left of centre in the large beam at eaves level. There is no evidence to indicate that the infestation is live although we believe that this is the case. The decay is sufficient to severely weaken the beam to the extent that it could compromise the integrity of the framework on this wall and also reduce the effectiveness of the tie between the eaves beams on the front and rear elevations. Repair or renewal is required as soon as possible.

2. The vertical timbers each side of the windows have been altered or repaired on several past occasions. There are horizontal butt joints in the timbers. There appears to be no lateral restraint at the joints and the timbers are displaced. They have probably been displaced for many years but some are loose and capable of movement with light pressure. To the lower left of the ground floor window, there is an infill section of the vertical framing which is loose and is not receiving any vertical load. It appears likely that the load is being transferred to an adjacent horizontal timber through a notched joint. The various connections in this area should be overhauled to properly transfer the load to the oak framework without loading the brickwork. The other joints require further investigations for similar reasons.

3. The panel of brickwork above the first floor window is loose and proud of the adjacent oak framework. The cause of this is probably associated with the movement of the timber framework but needs to be investigated further. You should anticipate the need for this section of brickwork to be rebuilt or tied back, whichever is appropriate. Other infill panels may need similar restraint.

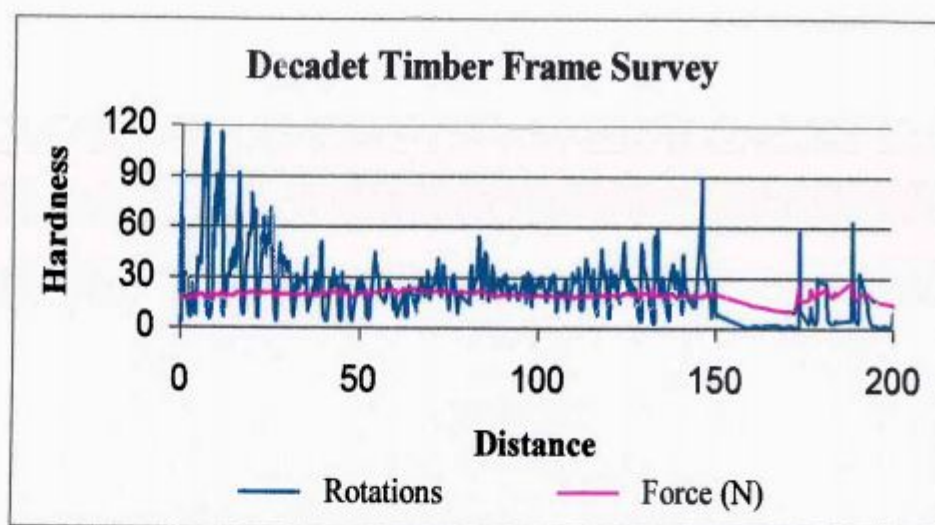
Decay is evident between 150mm and 175mm and again around 185mm on the above sample probe result.

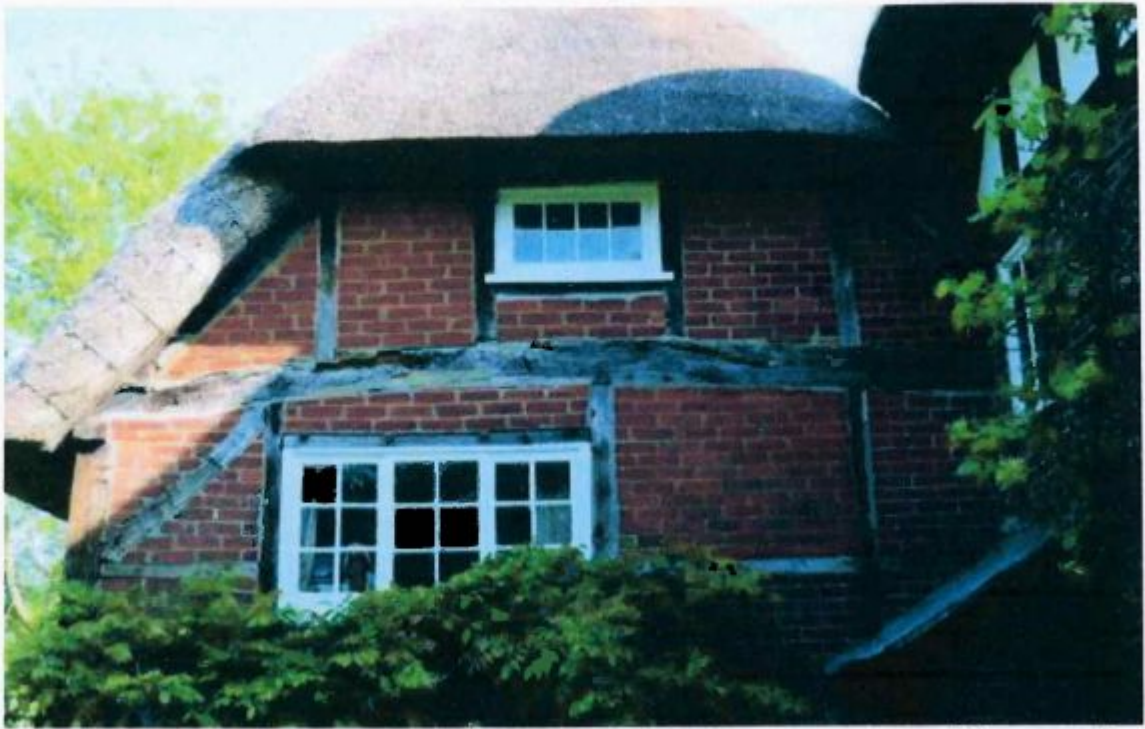
Photograph 1

General deterioration, weathering problems and inappropriate mortar patch repairs are shown in photographs 1 to 7.

Inappropriate face repairs in either timber or mortar should be removed and correct repairs carried out ensuring good weathering.

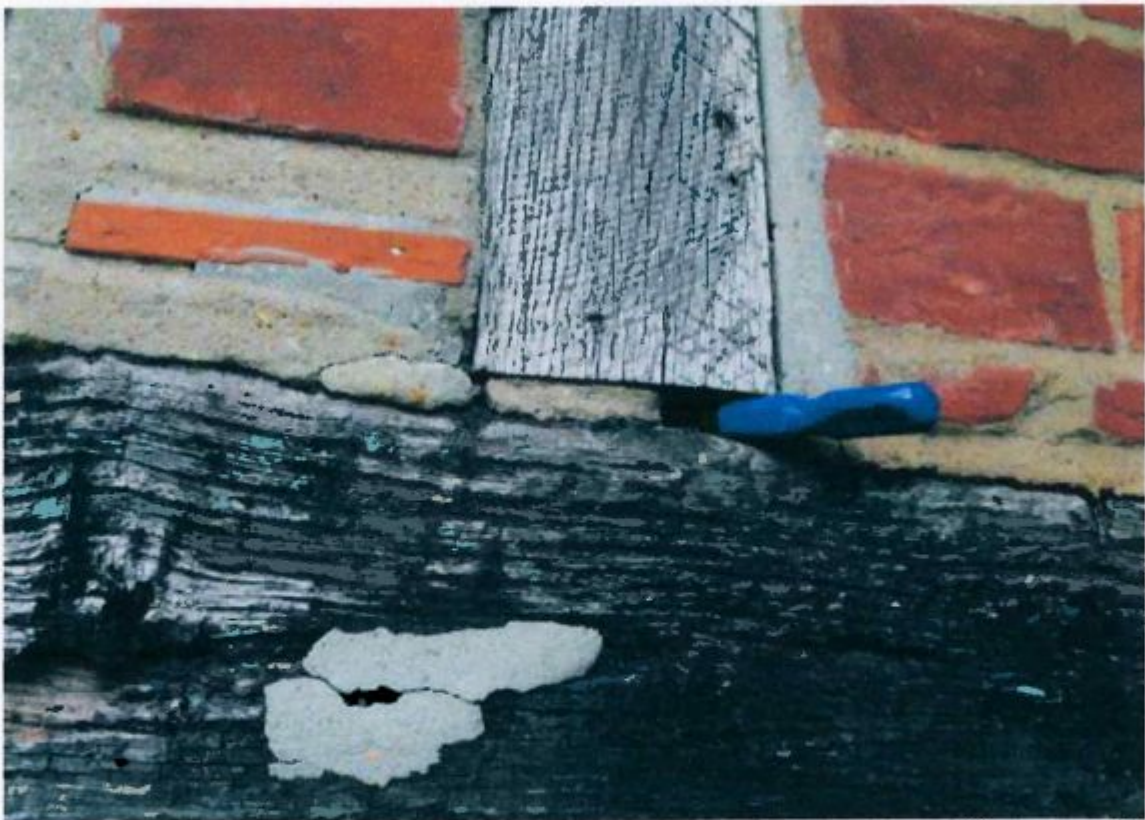
Photograph 2

Framing integrity is broken down where joints are non-existent, of poor quality or nailed as shown on photographs 2, 3, 5, 6, 8 and 9.

General framing joints should be repaired, but intermediate studs are considered thin in cross section. Either the timbers will have to be temporarily removed for end splice repairs or brickwork opened up for side mechanical fixings. It is not recommended to install diagonal face fixings due to the possibility of water ingress.

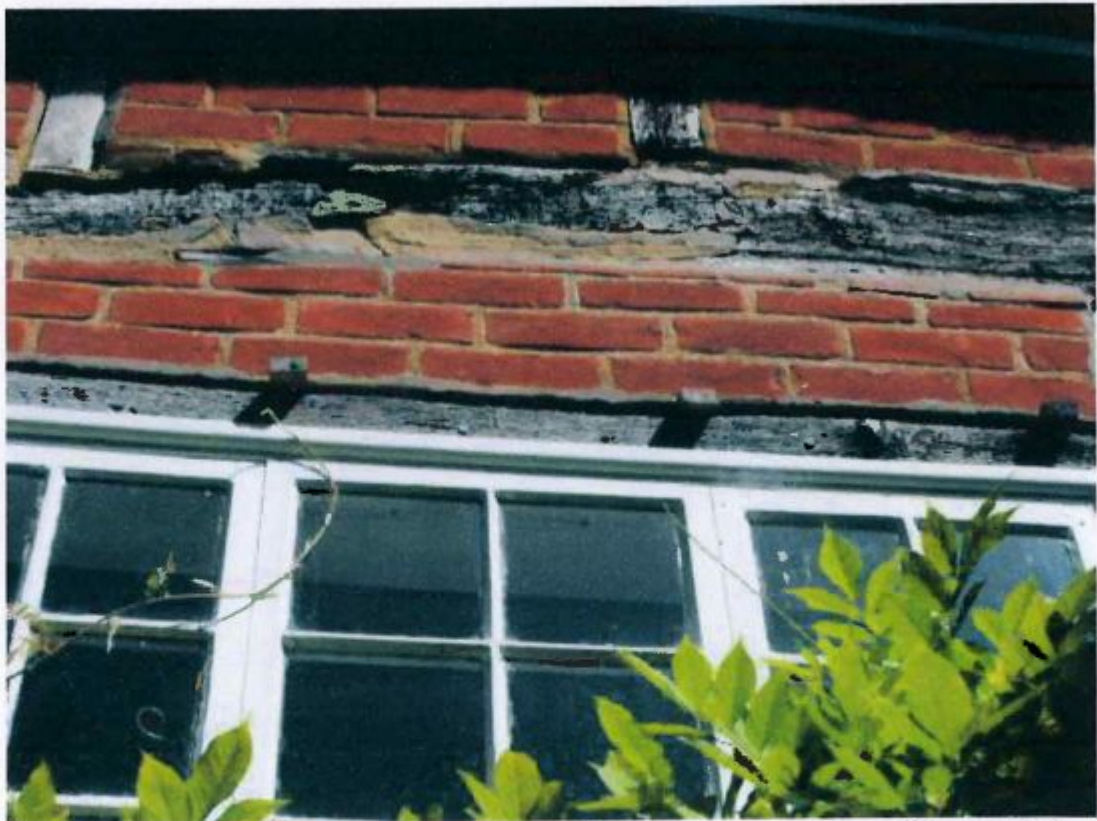
Photograph 4

Vertical support is inadequate as shown on photograph 4.
