# Arboricultural Consultancy for Churchill Building Insurance

| <b>Insured</b> | Mr Philip Wakeford | <b>Address</b> | 21 Cavendish Drive, Waterlooville, Hampshire, PO7 7PJ | | |
| <b>Report Date</b> | 02/03/2012 | | | | |

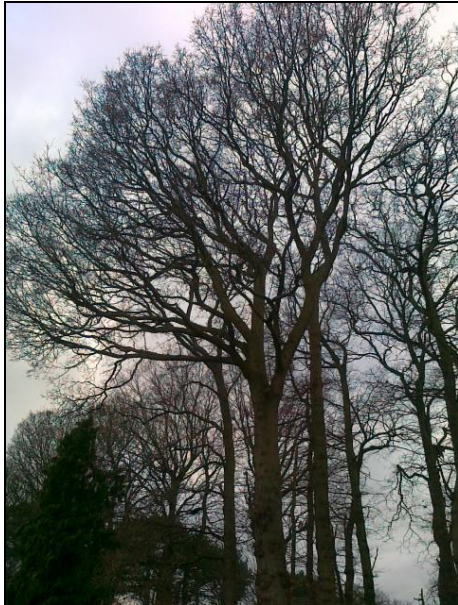
T1 - Oak

Based on our site investigations, and taking account of vegetation location, relative to the focal area of movement/ damage, it is our opinion that T1 (Oak) will be exerting the principal vegetative influence. This influence is determined by moisture content of soil in the locality of the area of damage combined with the above site investigations. This tree is also the largest one, closest to the property with the highest leaf area/ canopy size.

| Tree No. | Species | Age Cat | Approx. Height (m) | Distance to Building (m) | Ownership | Action | Requirement |
|---|---|---|---|---|---|---|---|
| T1 | Oak | 3 | 24 | 10 | C - Insured | Remove | Remove. |

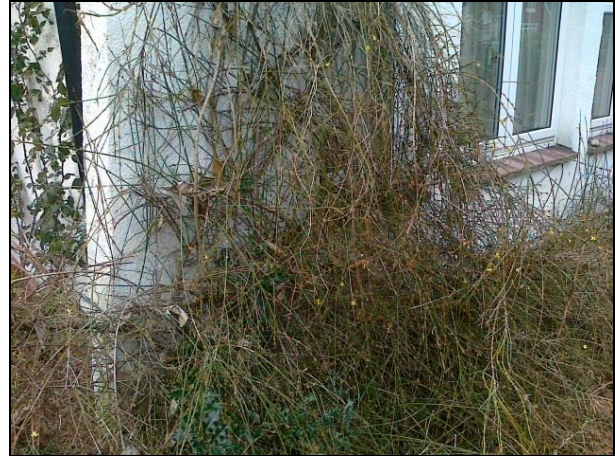
CG2 - Mixed Climbers

| Tree No. | Species | Age Cat | Approx. Height (m) | Distance to Building (m) | Ownership | Action | Requirement |
|---|---|---|---|---|---|---|---|
| CG2 | Forsythia & Cotoneaster | 1 | 2 | 0.2 | C - Insured | Action to avoid future risk | Do not allow to exceed current dimensions. |

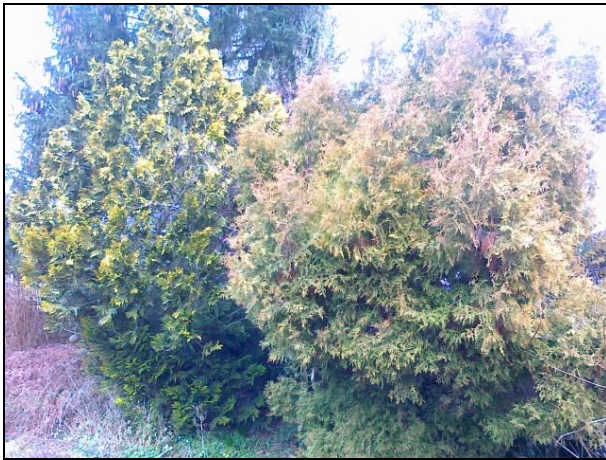
TG2 - Cypress

| TG2 | Cypress | 1 | 4.3 | 7.8 | C - Insured | Action to avoid future risk | Do not allow to exceed 6m height. x2 |

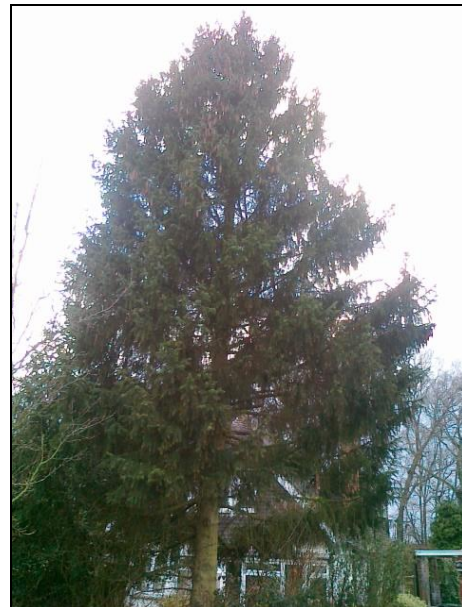
T7 - Spruce

| T7 | Spruce | 1 | 8.5 | 7.9 | C - Insured | Action to avoid future risk | Do not allow to exceed current dimensions. |

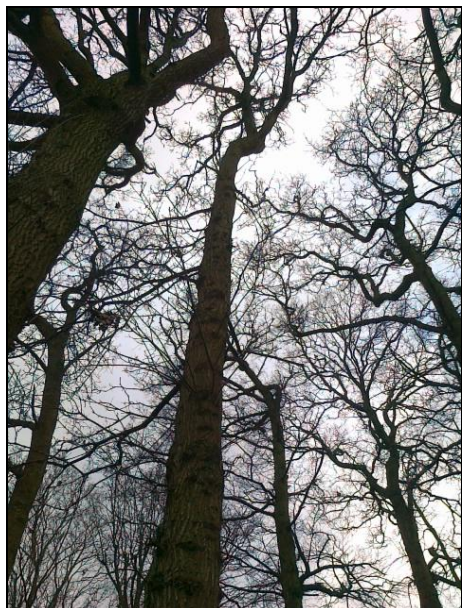
T2 - Oak

| T2 | Oak | 3 | 24 | 12 | C - Insured | Action to avoid future risk | Remove. |

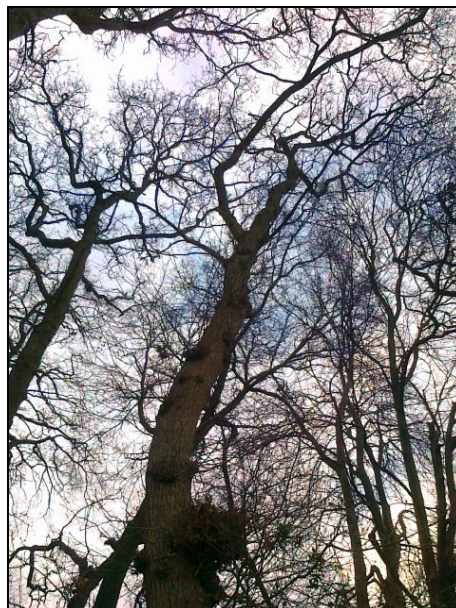
T3 - Oak

| T3 | Oak | 3 | 24 | 12.8 | C - Insured | Action to avoid future risk | Remove. |

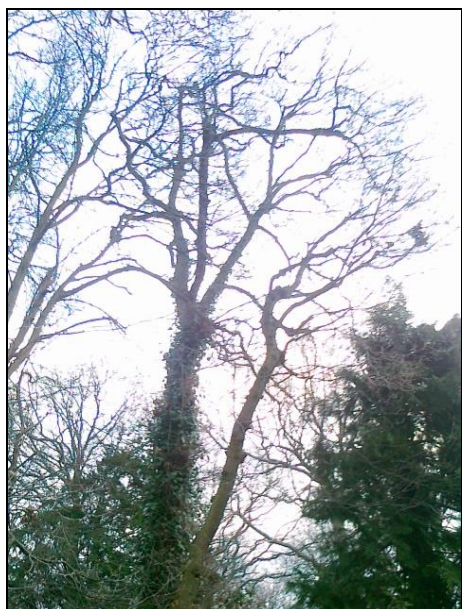
T4 - Oak

| T4 | Oak | 3 | 24 | 12.8 | C - Insured | Action to avoid future risk | Remove. |

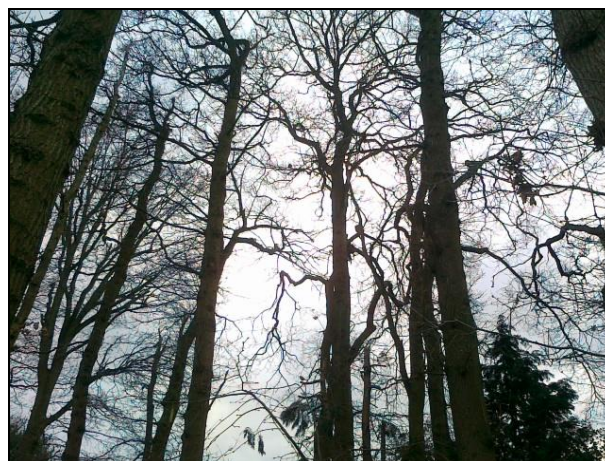
TG1 - Oak

| TG1 | Oak | 3 | 24 | 16 | C - Insured | Action to avoid future risk | Do not allow to exceed current dimensions. x11 |

TG1 will mitigate any losses by retaining a tree vista.

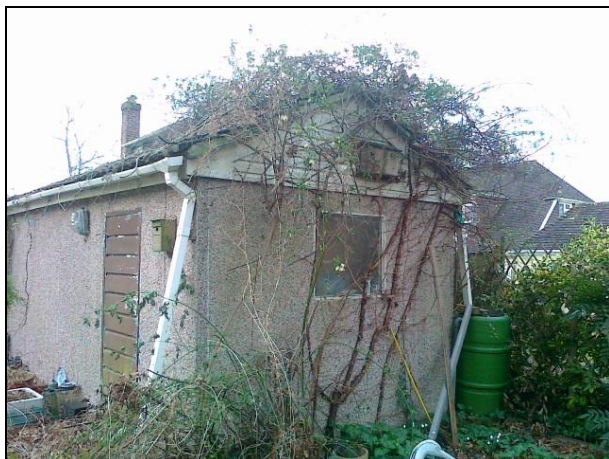
CG1 - Climbing Hydrangea & Jasmine

| Tree No. | Species | Age Cat | Approx. Height (m) | Distance to Building (m) | Ownership | Action | Requirement |
|---|---|---|---|---|---|---|---|
| CG1 | Climbing Hydrangea & Jasmine | 1 | 3 | 0.5 | C - Insured | Action to avoid future risk | Remove and treat stumps to inhibit regrowth. |

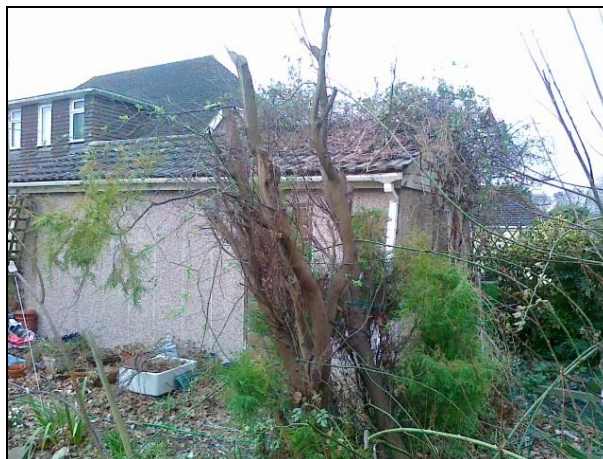
S3 - Cypress

| S3 | Cypress | 1 | 1.8 | 1.7 | C - Insured | Action to avoid future risk | Do not allow to exceed current dimensions. |

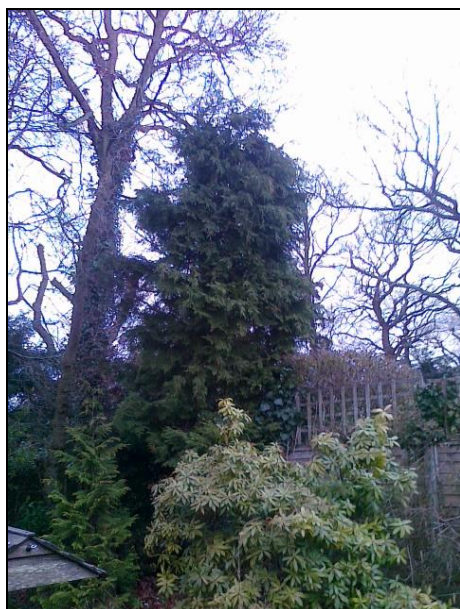
T6 - Cypress

| T6 | Cypress | 1 | 5.5 | 9.5 | C - Insured | Action to avoid future risk | Do not allow to exceed 7m height. |

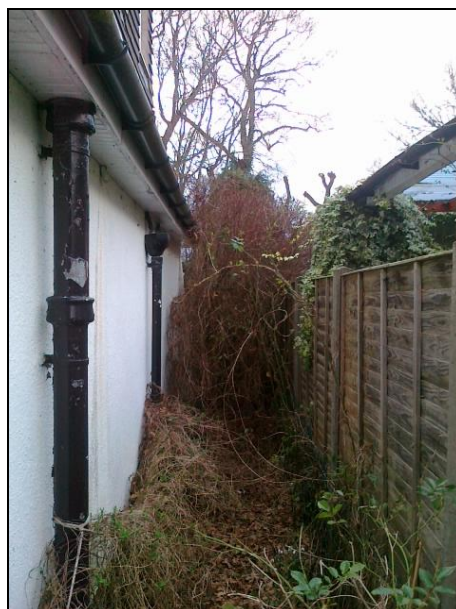
S4 - Berberis

| S4 | Berberis | 1 | 3 | 1 | C - Insured | Action to avoid future risk | Remove and treat stump to inhibit regrowth. |
