# Arboricultural Consultancy for Royal & Sun Alliance

## 1. Case Details

| <b>Insured</b> | Mr James Grattan | <b>Address</b> | 4 Hermitage Gardens, Waterlooville, Hampshire, PO7 7PR | | |

**Scope of Report:** To survey the property and determine significant vegetation contributing to subsidence damage, make recommendation for remedial action and assess initial mitigation and recovery prospects. The survey does not make an assessment for decay or hazard evaluation.

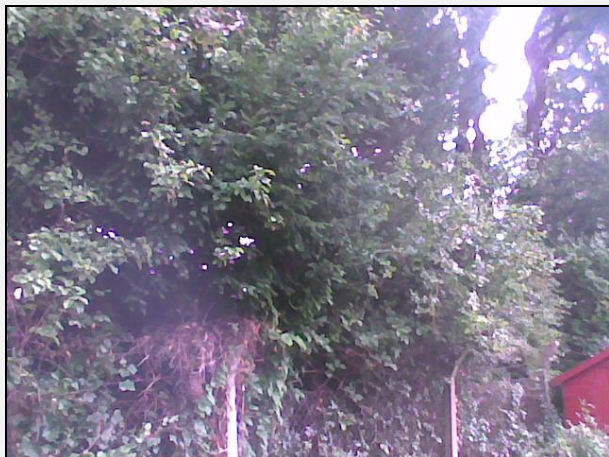
TG3 - Mixed Species Group (H)

| Tree No. | Species | Age Cat | Approx. Height (m) | Distance to Building (m) | Ownership | Action | Requirement |
|---|---|---|---|---|---|---|---|
| TG3 | Mixed Species Group (H) Scrub understorey containing Hawthorn, Acer, Yew, Holly & Cypress | 2 | 3.8 | 11 | A - Third Party<br>21 Cavendish Drive<br>Waterlooville<br>Hants | No Action | No works. |

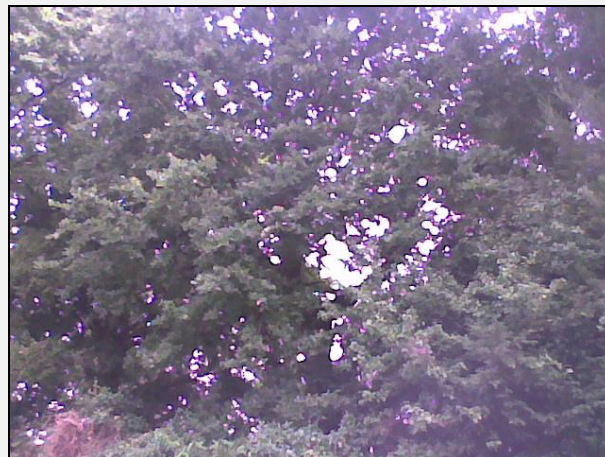
T1 - Oak

| Tree No. | Species | Age Cat | Approx. Height (m) | Distance to Building (m) | Ownership | Action | Requirement |
|---|---|---|---|---|---|---|---|
| T1 | Oak | 3 | 13 | 12 | A - Third Party<br>23 Cavendish Drive<br>Waterlooville<br>Hants | Action to avoid future risk | Reduce to points of previous reduction and maintain at reduced dimensions. |

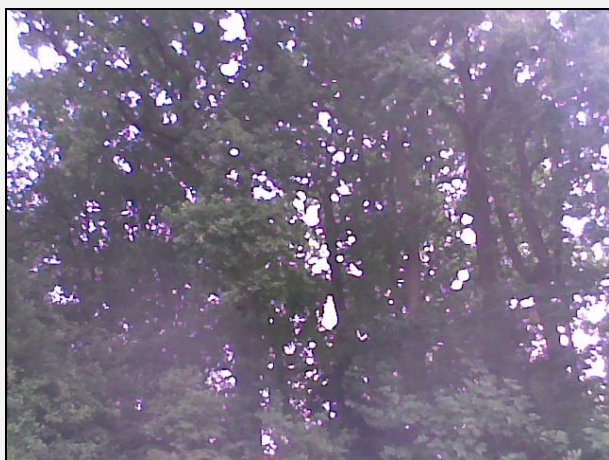
TG1 - Oak

Based on our site investigations, and taking account of vegetation location, relative to the focal area of movement / damage, it is our opinion that TG1 (Oak) will be exerting the principal vegetative influence. This influence is determined by the moisture content of soil in the locality of the area(s) of damage and recovery of *Quercus* roots.

Laboratory analysis of the roots has confirmed the species. Testing has revealed that the roots have a low starch content. Starch content does not definitively define whether a root is alive or dead. There is considerable species variation in relation to the storage of starch. Many of the smaller roots recovered from trial pits are not utilised by trees for starch storage. Whilst starch content may be low, or even 'none' this does not mean that the tree is not actively rooting in this area. Many fine roots have only a very limited lifespan in the soil. Recovery of root material will generally indicate the tree is actively removing resources (water and nutrients) from this area.

The close grown nature of the Oaks means removal of TG1 may ultimately not be possible without an impact on the remaining trees which would become exposed and potentially prone to a greater risk of branch / stem failure.

| Tree No. | Species | Age Cat | Approx. Height (m) | Distance to Building (m) | Ownership | Action | Requirement |
|---|---|---|---|---|---|---|---|
| TG1 | Oak | 3 | 18 | 12 | A - Third Party<br>21 Cavendish Drive<br>Waterlooville<br>Hants | Remove | Remove. Remove any regrowth annually.(x 3 trees) |
