# Arboricultural Assessment Report

## Detailed Report on Trees

| | <b>Risk Address:</b> | 22 Oakmont Drive, Waterloooville PO8 8TH |
| <b>Refs:</b> | <b>OCA Ref:</b> | 49581 |

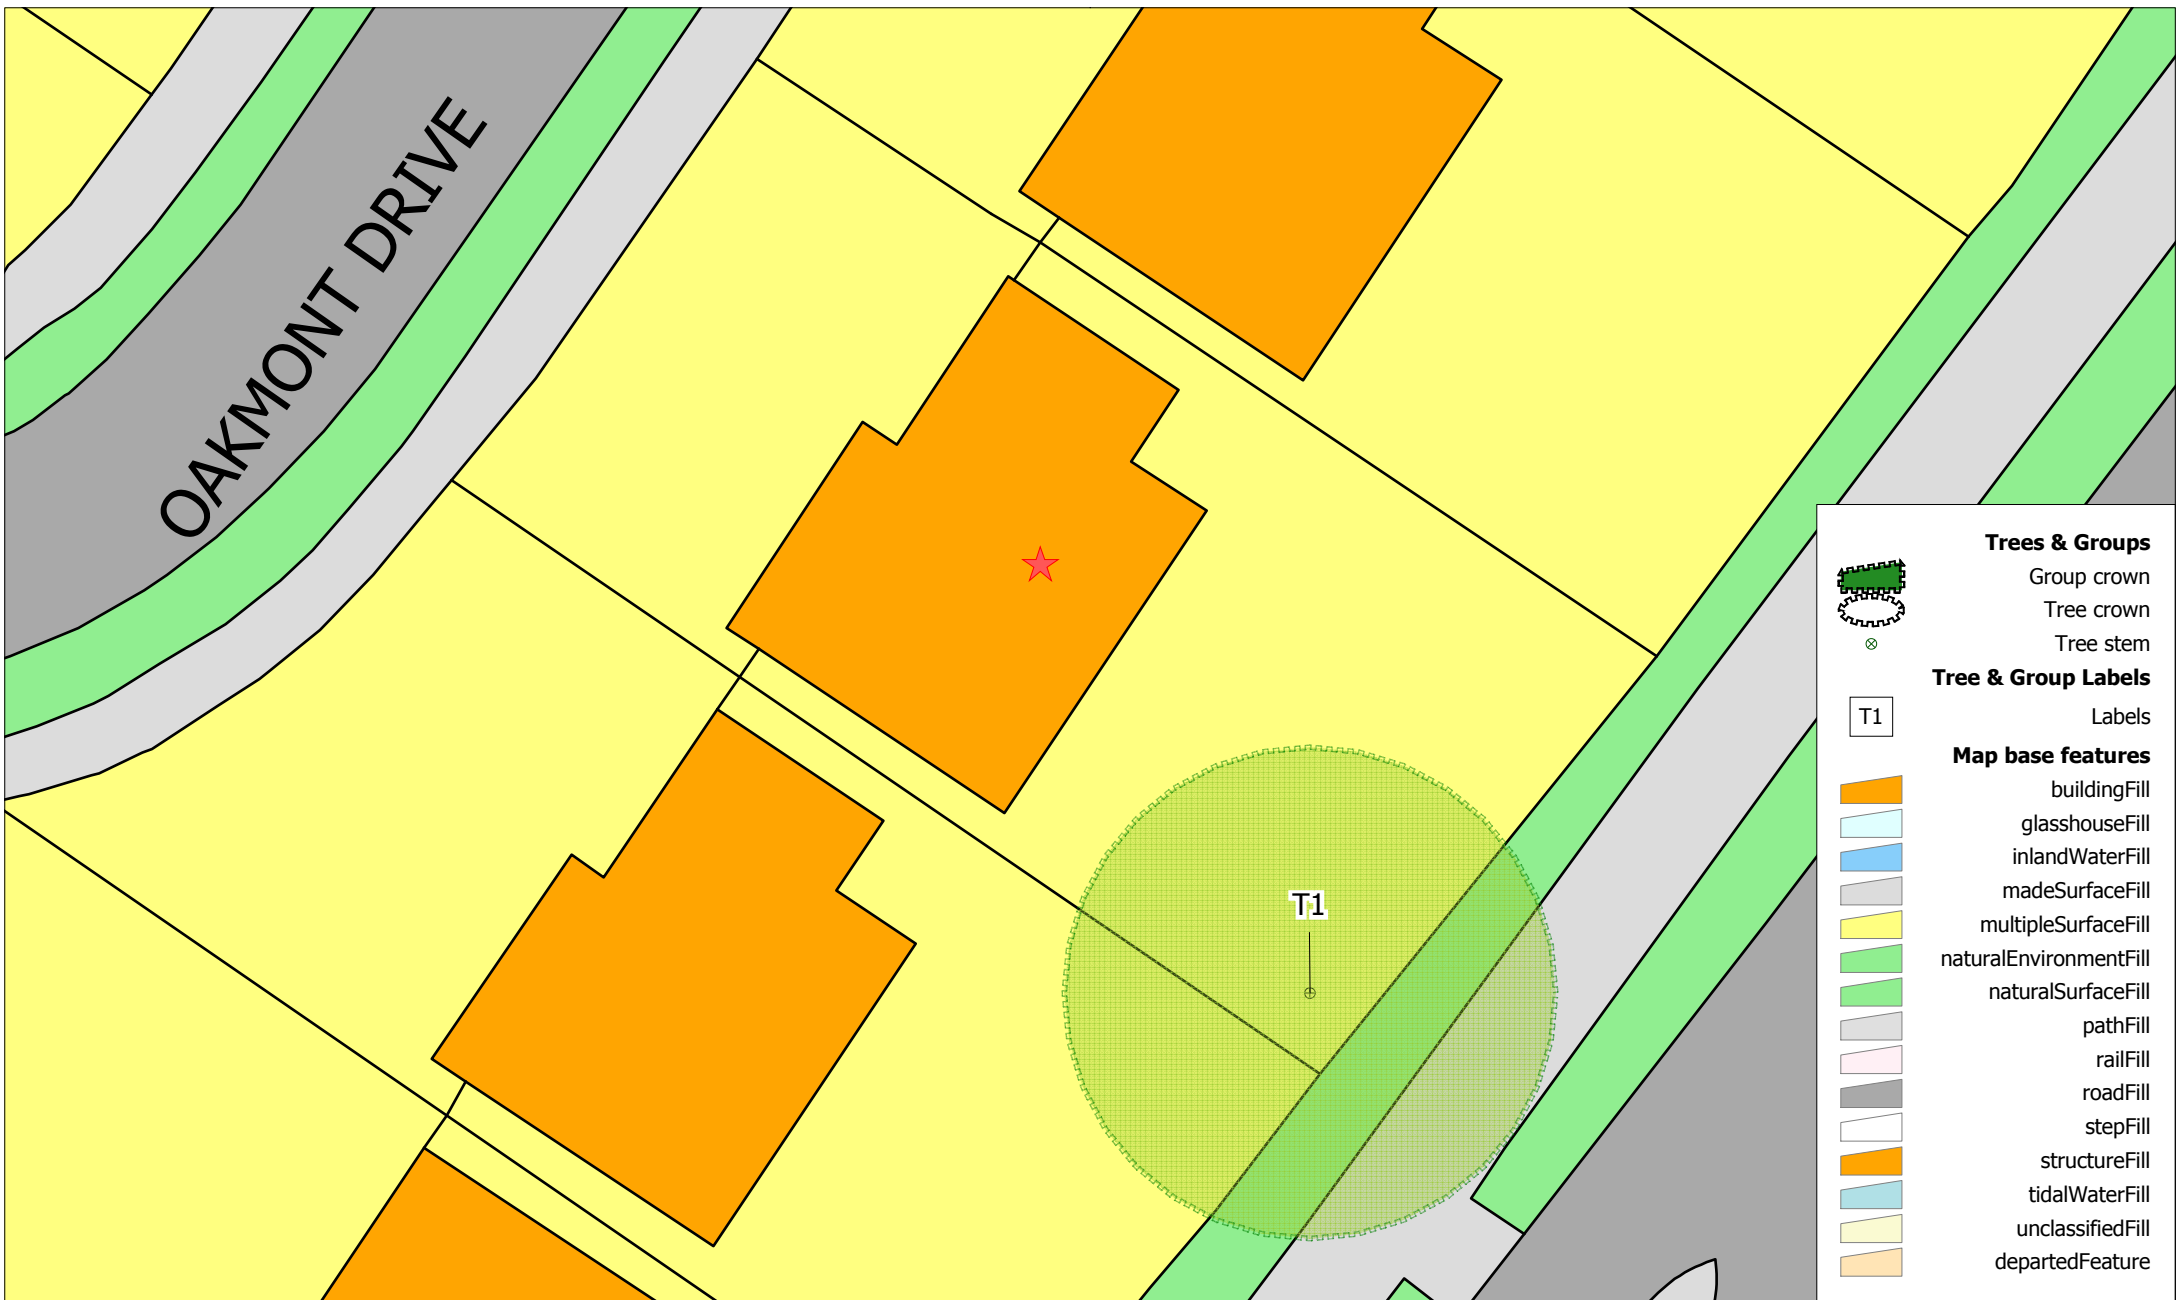
| Tree No | Common Name | Age Class | Condition | Height (m) | Crown Spread (m) | Stem diam. (mm) | Dist to bldg (m) | Pruning history | Recommendation | Tree work constraints | Notes | Owner address | Owner |
|---|---|---|---|---|---|---|---|---|---|---|---|---|---|
| T1 | Oak | MA | F | 22 | 13 | 1130 | 9 | No significant past tree works. | Fell and treat stump. | None. | | 22 Oakmont Drive,<br>Waterlooville, PO8 8TH. | PH |

| Tree No: | Species | Works Required |
|---|---|---|
| T1 | Oak | Fell to ground level as close as practicable and treat the stump with an appropriate herbicide. |
