## Proposed Development for Debtorbook Solutions 20 Forest Avenue Cowplain PO8 8JD Hampshire

Debtorbook Solutions instructed H J Concepts Ltd to undertake a limited intrusive site based investigation to establish baseline information which included percolation tests, a trial scrape within the RPA by Plot 2 and a trial pit on the site at 20 Forest Avenue Cowplain.

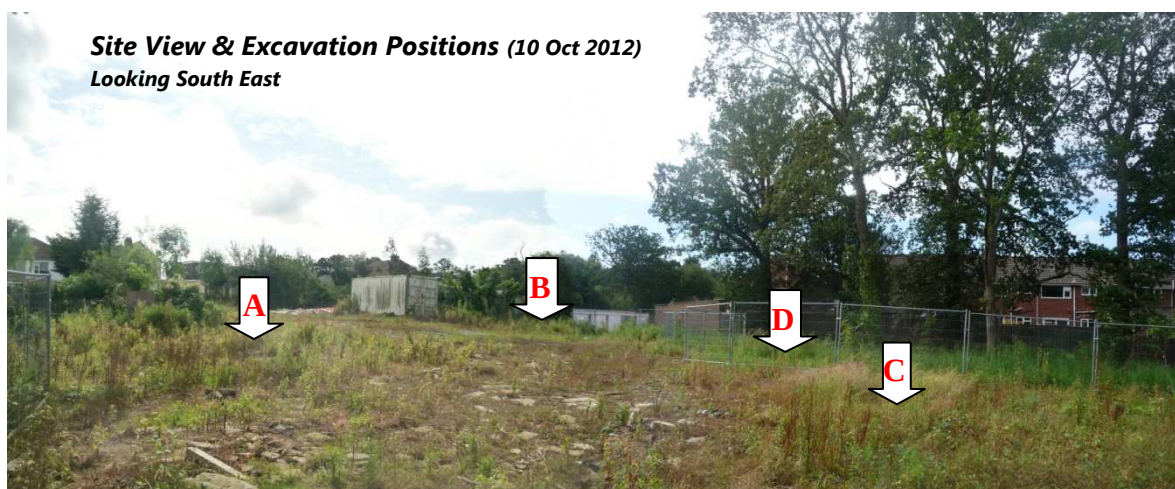
The excavations were located as follows: (see above photo)

**Excavation A** - Percolation excavation pit 1 located in the new proposed access drive in front of plots 1 & 2

**Excavation B** - Percolation excavation pit 2 located in the rear garden area of Plot 1

**Excavation C** - Excavation pit 3 taken to a depth of 2.0m

**Excavation D** - Surface scrape within area of Plot 2 carport. The principal reason for this scrape on the edge of the RPA (Root Protection Area) was to establish the extent of the made ground

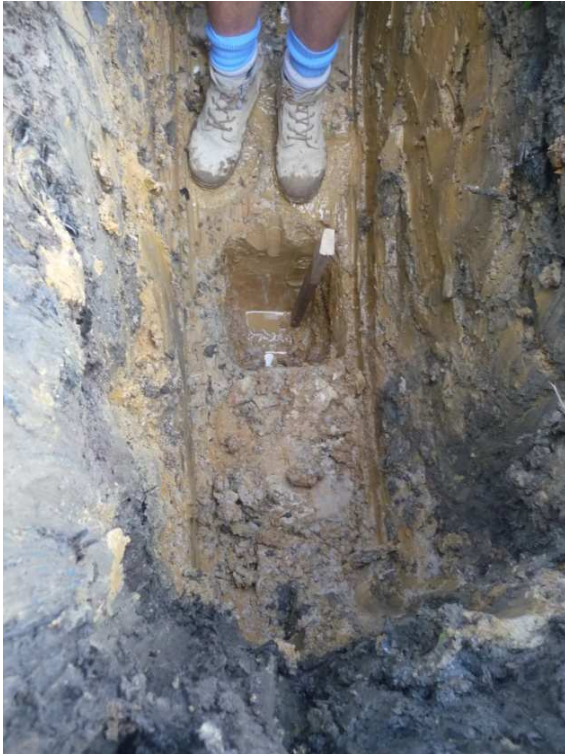
**Excavation A at commencement**

**Excavation A** was taken to a depth of 1.0m below existing ground level and the soil encountered was a cohesive medium to stiff light brown silty CLAY with signs of silver grey clayey fines inter-moulded together. Initially the top layer was of organic soil and made ground, with builders debris and decomposing vegetation, which gave off a slight odour upon striking the soil.

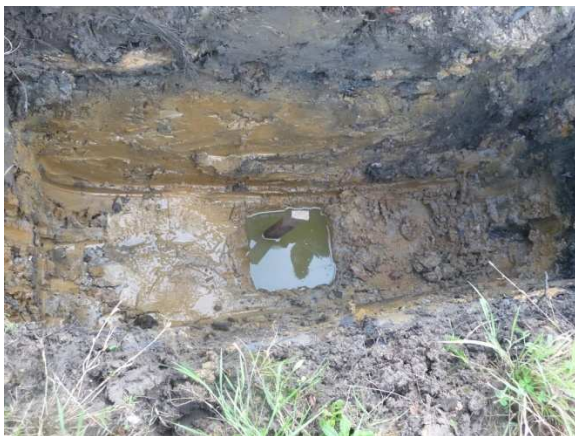
**Excavation A start of percolation test**

Slight water seepage was noted upon early completion of the excavation, and whilst the percolation test hole was being excavated. This hole measured 300mm deep with side of 300mm, thus creating a 300mm cubic hole. This was flooded with clean water and a time noted at 9.07am. A measuring stick was inserted to allow timed measurements to be taken to establish the rate of percolation.

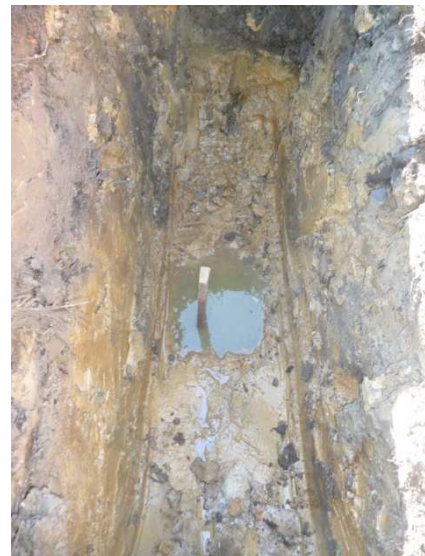
**Excavation A end of percolation test**

The excavation was left for a period of 67 minutes (approx 10.15am). During this time a number of casual observations were made. Following 67 minutes of observations the water within the percolation hole had risen and over flowed into the base of the main excavation.

This was primarily due to the water seepage at the base of the excavation. It was concluded that the percolation test would fail and as a result the excavation was backfilled for safety reasons and the fact that heavy inclement weather was forecast for the following day (11 October)

From the exploratory excavations and the initial percolation test it is clear that the site sub-strata is not suitable for the construction of storm water soakaways. Therefore to enable storm water to be efficiently disposed of will require an application to Southern Water and a connection to the public storm drain. This will be primarily for the disposal of the roof storm water. As such the applicant is mindful in preparing and submitting an application to Southern Water.

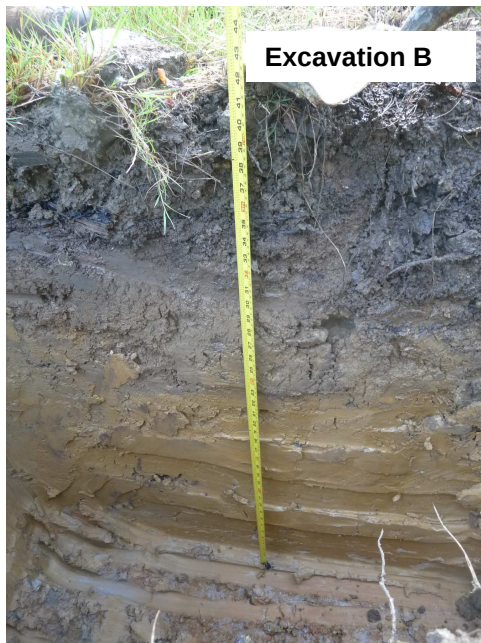
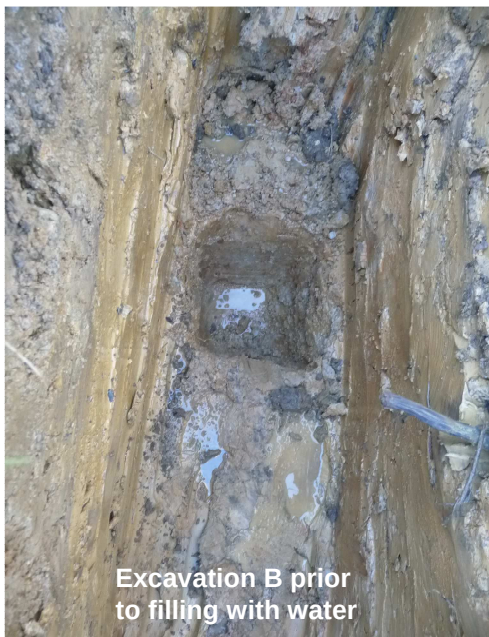
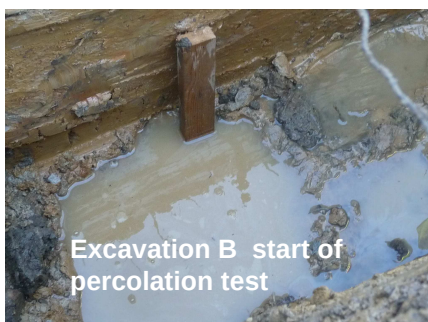
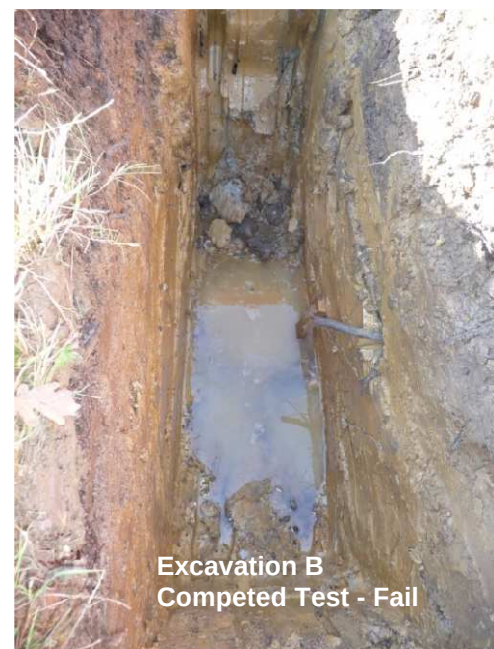
**Excavation B** was taken to a depth of 1.0m below existing ground level and the soil encountered was a cohesive medium to stiff light brown silty CLAY with signs of silver grey clayey fines inter-moulded together. The soil and conditions encountered were much the same as excavation A. Initially the top layer was of made ground, with builders debris and decomposing vegetation, but no odour was noticed upon striking the soil.

Slight water seepage was noted upon early completion of the excavation, whilst the percolation test hole was being excavated. This hole measured 300mm deep with sides of 300mm, thus creating a 300mm cubic hole. This was flooded with clean water and a time noted at 9.26 am. A measuring stick was inserted to allow timed measurements to be taken to establish the rate of percolation.

The excavation was then left for a period of 64 minutes (approx 10.30am). During this time a number of casual observations were made. Following the 64 minutes the water within the percolation hole had risen and over flowed into the base of the main excavation.

This was primarily due to the water seepage at the base of the excavation. It was concluded that the percolation test would fail and as a result the excavation was backfilled for safety reasons and the fact that heavy inclement weather was forecast for the following day (11 October)

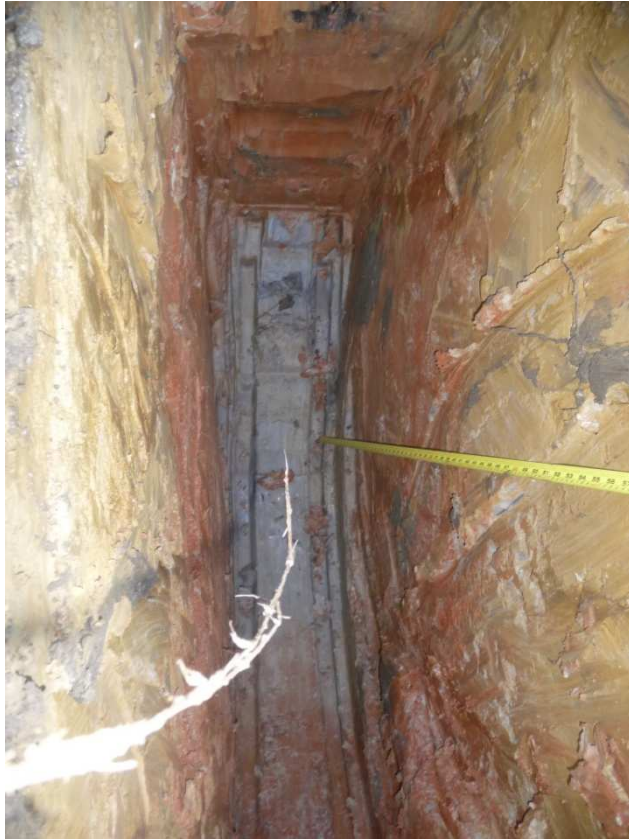
**Excavation C** - Whilst excavation pits A & B were being allowed to run their initial course a third excavation was under taken to a maximum machine depth of 2.0m. The soil make up was as follows

0.0m – 0.30m made ground with builders debris decomposing vegetation

0.30m – 1.00m Medium to stiff light brown silty CLAY with signs of silver grey clayey fines inter-moulded together.

1.00m – 2.00m Medium to stiff red silty CLAY with silver and light brown veins inter moulded. This section of clay was crumbly in texture with some fine roots

At 2.0m the clay started to lose its redness and become stiff to very stiff and more silver in colour. Fine small tree roots were still evident at the base of the excavation and within the soil extracted.

Very minimal water seepage was noted within this excavation. The excavation sides were stable and showed no signs of failure at the time of the excavation.

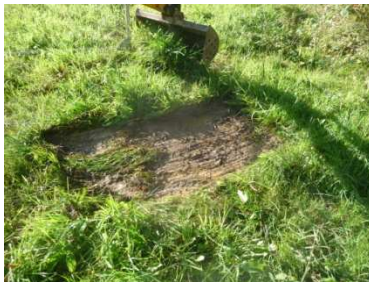
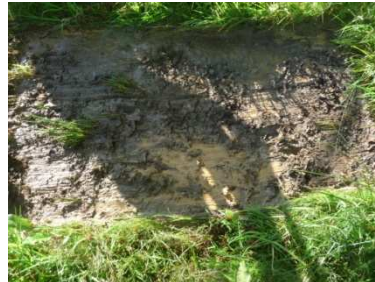
The excavator was located outside the RPA which allowed for a small grading blade to scrape back the surface vegetation. The first 2 scrapes (1 & 2) circa 50mm removed the immediate grass vegetation only, which exposed a wet lightbrown CLAY soil with no signs of tree roots. The 3<sup>rd</sup> scrape was extended deeper by a further 50mm which exposed general builders rubble (bricks and cloth material). This was then deepened by 2 further 50mm scrapes (4 & 5) which exposed further clay soil and more general made ground material. Extending the overall excavation scrape to 250mm (6) started to reveal the top of what was considered to be the original ground level with signs of decomposing long grass and top soil. Water seepage started at this level which was flowing in from the surrounding soil.

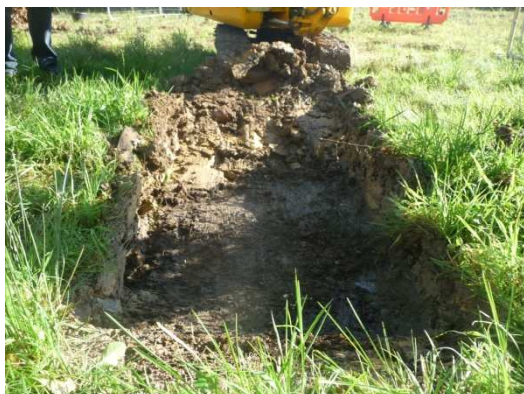
**Finished scrape**

The excavation was stopped at this point due to a qualified Arborist not being present.

However whilst the car port for Plot 2 entered the RPA for tree 12 the trial excavation established that the area was covered in superficial recently deposited clay soil and builders debris.

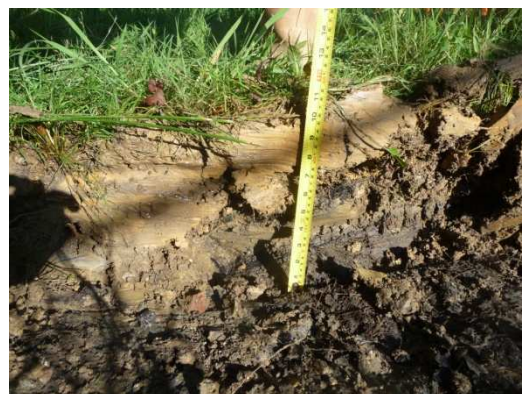
**Side profile of excavation (250mm)**

Excavation D verified the existence of made ground within the RPA area of Plot 2's proposed car port, thus allowing any construction of RC ground beams and heave protection to be incorporated without damaging any significant tree roots.
