## Arboricultural Consultancy for AXA Insurance

| <b>Insured</b> | Mr & Mrs Baker | <b>Address</b> | 97 Sutton Road, Waterlooville, Hampshire, PO8 8PT | | |

**Scope of Report:** To survey the property and determine significant vegetation contributing to subsidence damage, make recommendation for remedial action and initiate mitigation action. The survey does not make an assessment for decay or hazard evaluation.

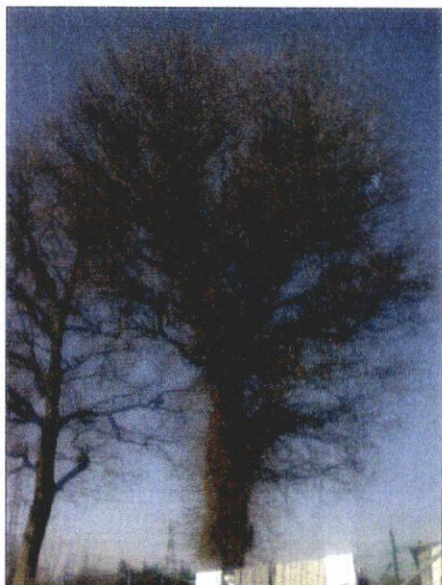
T1 - Oak

In our opinion, T1 (Oak) and T4 (Ash) also have the potential to be significant contributory factors in the damage, albeit in a secondary capacity to T2.

| Tree No. | Species | Age Cat | Approx. Height (m) | Distance to Building (m) | Ownership | Action | Requirement |
|---|---|---|---|---|---|---|---|
| T1 | Oak | 3 | 13 | 11.5 | A - Third Party<br>95 & 97 Sutton Road<br>Waterlooville<br>Hampshire<br>PO8 8PT | Remove | Remove. |

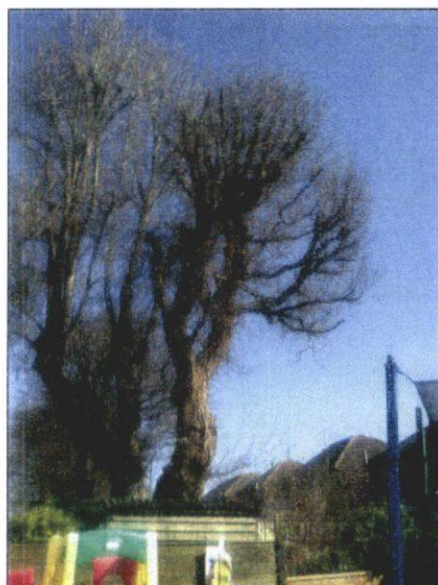
T2 - Oak

Based on our site inspection, and taking account of vegetation location, relative to the focal area of movement / damage, it is our opinion that T2 (Oak) will be exerting the principal vegetative influence to the insured's property.

| Tree No. | Species | Age Cat | Approx. Height (m) | Distance to Building (m) | Ownership | Action | Requirement |
|---|---|---|---|---|---|---|---|
| T2 | Oak | 3 | 10 | 13* | A - Third Party<br>99 Sutton Road<br>Waterlooville<br>Hampshire<br>PO8 8PT | Remove | Remove. |

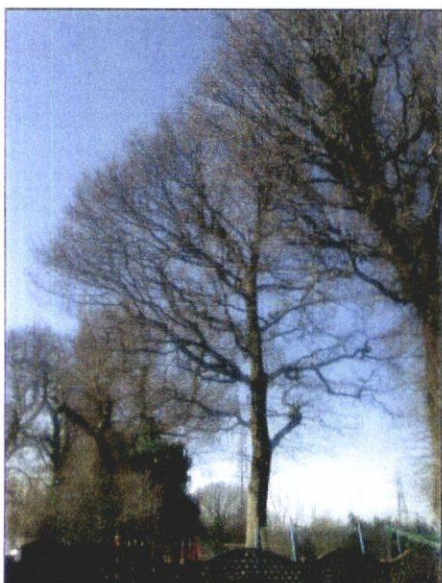
T3 - Oak

The remaining tree was recorded as future risk and should be managed as per the recommendations.
