# Engineer's Report

| Our Reference | <b>IFS-RBS-SUB-11-0031275</b> |
| Claim Reference | <b>61746755/01</b> |

| Address | <b>21 Cavendish Drive, Waterlooville, Hampshire,<br/>PO7 7PJ</b> |

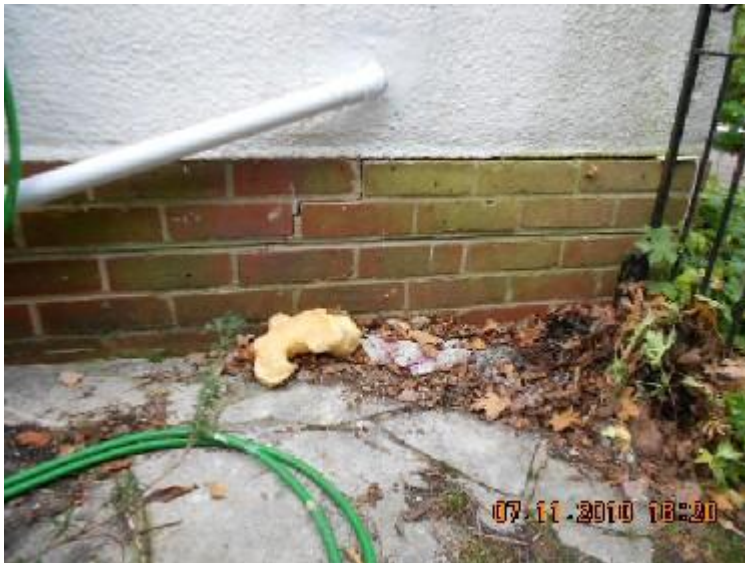
On the rear elevation there is a diagonal tapering fracture which emanates from ground level and continues up to DPC where it continues along to the left hand elevation and is indicative of a localised dropping about the rear left hand corner.

Similar diagonal tapering fractures were noted along the left hand elevation continuing up to DPC and extending to the rear elevation.

FIGURE 3 Diagonal tapering fracture in the brickwork at low level

The diagonal aspect of the cracks, together with the fact that they increase in width with height is indicative of subsidence as a result of shrinkage of the clay subsoil due to the moisture extracting influence of adjacent oak, apple and fir trees within the policyholders garden as well the honeysuckle immediately adjacent.

In this particular instance, damage is confined to cracking within bed joints below DPC and is very localised. Repairs will take the form of raking the cracks out and cleaning the joints prior to wedging and repointing the affected areas. We would anticipate the repairs will fall within the policy excess.

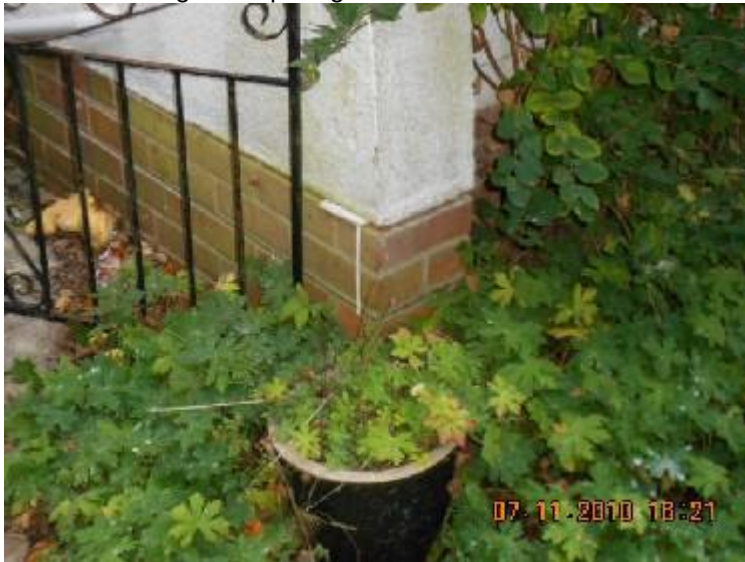
FIGURE 4 8mm Drop in brickwork on rear left hand corner

It is common practice to categorise the structural significance of the damage in accordance with the classification given in Table 1 of Digest 251 produced by the Building Research Establishment. In this instance, the damage falls into Category 3 (Moderate).

Following completion of tree management works, the property will then be monitored to reaffirm stability.

Provided the property stabilises as expected, no foundation stabilisation works are considered necessary, with structural repairs of the superstructure being required only.

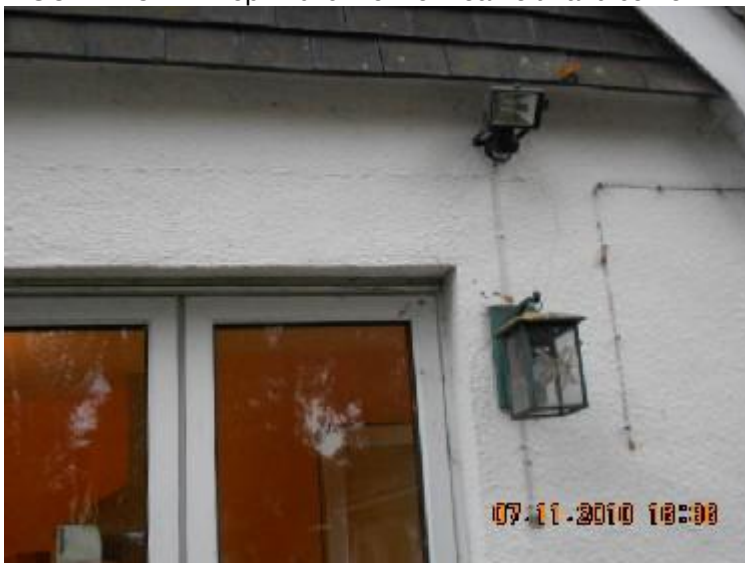
Cracks were noted within the render over the kitchen door and window which are considered to result from thermal movement associated with the lintels over the windows.

FIGURE 5 Thermal cracks around lintel bearing at the rear kitchen window

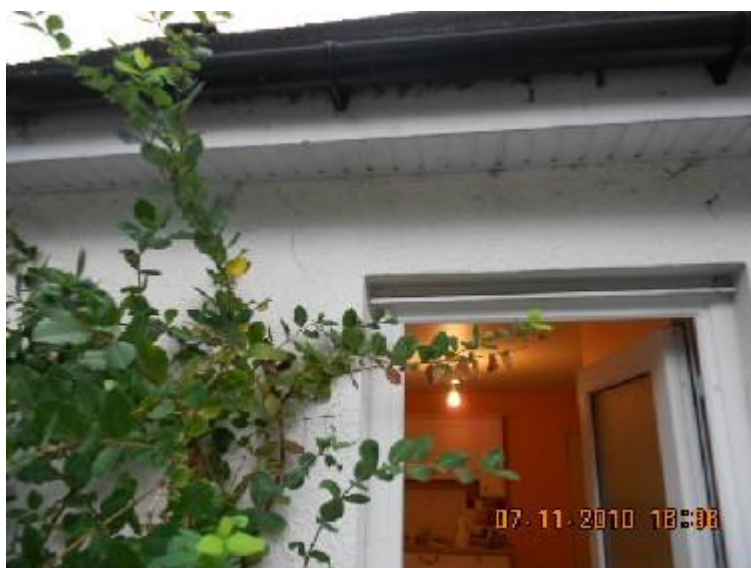
FIGURE 6 Thermal cracking around the end of the lintel bearing above the left hand kitchen door
