## **Subsidence Claim**

# **Engineer's Report**

| Report Date | <b>19 July 2010</b> |
| Claim address | <b>4 Hermitage Gardens, Waterlooville,<br/>Hampshire, PO7 7PR</b> |

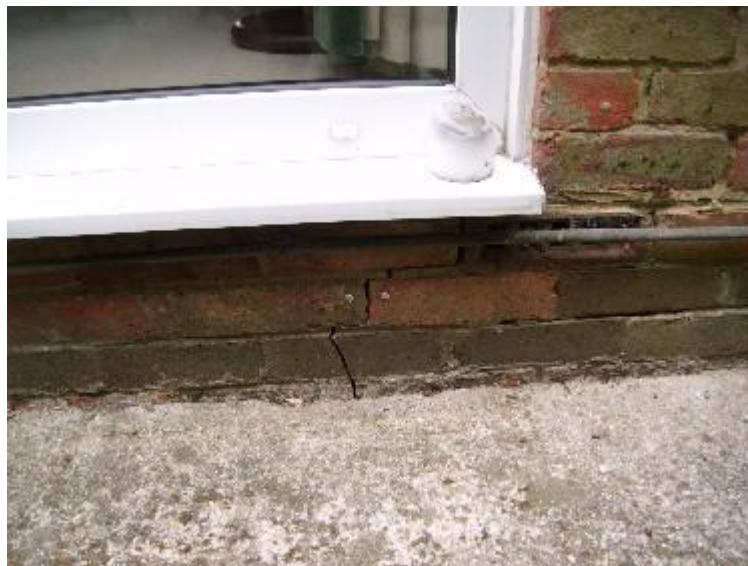
FIGURE 3 Rear Wall\_01

- Horizontal gap 22mm wide at damp proof course level from patio door to corner continuing around corner to right flank elevation
- Vertical stepped tapered crack 5.5mm wide beneath patio door

It is common practice to categorise the structural significance of the damage in accordance with the classification given in Table 1 of Digest 251 produced by the Building Research Establishment. In this instance, the damage falls into Category 3 (Moderate).

The nature of the cracking at the rear corner is indicative of a minor episode of subsidence. The foundation at the rear corner has subsided and we believe that the cause is shrinkage of the clay subsoil caused by root activity from the mature oak trees beyond the rear boundary. Shrinkage of clay is reversible by removal or reduction of nearby vegetation. Clay soils will, in time, recover to their normal moisture content and the cracks will close. Consideration therefore needs to be given to the removal or reduction of the dominant vegetation.

Rear and Flank Elevations fill horizontal cracking repair vertical crack beneath patio door

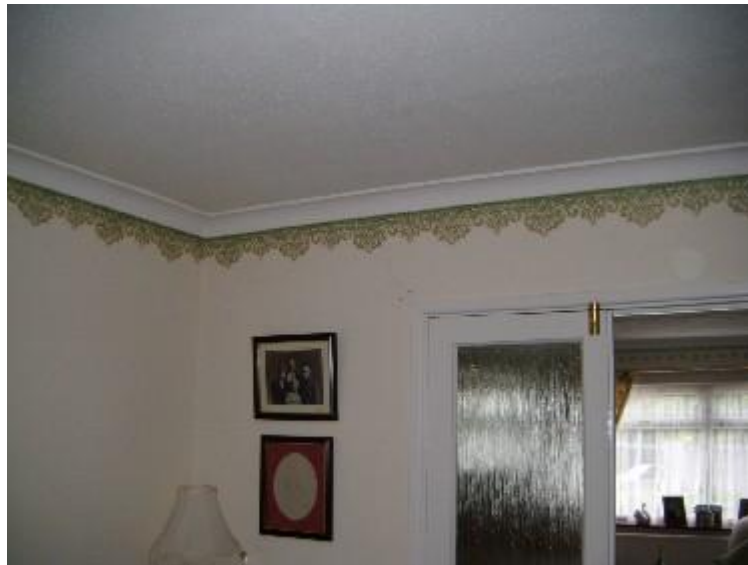
FIGURE 5 Dining Room

- Diagonal tapered crack 1mm wide from window to underside of ceiling
- Diagonal tapered crack 1mm wide from LR door to underside of ceiling

Dining Room repair cracking on rear wall repair cracking on LR wall redecorate room

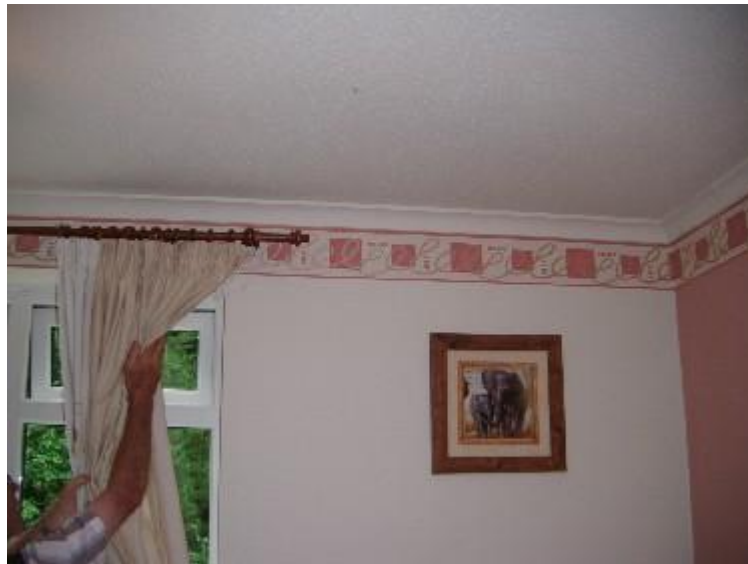
FIGURE 6 Rear Bedroom

- Diagonal tapered crack 1mm wide from window to underside of ceiling

Rear Bedroom repair cracking on rear wall redecorate room
