# HAVANT BOROUGH COUNCIL

## Arboricultural Officer Report Application For Consent To Carry Out Tree Work

| Application number | APP/12/00778 | | |
| Location of trees. | Garden of Saxted House, 5 Tower Street, Emsworth | | |

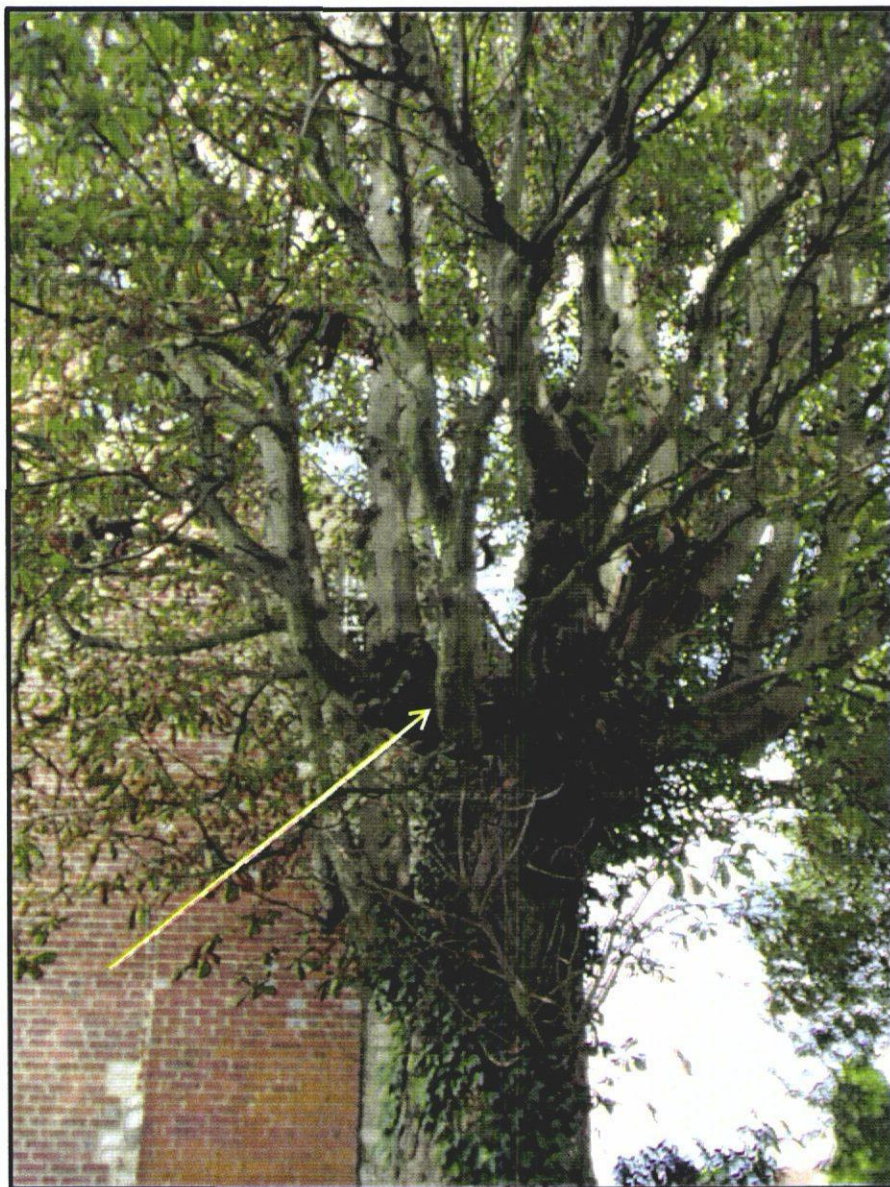
The horse chestnut is a mature tree approximately 14m in height growing in close proximity to the flank wall of the property adjacent to Tower Street. It has been heavily pollarded and repeatedly reduced over the years resulting in many cutting points within the crown.

The horse chestnut has been repeatedly cut back over the years resulting in many weak branch junctions and decay in the main stem. The proposal to reduce the crown by up to 2.5m is perfectly reasonable management taking account of its position and previous history. The work will also reduce the risk of branch breakout to an acceptable level.

**Photo 1: The yellow arrow shows the horst chestnut**

**T1 Permit the following:** Horse Chestnut: Crown reduce by 2.5m  
Holm oak: Crown lift southern aspect by up to 5m.

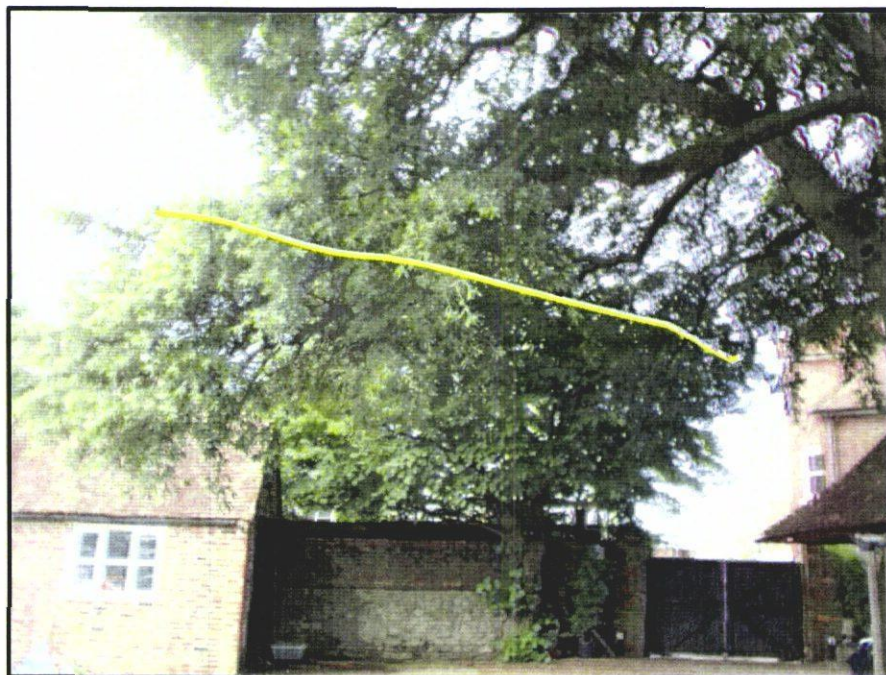
The holm oak is a mature tree approximately 16m in height with a broad open crown growing over the rear vehicular access to the property. It appears to be in normal health with no major defects.

The holm oak has been crown lifted on the northern aspect previously leaving the crown on the southern aspect over the access drive low. The proposal to

crown lift the southern aspect to 5m will balance the crown and have no impact upon either the amenity or health of the tree.

**Photo 2: The yellow line shows the approximate pruning line to crown lift the holm oak branches on the southern aspect overhanging the drive.**
