# PERMIT

The Flint Barn, Old Barn Gardens, Lovedean, Waterloooville. PO8 9XL

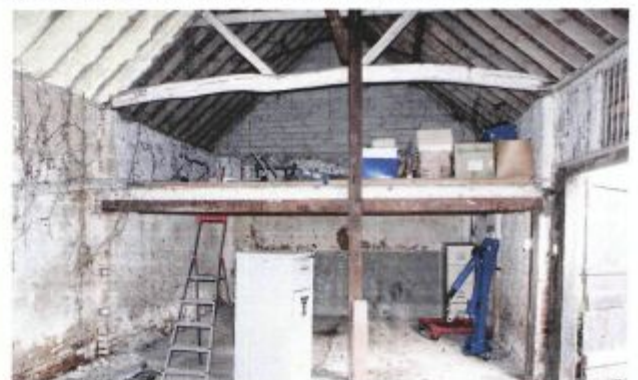
REF FB 1

The two trusses were not supported by the wall or the plate.

Two large rusty chains were hanging from the rafters and had possibly been used for heavy lifting in the past as

many of the rafters had been broken.

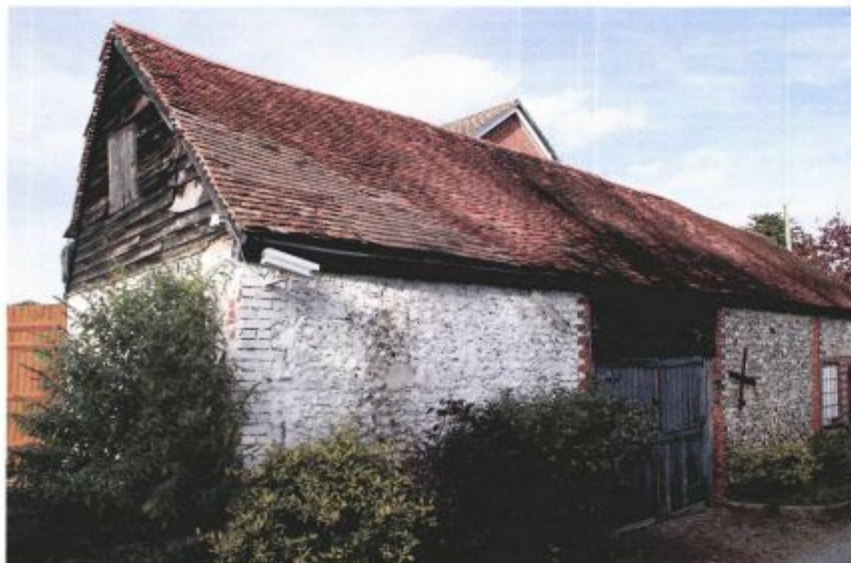
The roof timbers were leaning and had pushed the gable end out, and had been propped up by a large timber beam.

The roof design was as near to the original as possible but to include ceiling ties throughout to avoid further movement of the walls. (Please see attached drawings).

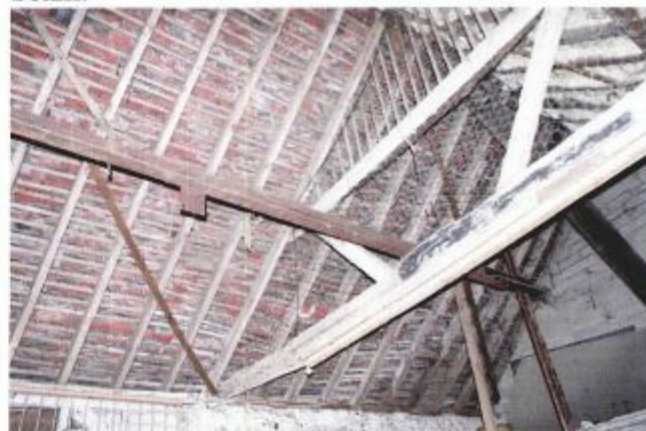
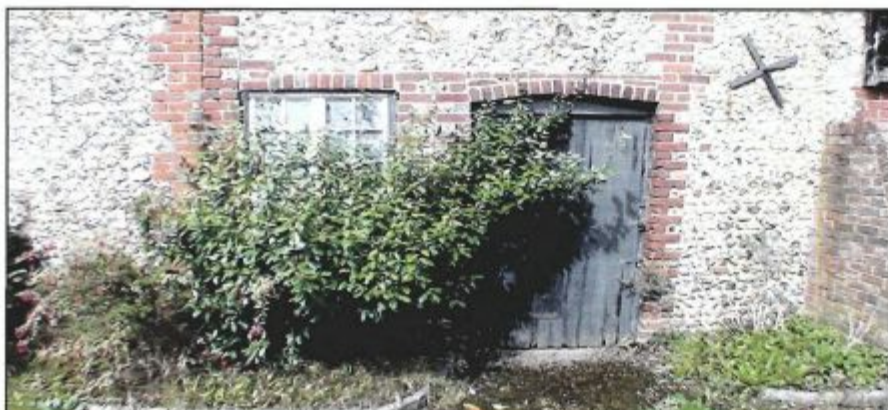
The middle section is accessed by a single door, has a small window and was originally an animal pen. The wooden attic floor has been badly damaged by wood worm and damp, and continues over the third section into the barn end.

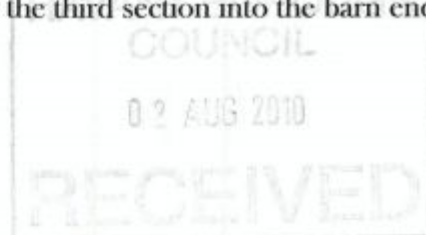
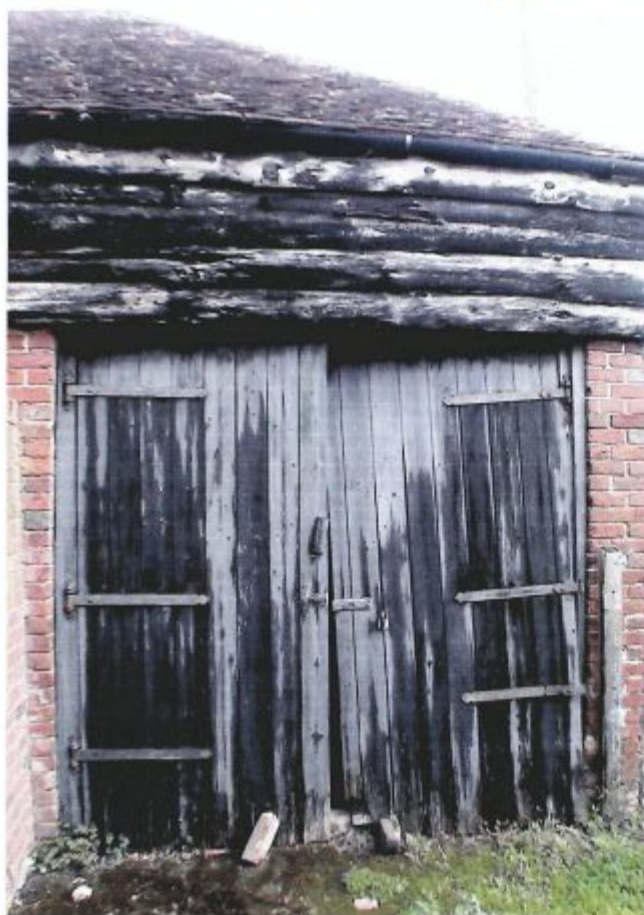
This is the third section, at the right hand end of the building. It is a similar size to a single garage, and was full of rubbish. Wood, rusty scaffolding and three large gas bottles have been removed.

The guttering here did not connect with the down pipe, causing silt to build up over the years and the walls to be damp. There was no guttering at all on the rear of the roof, causing problems for the neighbour in the house behind.

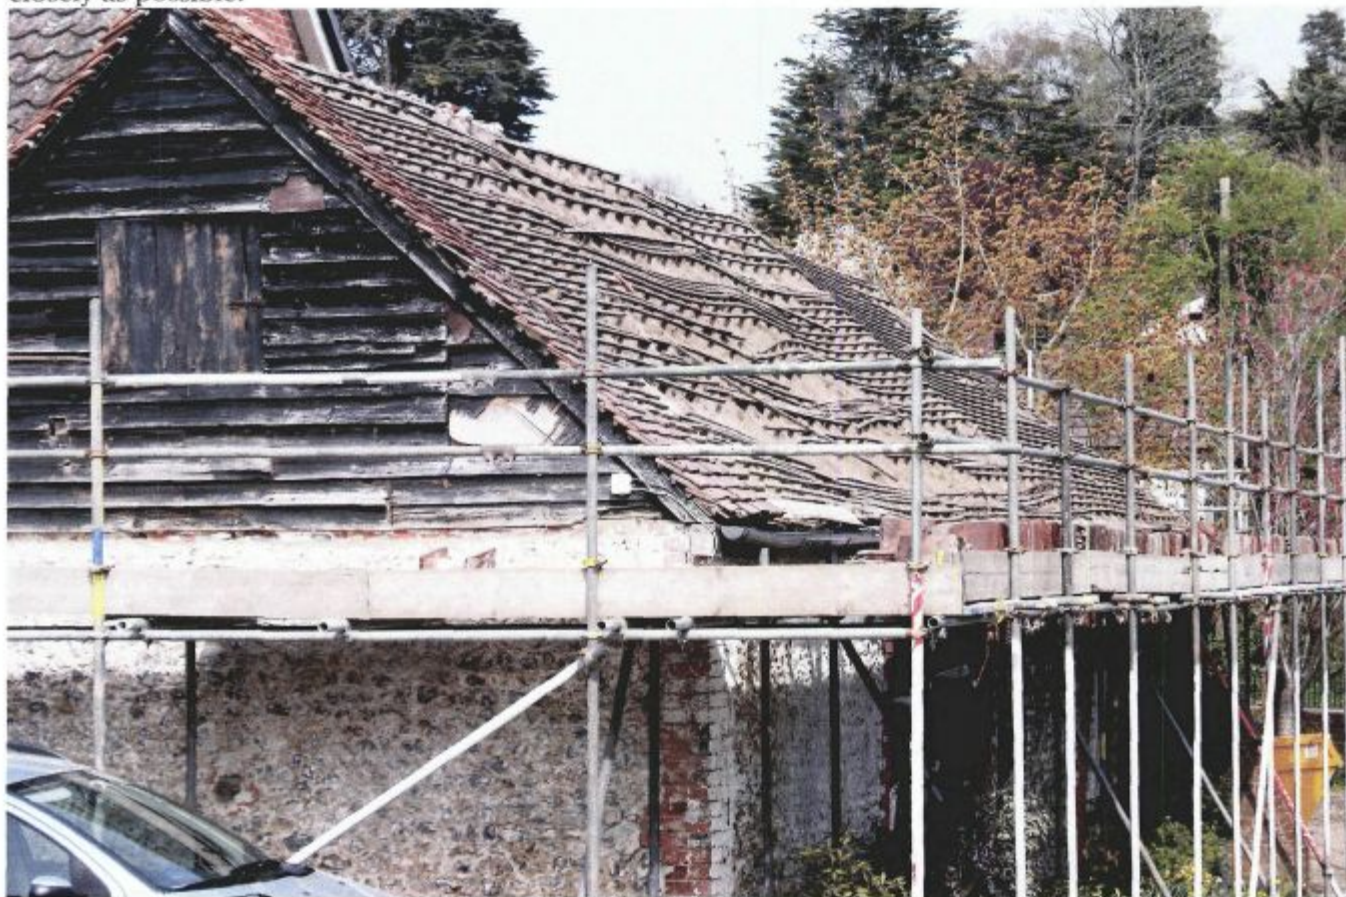
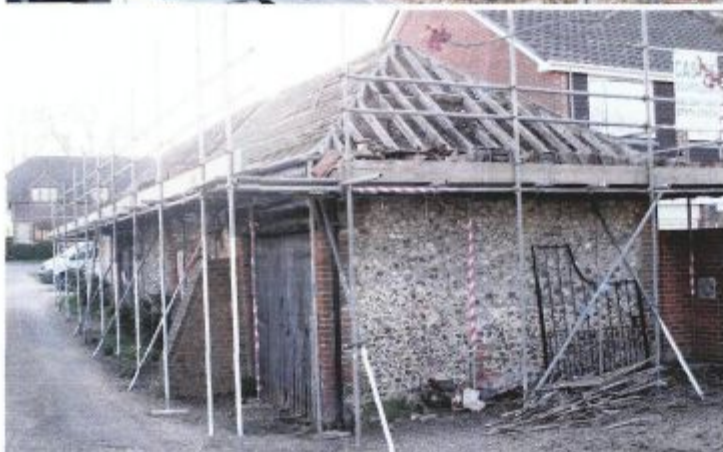
All the clay peg tiles were removed and saved. A large number were scraped by hand to remove the yellow expanding foam, so they could be re-used.

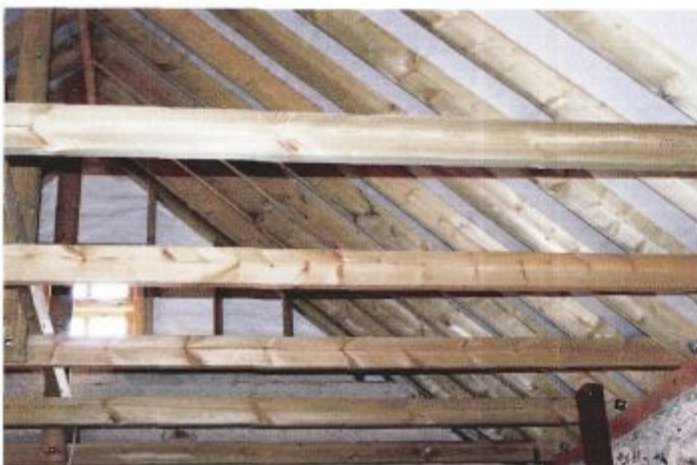
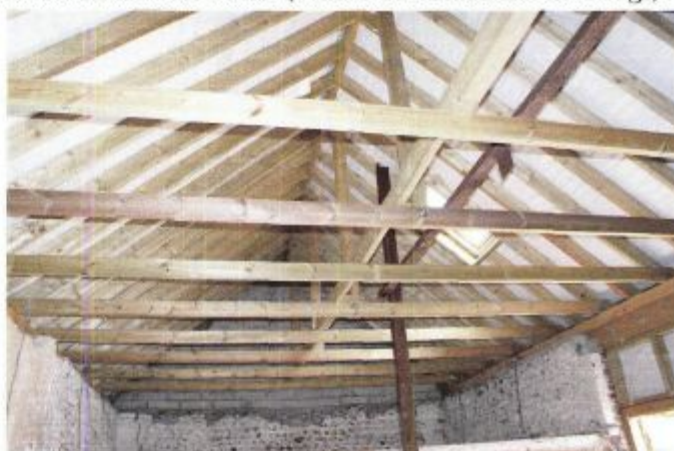
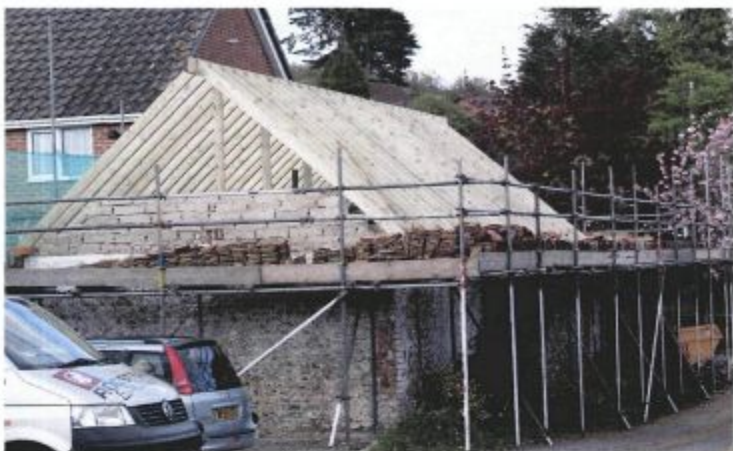
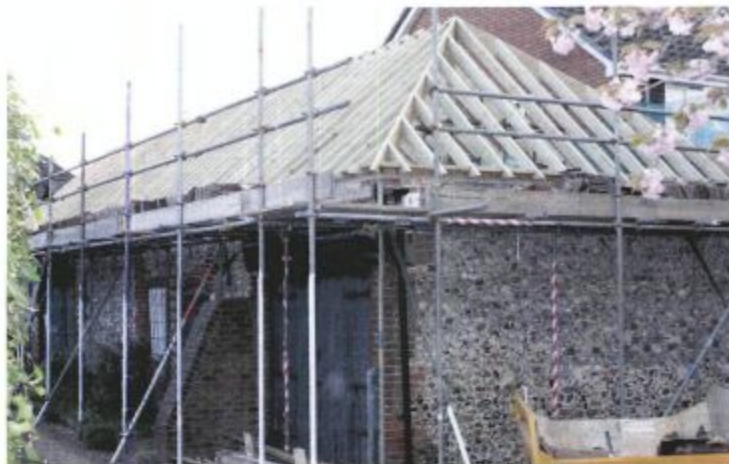
The central portion of the front flint and brick wall is leaning outwards, which was probably why wall ties were added and a brick stanchion built in the past.

Felt and battens complete, the original clay peg tiles were re-laid, and two conservation roof lights installed, to allow light into the building when the doors are shut. The small window in the gable end was also re-instated.
