# Tree report

4<sup>th</sup> October 2012

51 Southwood Road

Hayling Island

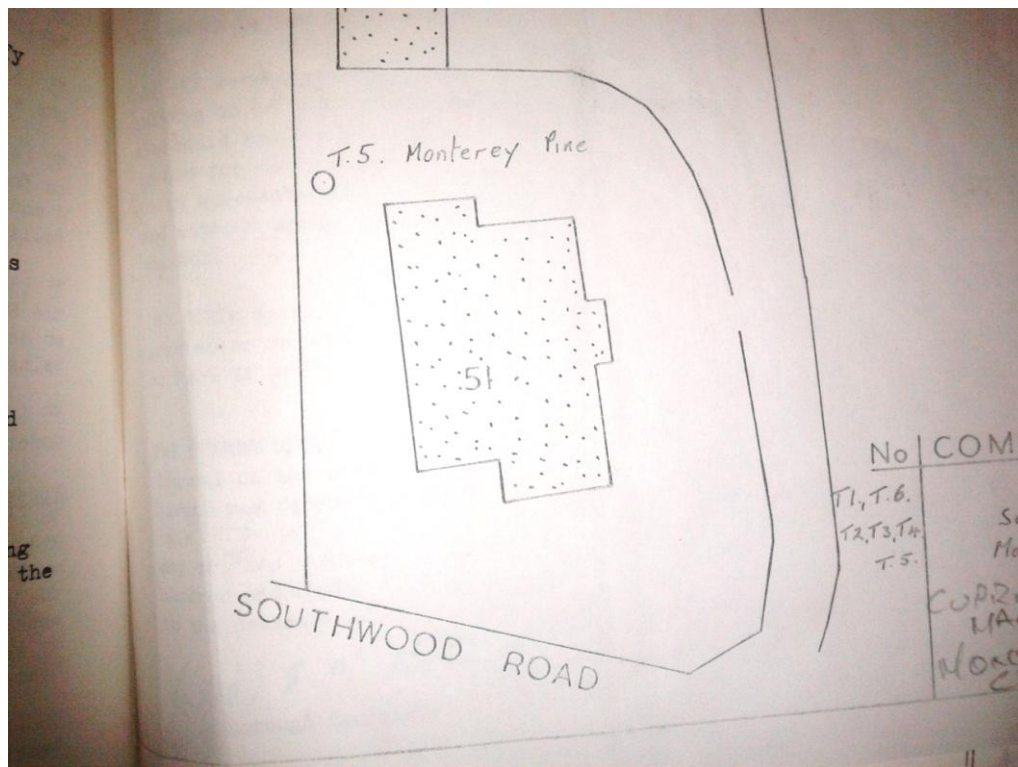
1.2

Extract of TPO document location of T5 Monterey Pine.

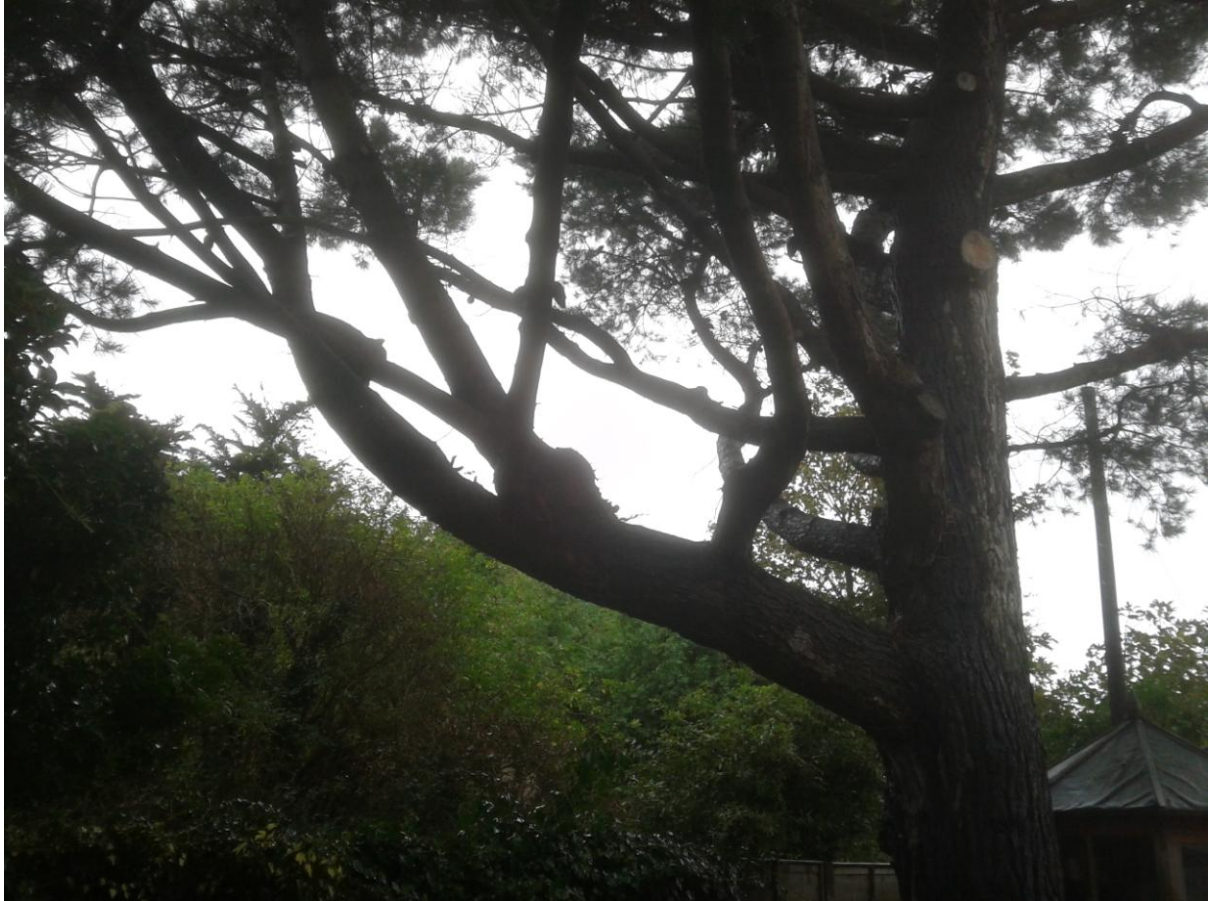
1.5 Arboriculture condition: Poor structural scaffold limbs due to previous pruning, vigorous overall condition first branch at 2.5m at 60cms diameter protruding south west wards over neighbouring property poor structure and the trunk has a slight lean developing westwards. The upper crown compiles of a dense matrix of branches and pine needle foliage with volumes of developing and mature pine cones throughout the canopy. The east side has been pruned back recently from the property. Deadwood has also recently been removed from the crown.

A. Limb at 2m poor branch structure low over neighbouring property.

**1.11 Recommendation:** To remove T5 Monterey Pine and mitigate the removal by providing a large 6m specimen tree to be planted in a frontal location of the property.

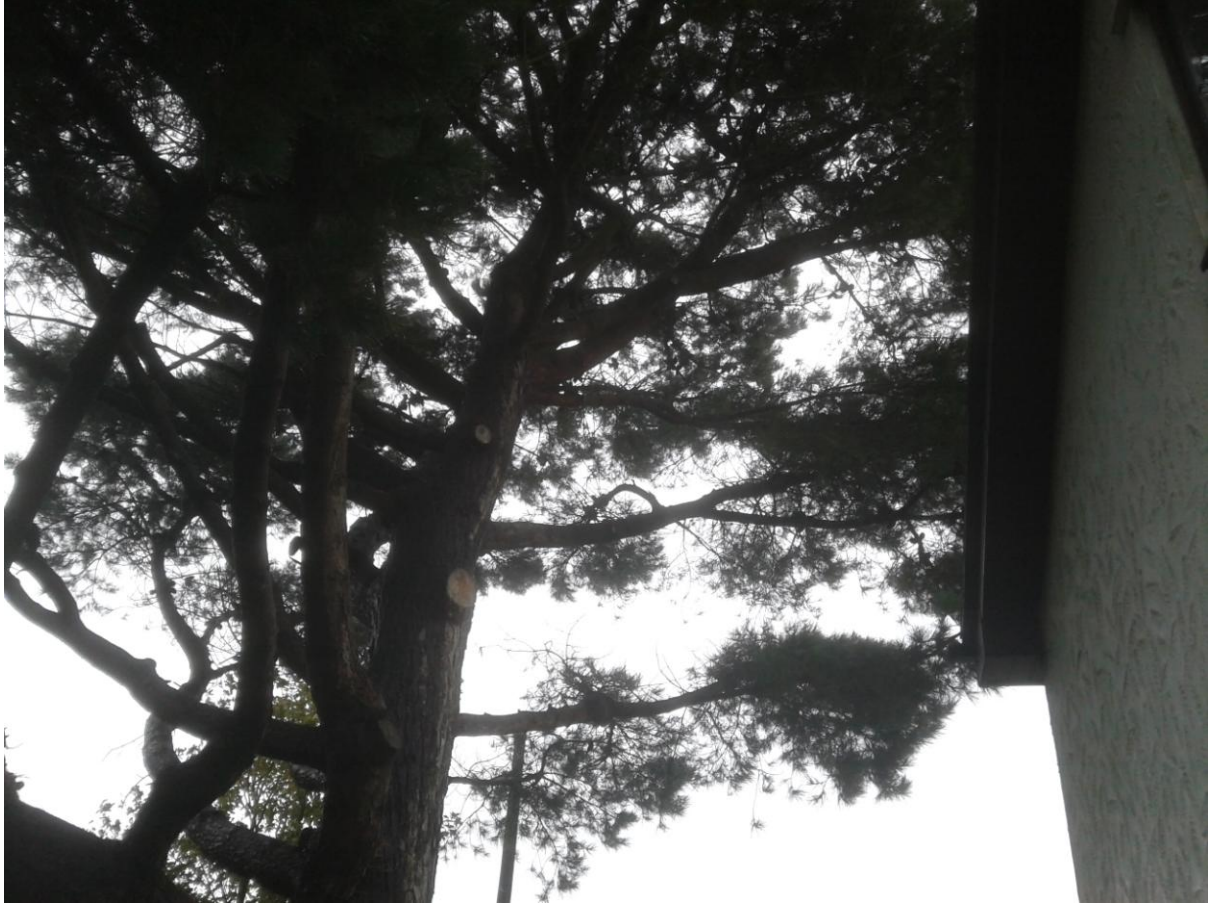
B. Upper crown overhanging roof, recent pruning wounds.

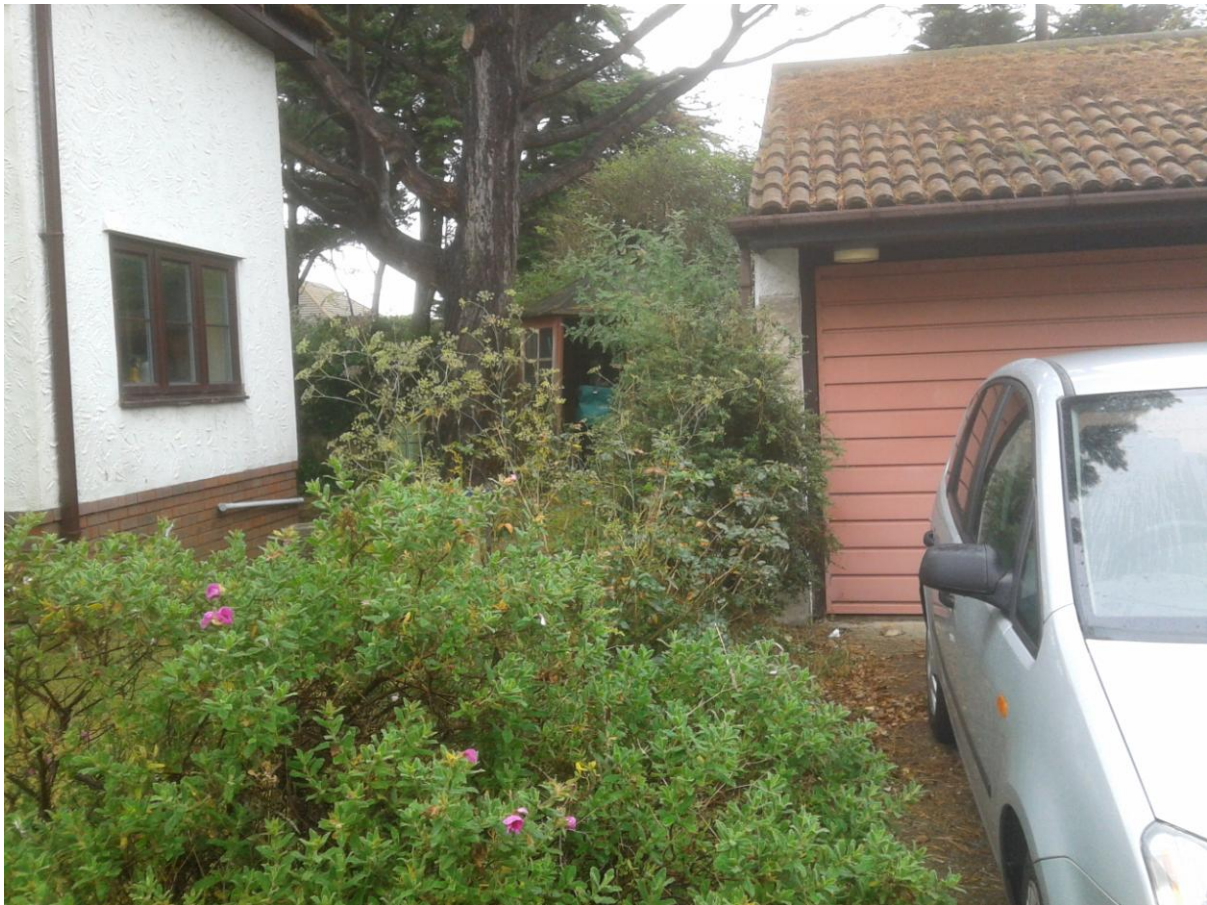
1.7 Damage and defects: direct damage by root activity is identified in the movement of the garden path leading from the patio to the garage door. There is a drain adjacent and concerns of root invasion. There is a wall crack above the garage side door. The surface roots in lawn where attributed to damaging a garden wall (since taken down) in front of the garage. The wooden shed underneath T5 has moved and become dislodged by the uneven ground produced by root development. There is a continual mass of debris produced by T5 over the property gutters roof and gardens. (Refer to photographs A to H below)

C. Removed wall front of garage because of root damage.

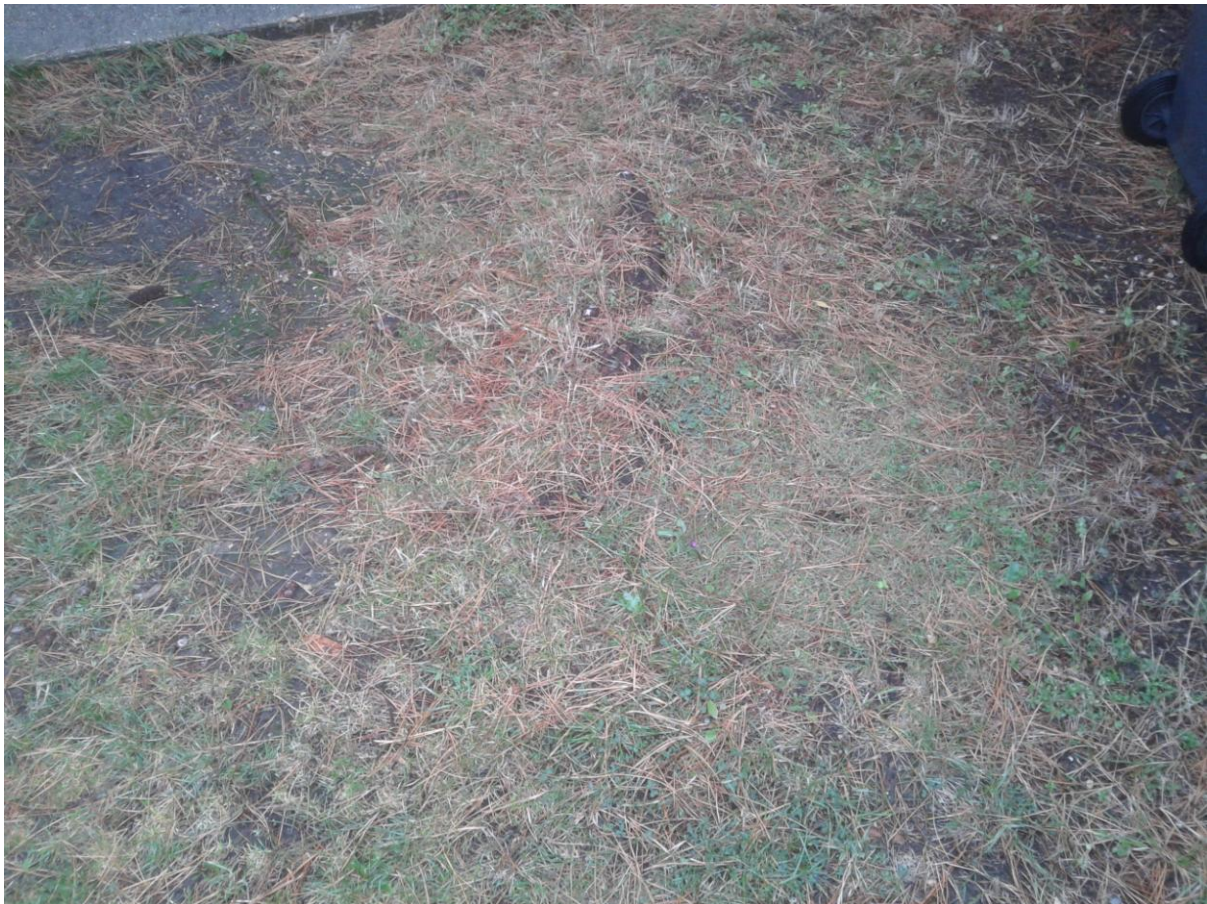
1.6 Roots and buttresses: The buttress level is raised at approximately 60cms from the house foundation level. These appear healthy and sound by visual inspection. There is evidence of root activity in the lawn area adjacent to T5 at 5m from the base close to the garage.

D. Surface roots in lawn and pine needle debris. Adjacent to cracked and damaged path.

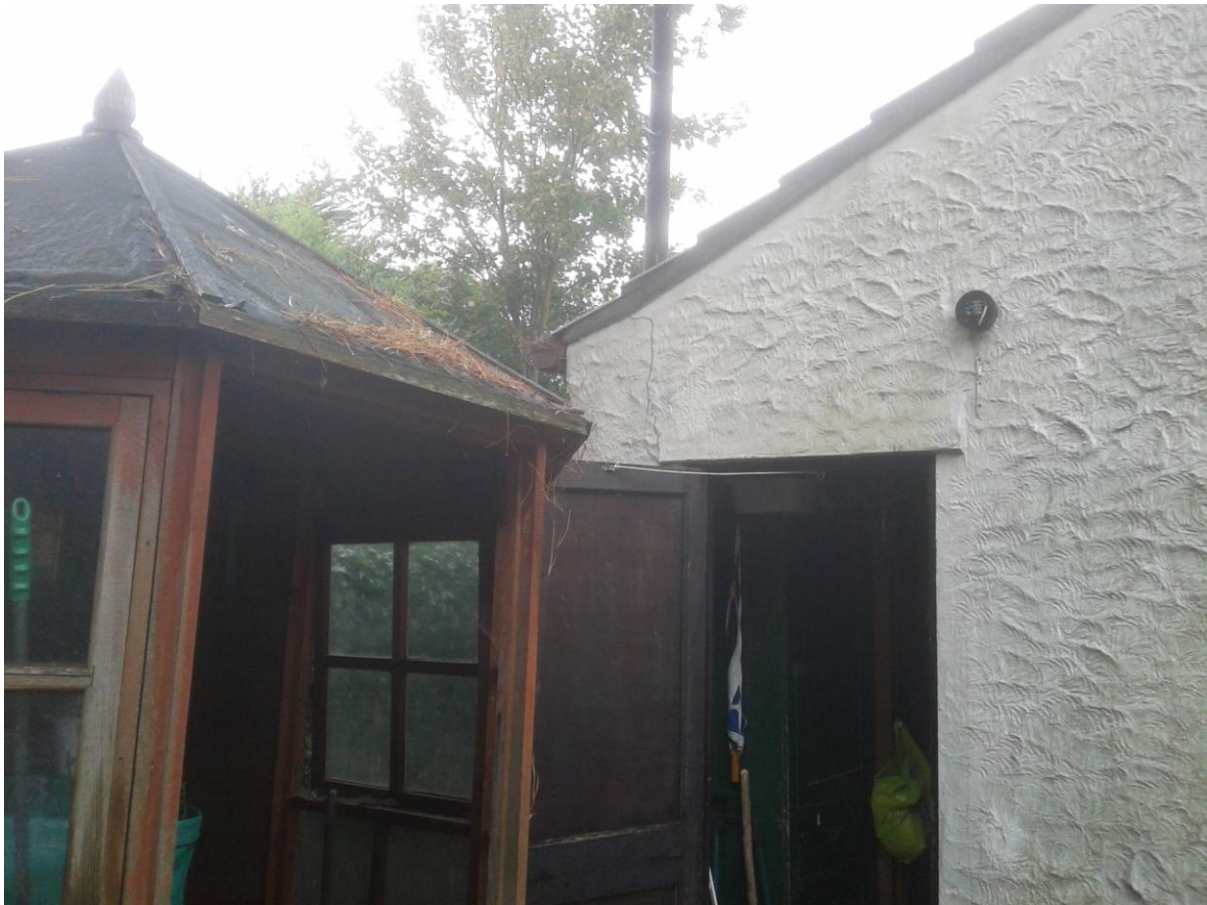
E. Leaning shed and wall crack in garage.

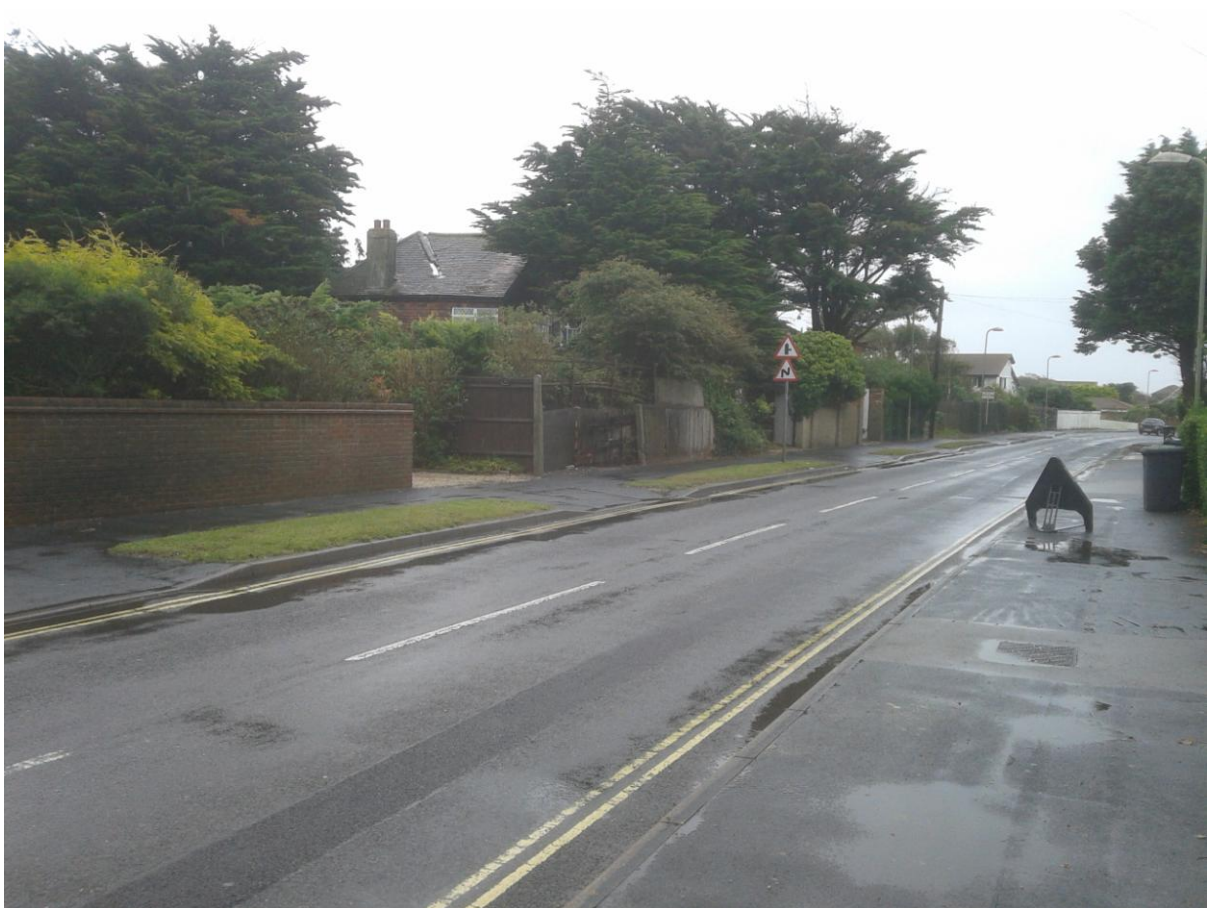
F. View from Southwood Road west side T5 not visible.

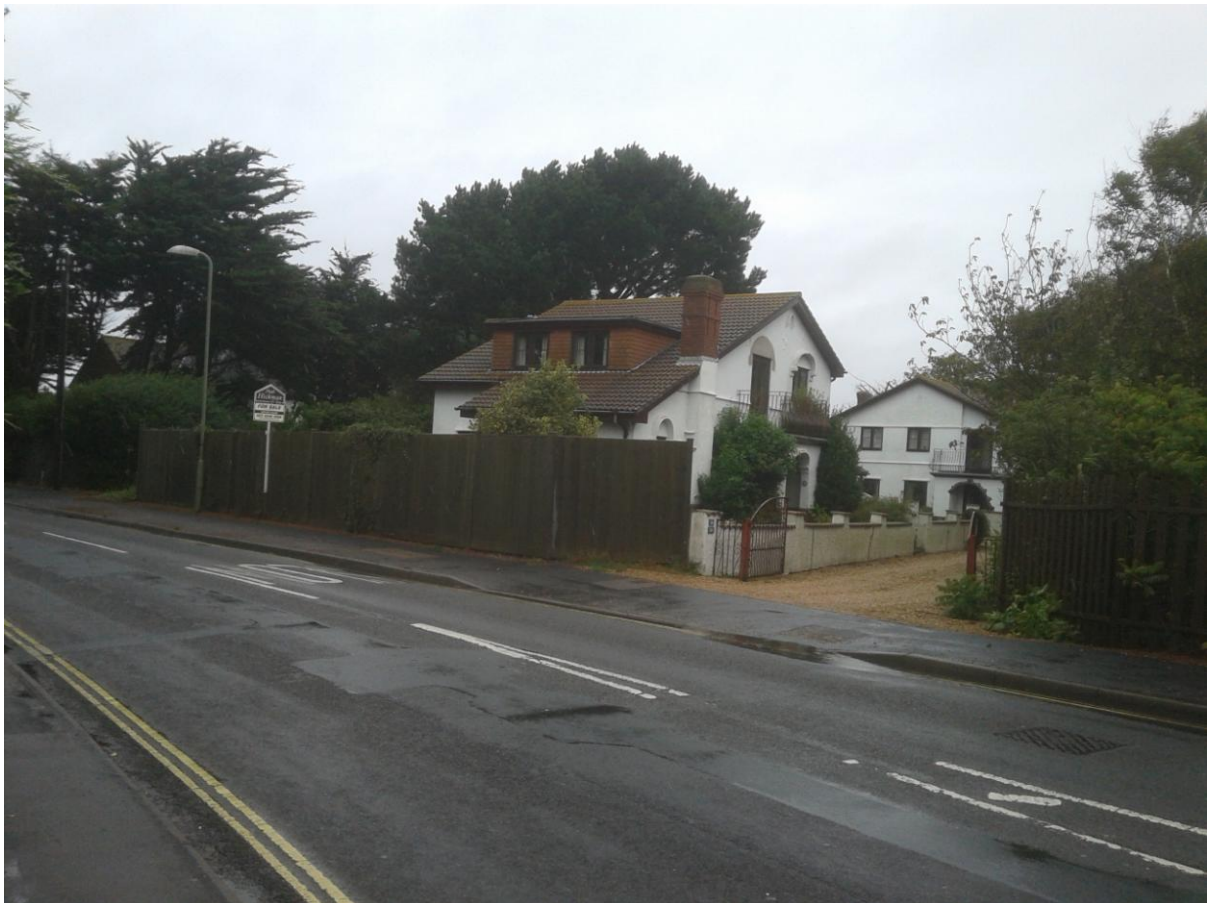
G. View from Southwood Road east side T5 over roof.
