## Arboricultural Assessment Report

### Detailed Report on Trees

| | <b>Risk Address:</b> | 52 Hulbert Road, Havant, Hants PO9 3TF |
| <b>Refs:</b> | <b>OCA Ref:</b> | 44406 |

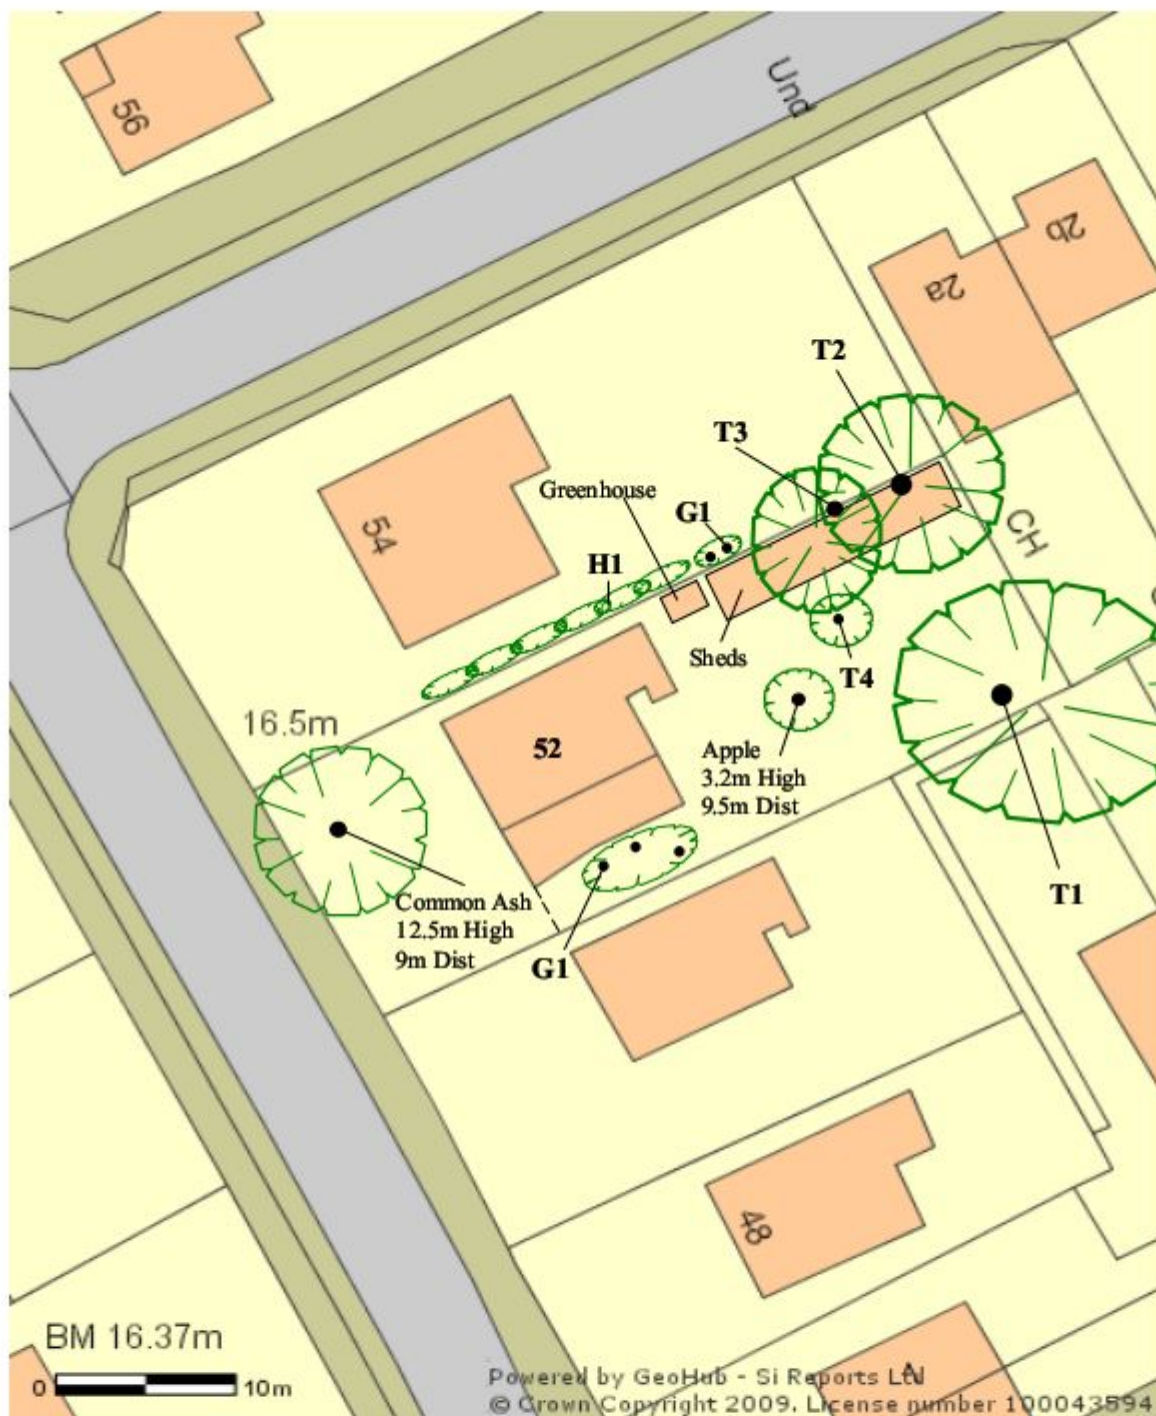
| <b>Monitoring</b> | A programme of precise level monitoring is currently being undertaken at the Insured Property. Readings are available for the period 28 October 2010 to 06 September 2010 and show a clear pattern of seasonal movement. The greatest amplitude of movement is recorded at points 6, 7, 8, 9, and 10. I note that these points are closest to Grey Poplar T1, Grey Poplar T2 and Sycamore T3. |

The mechanism of movement as described by the Engineer is entirely consistent with the location of Grey Poplar T1, Grey Poplar T2 and Sycamore T3.

Level monitoring demonstrates a seasonal pattern of movement that I can only attribute to the influence of adjacent vegetation. I note that the greatest amplitude of movement is consistent with the location of Grey Poplar T1, Grey Poplar T2 and Sycamore T3.

Therefore it is my opinion that sufficient information has been provided to demonstrate that, on the balance of probabilities, Grey Poplar T1, Grey Poplar T2 and Sycamore T3 are the material cause of the current subsidence damage

Given their proximity to the Insured Property I do not consider that undertaking pruning works to Grey Poplar T1, Grey Poplar T2 and Sycamore T3 will provide either an effective or sustainable means of controlling their water use. Therefore and in order to provide a long-term solution to the current subsidence damage I recommend that Grey Poplar T1, Grey Poplar T2 and Sycamore T3 be removed.

| Tree No: | Species | Works Required |
|---|---|---|
| T1 | Grey Poplar | Fell to ground level and remove the stump to prevent future growth |
| T2 | Grey Poplar | Fell to ground level and remove the stump to prevent future growth |
| T3 | Sycamore | Fell to ground level and treat stump with an appropriate herbicide to prevent future growth |
