43, Hollybank Lane  
Emsworth  
Hants  
PO10 7UE

## **INSURANCE CLAIM**

## **CONCERNING SUBSIDENCE DAMAGE**

## **ENGINEERING APPRAISAL REPORT**

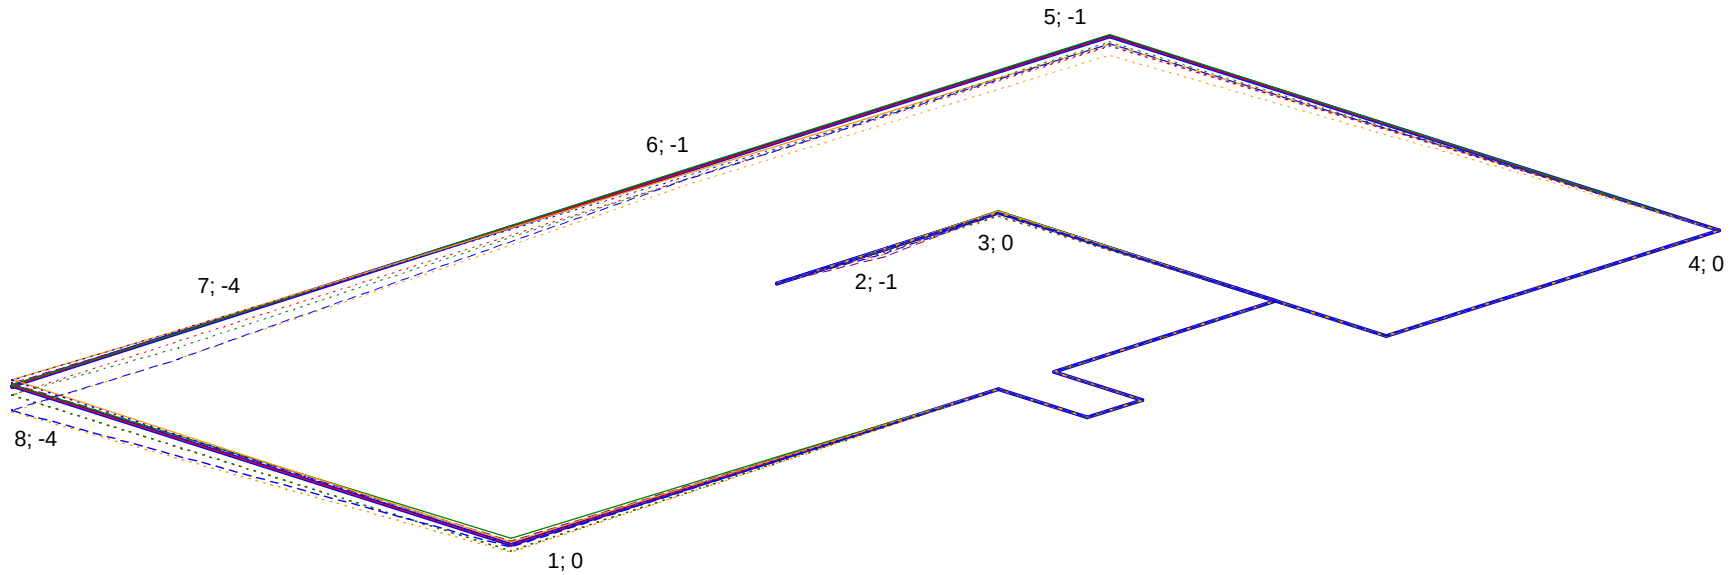
Crack width monitoring was initiated in November 2010. The first reading to December 2010 shows point 2 ( internal hall) dropped by 1.1mm, with the front right and front left corners of the house lifting by 0.4 and 0.3mm respectively.

Chart is displaying Subsidence

Point labels give level difference of last reading from original datum in mm.
