**BRIAN EYLEY PARTNERSHIP**  
CHARTERED BUILDING SURVEYORS

**MEADOWSWEET, ST PETERS ROAD, HAYLING ISLAND**

Decadet Timber Frame Surveys  
Unit 3, Roses Farm  
Gallants Lane, East Farleigh, Kent ME15 0LG  
Tel: 07836 746520

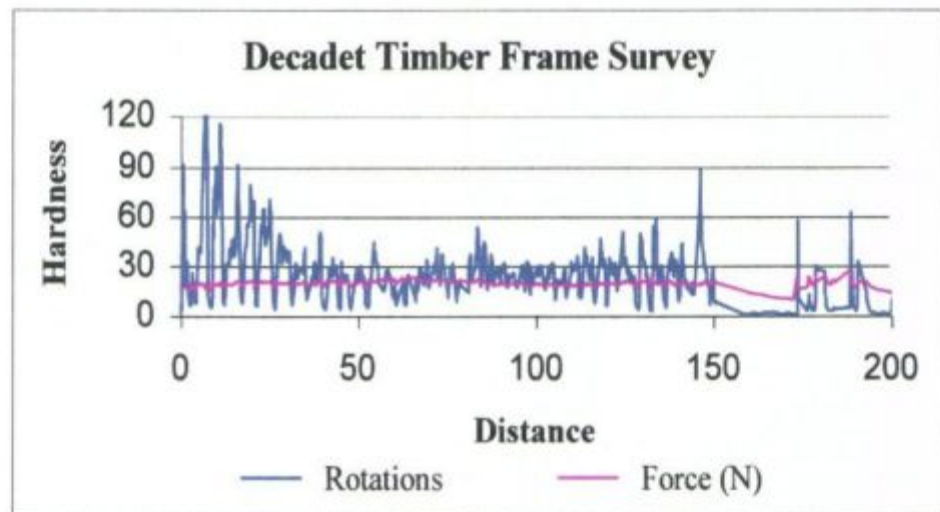
Decay is evident between 150mm and 175mm and again around 185mm on the above sample probe result.

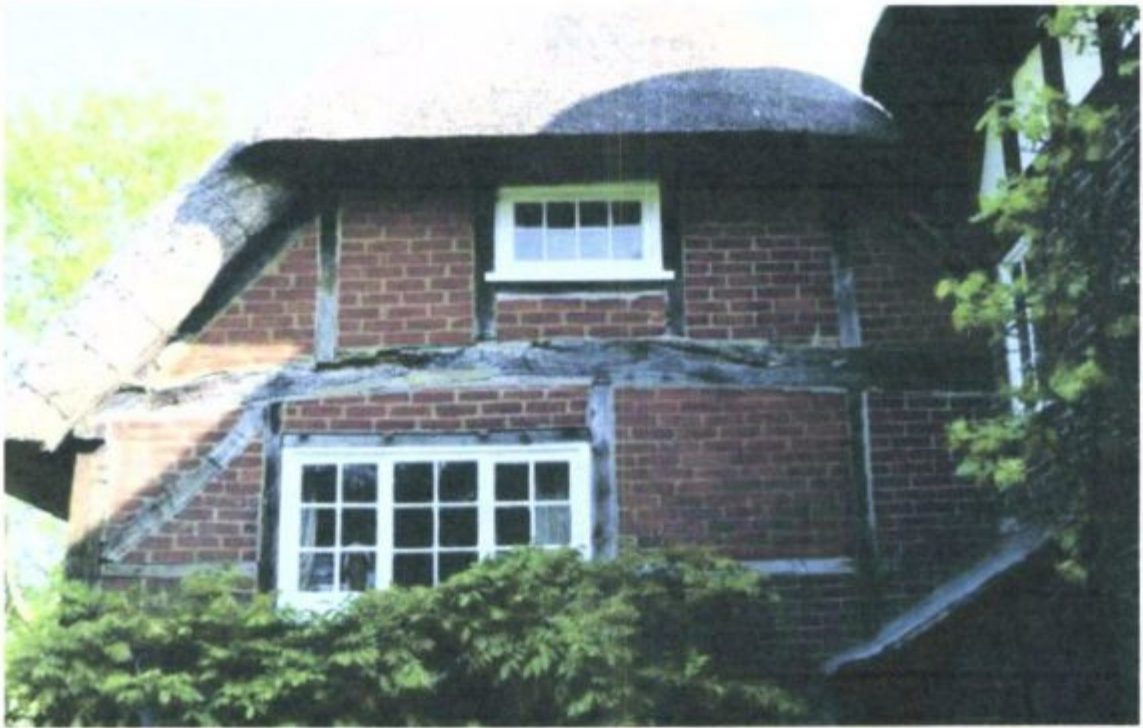
Photograph 1

General deterioration, weathering problems and inappropriate mortar patch repairs are shown in photographs 1 to 7.

Inappropriate face repairs in either timber or mortar should be removed and correct repairs carried out ensuring good weathering.

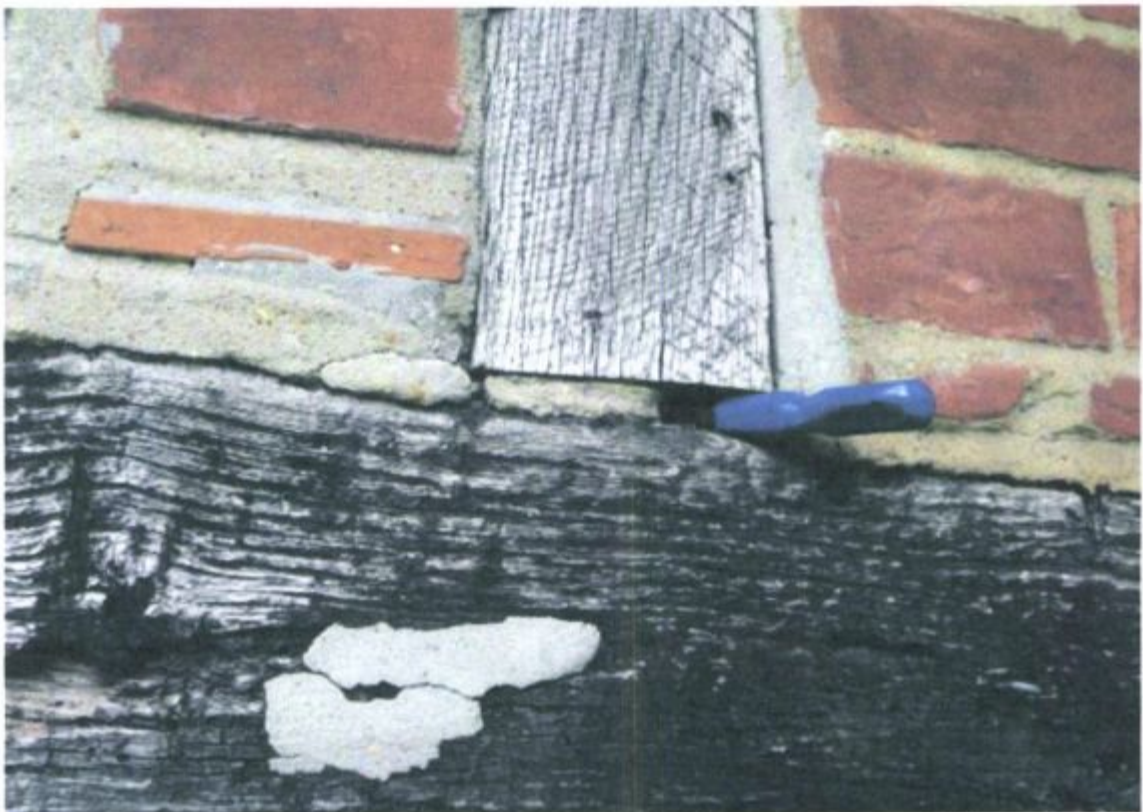
Photograph 2

Framing integrity is broken down where joints are non-existent, of poor quality or nailed as shown on photographs 2, 3, 5, 6, 8 and 9.

General framing joints should be repaired, but intermediate studs are considered thin in cross section. Either the timbers will have to be temporarily removed for end splice repairs or brickwork opened up for side mechanical fixings. It is not recommended to install diagonal face fixings due to the possibility of water ingress.

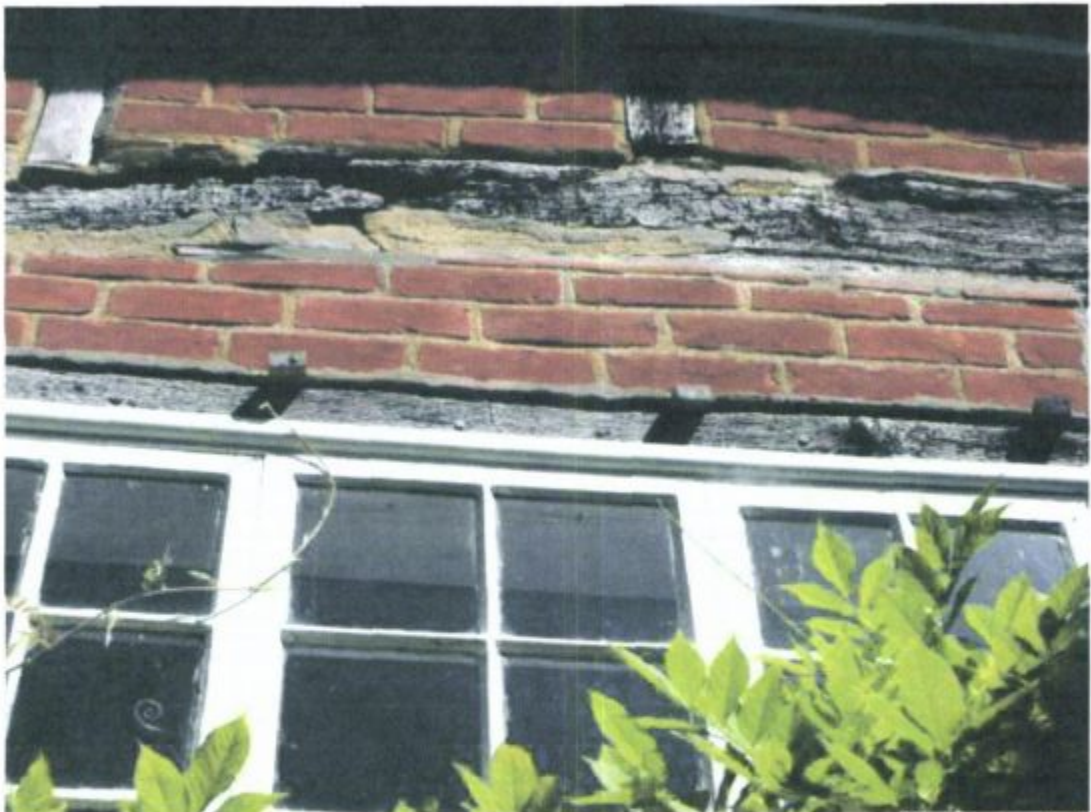
Photograph 4

Vertical support is inadequate as shown on photograph 4.
