## Arboricultural Assessment Report

### Detailed Report on Trees

| | <b>Risk Address:</b> | 32, Holman Close, Waterlooville, Hants, PO8 8DW |
| <b>Refs:</b> | <b>OCA Ref:</b> | 46536 |

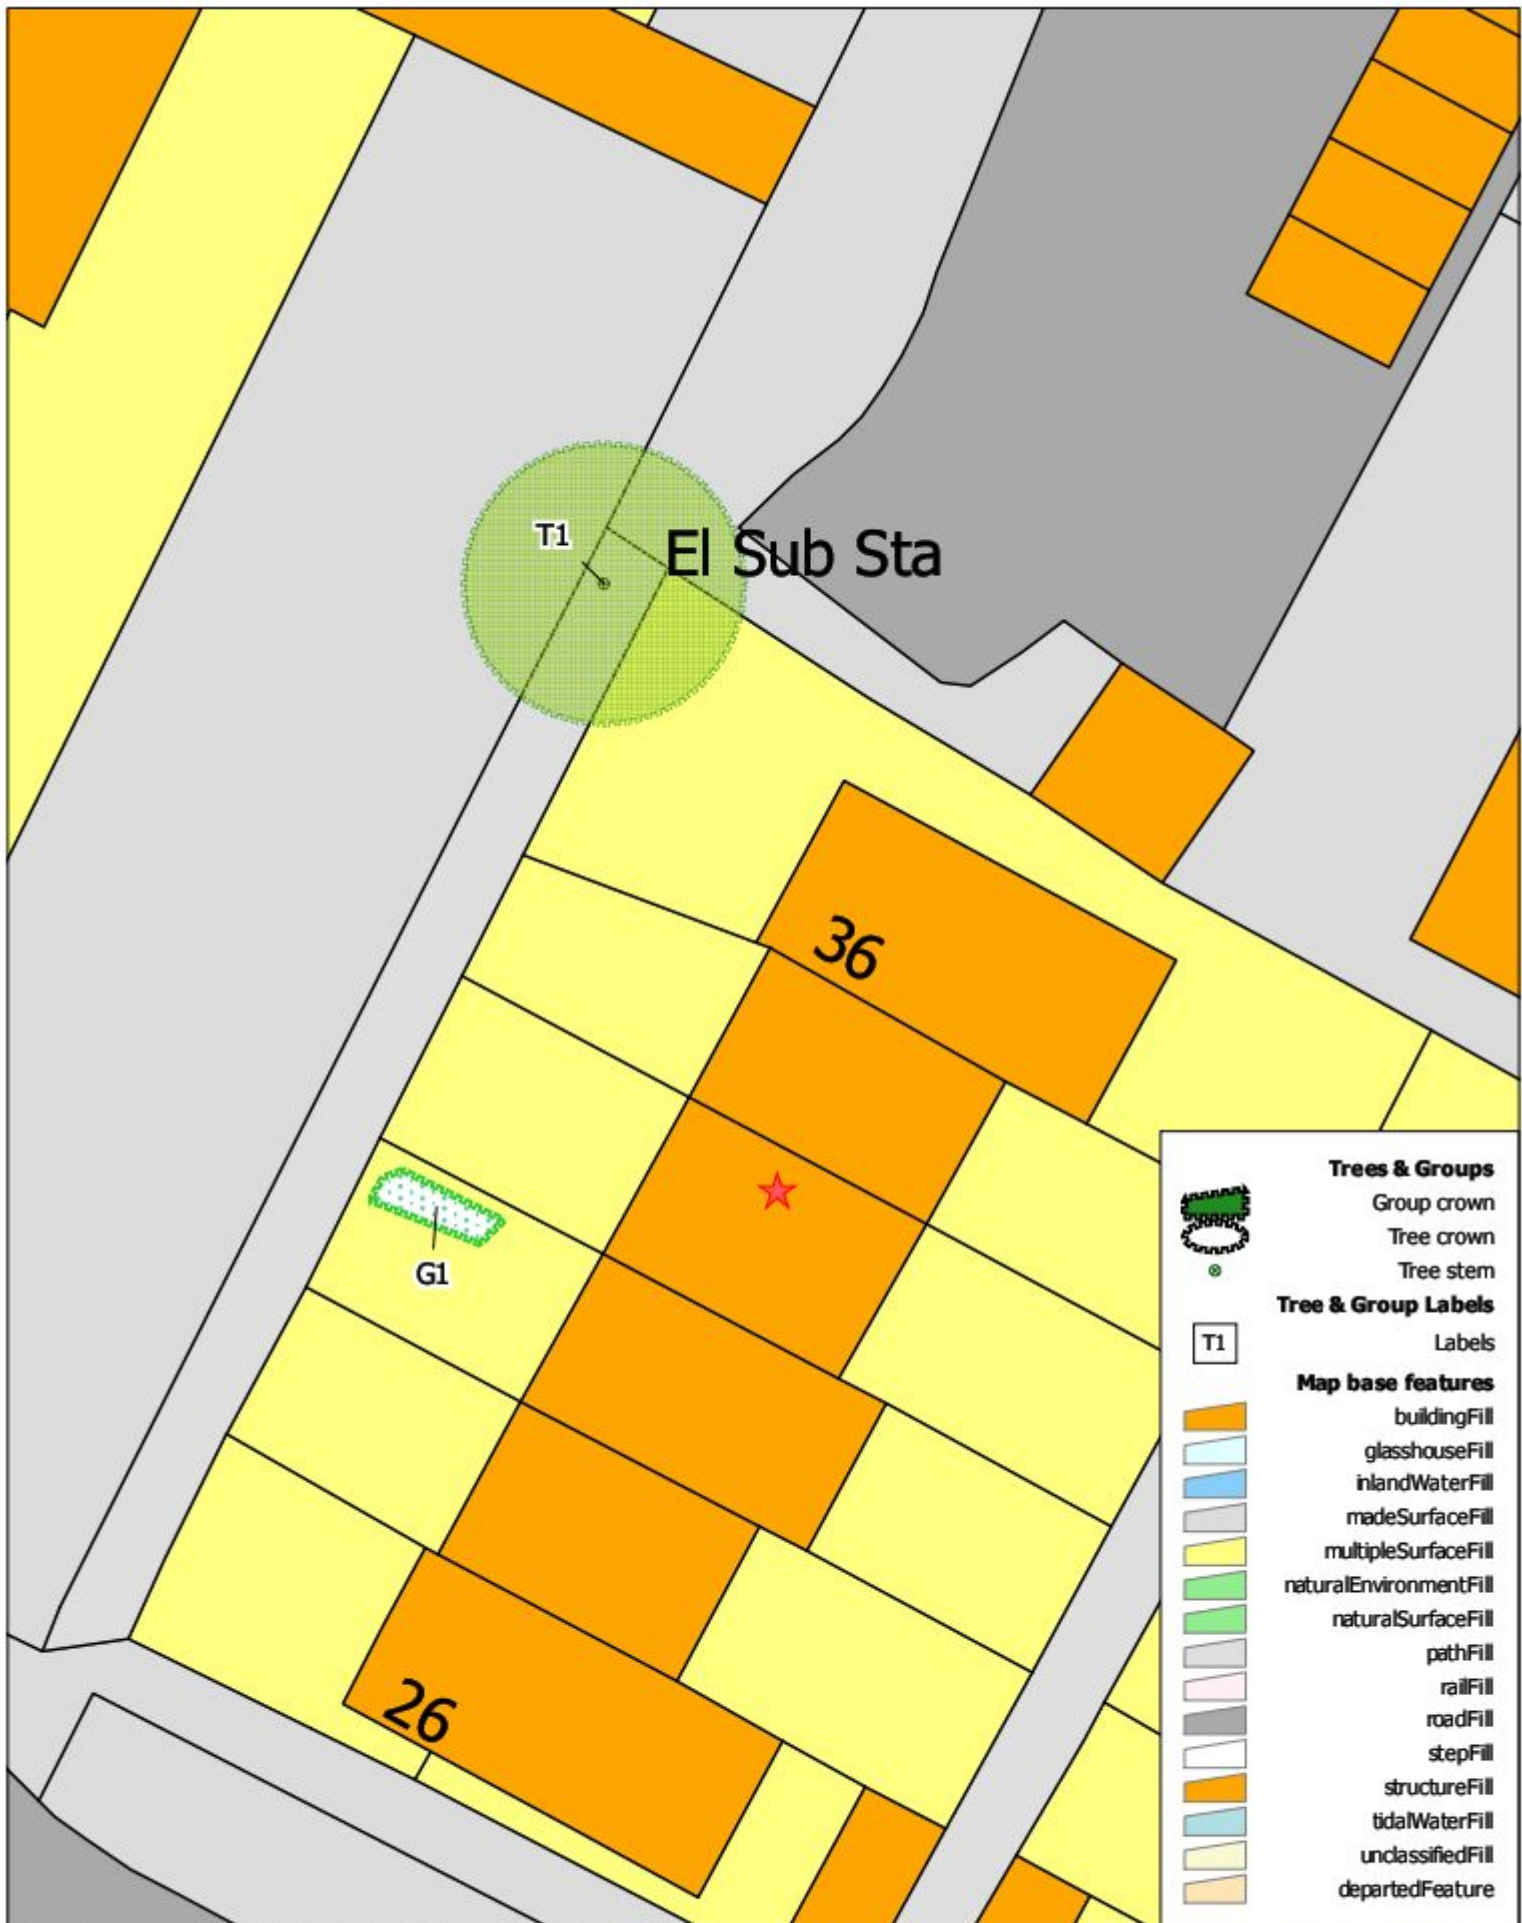
Location: 32 HOLMAN CLOSE, WATERLOOVILLE, PO8 8DW  
 Job Ref.: 46536  
 Survey Date: 02/11/2007  
 Scale: 1:220 @ A4

| Tree No | Common Name | Age Class | Condition | Height (m) | Crown Spread (m) | Stem diam. (mm) | Dist to bldg (m) | Pruning history | Recommendation | Tree work constraints | Notes | Owner |
|---|---|---|---|---|---|---|---|---|---|---|---|---|
| T1 | English Oak | MA | G | 20.6 | 8 | 600 | 14.7 | No significant past tree works | Fell and treat stump. | Lamp post underneath tree canopy | Both Council and Housing association have denied ownership. | U |
| G1 | Cherry | EM | G | 7.5 | 4 | 150 | 1 | No significant past tree works | Fell and treat stumps. (Future) | N/A | Comprises of 2x Cherry trees. | P3P |

| Tree No: | Species | Works Required |
|---|---|---|
| T1 | English Oak | Fell to as close to ground level as is practicable and treat stump with an appropriate herbicide to prevent future growth |

| Tree No: | Species | Works Required |
|---|---|---|
| G1 | Cherry | Fell to as close to ground level as is practicable and treat stumps with an appropriate herbicide to prevent future growth |
