# Arboricultural Assessment Report

## Detailed Report on Trees

| | <b>Risk Address:</b> | 43 Hollybank Lane, Emsworth, Hants PO10 7UE |
| <b>Refs:</b> | <b>OCA Ref:</b> | 45770 |

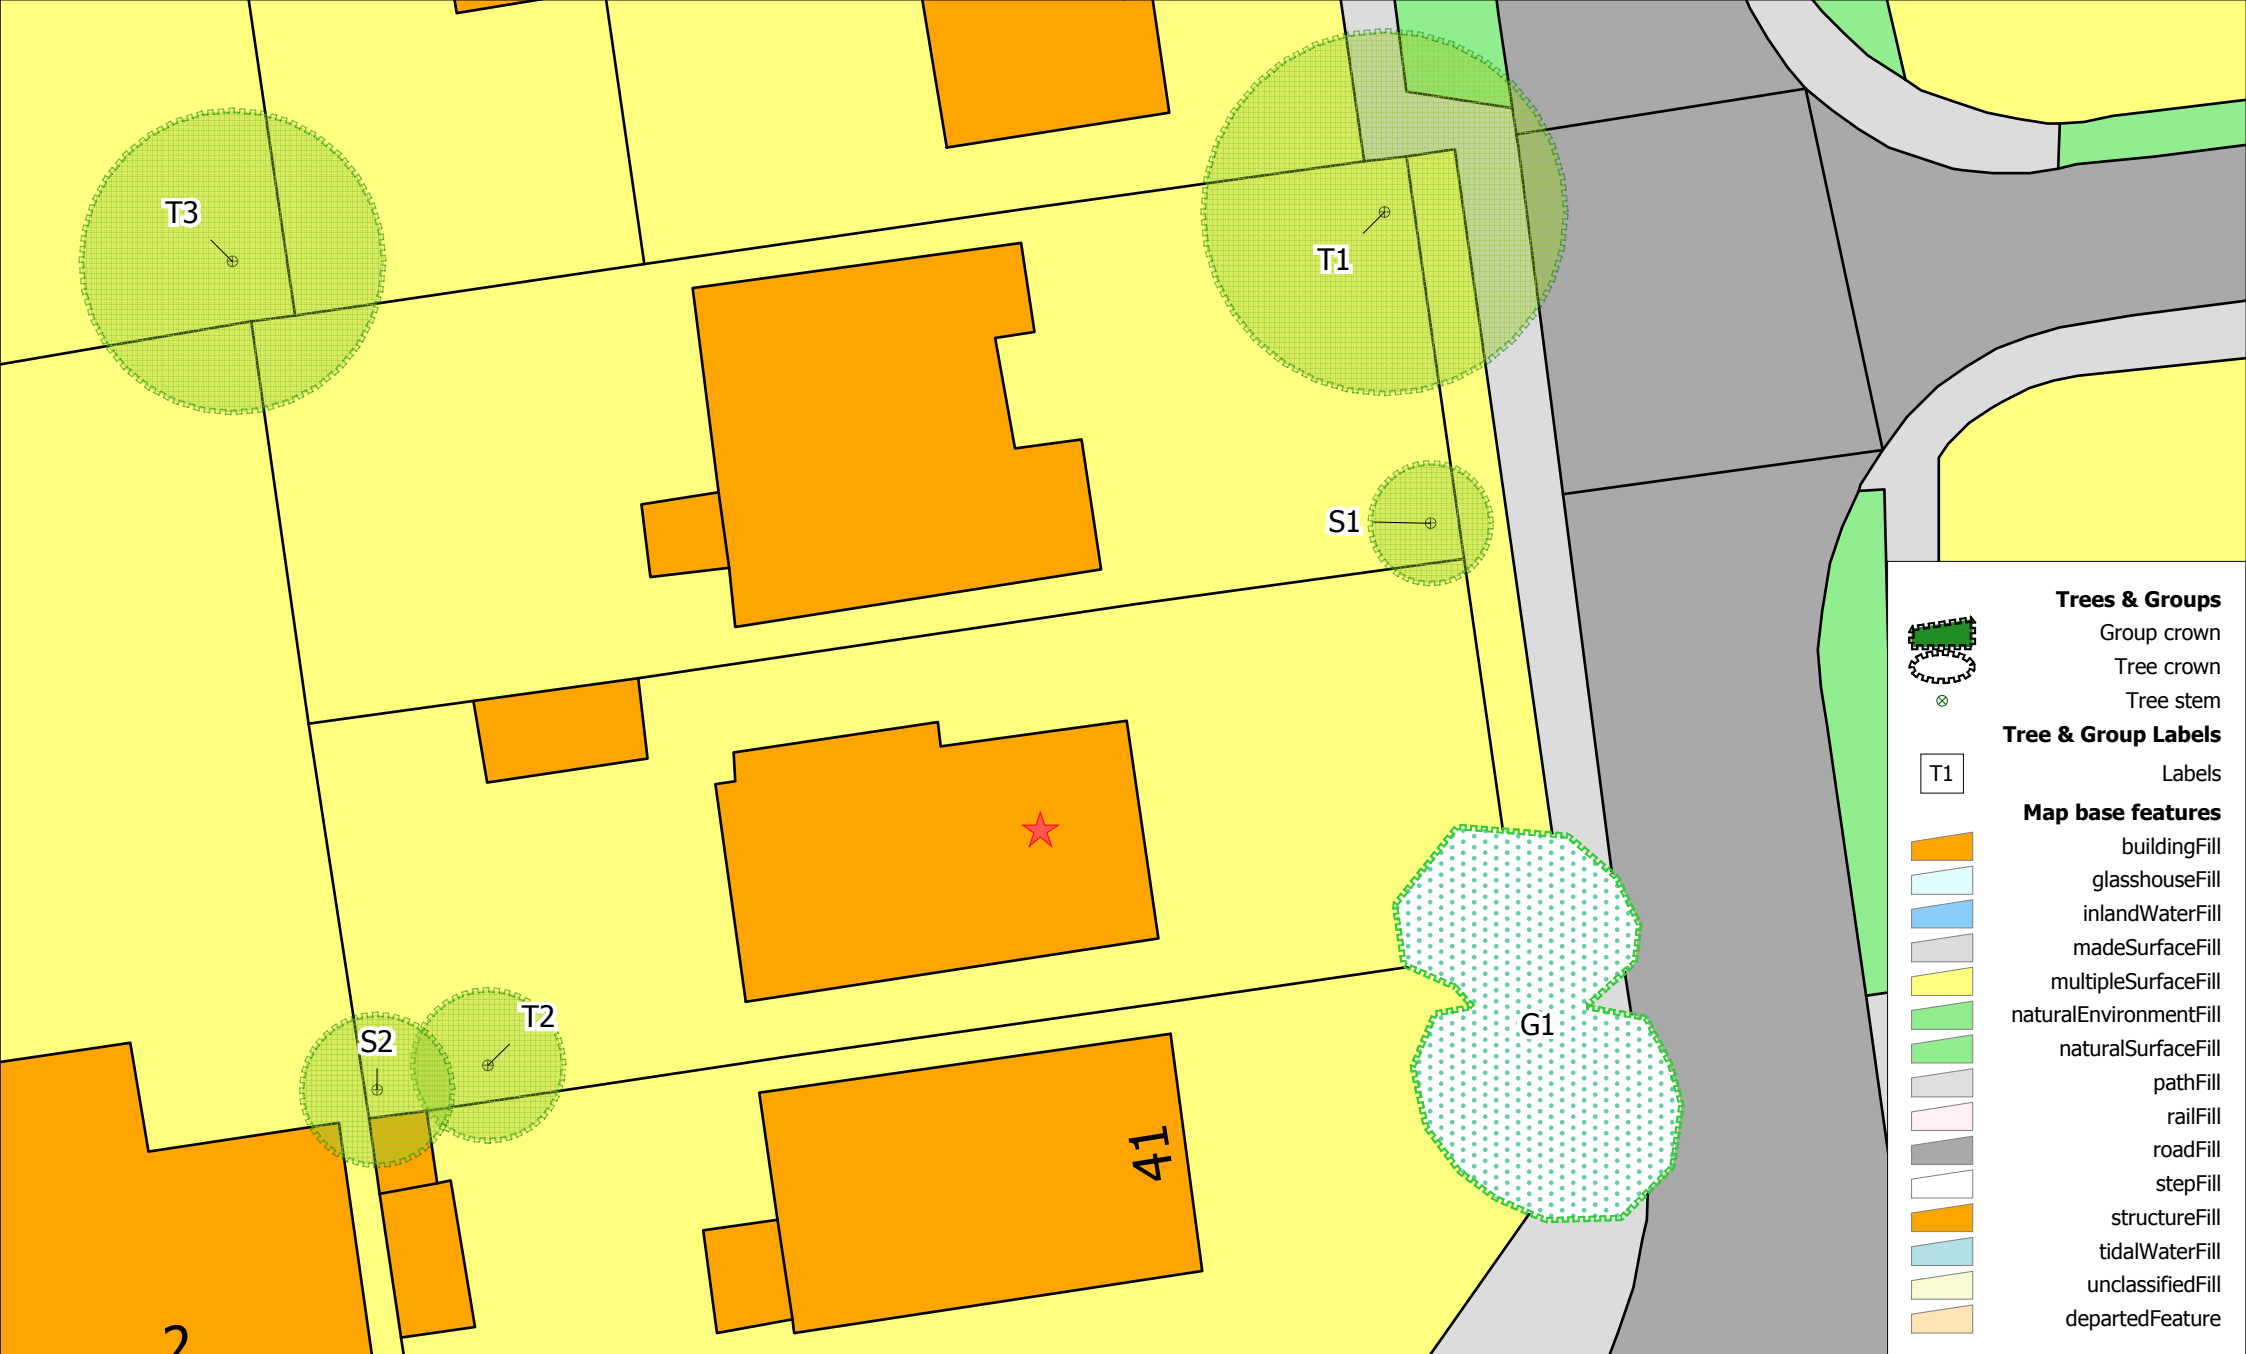
Location: 43 HOLLYBANK LANE, EMSWORTH, PO107UE  
Job Ref.: 45770  
Survey Date: 02/11/2007  
Scale: 1:250 @ A4

The area of damage and the mechanism of movement as described by the Engineer are consistent with the location of the English Oak and Common Beech trees (G1).

Level monitoring demonstrates a seasonal pattern of movement that I can only attribute to the influence of adjacent vegetation. The greatest amplitude of movement has been recorded at points 7 and 8 (front left corner) and I note that these points are closest to the English Oak and Common Beech trees (G1).

Therefore it is my opinion that sufficient information has been provided to demonstrate that, on the balance of probabilities, English Oak and Common Beech (G1) are the material cause of the current subsidence damage.

Given their close proximity to the Insured Property, I do not consider that undertaking pruning works to English Oak and Common Beech (G1) will provide either an effective or sustainable means of controlling their water use. Therefore and in order to provide a long-term solution to the current subsidence damage I recommend these trees be removed.

| Tree No: | Species | Works Required |
|---|---|---|
| G1 | English Oak & Common Beech | Fell to as close to ground level as is practicable and treat stumps with an appropriate herbicide to prevent future growth |
