# Arboricultural Assessment Report

## Detailed Report on Trees

| | <b>Risk Address:</b> | 4 Acre Lane, Waterlooville, Hampshire, PO7 8RJ |
| <b>Refs:</b> | <b>OCA Ref:</b> | 47560 |

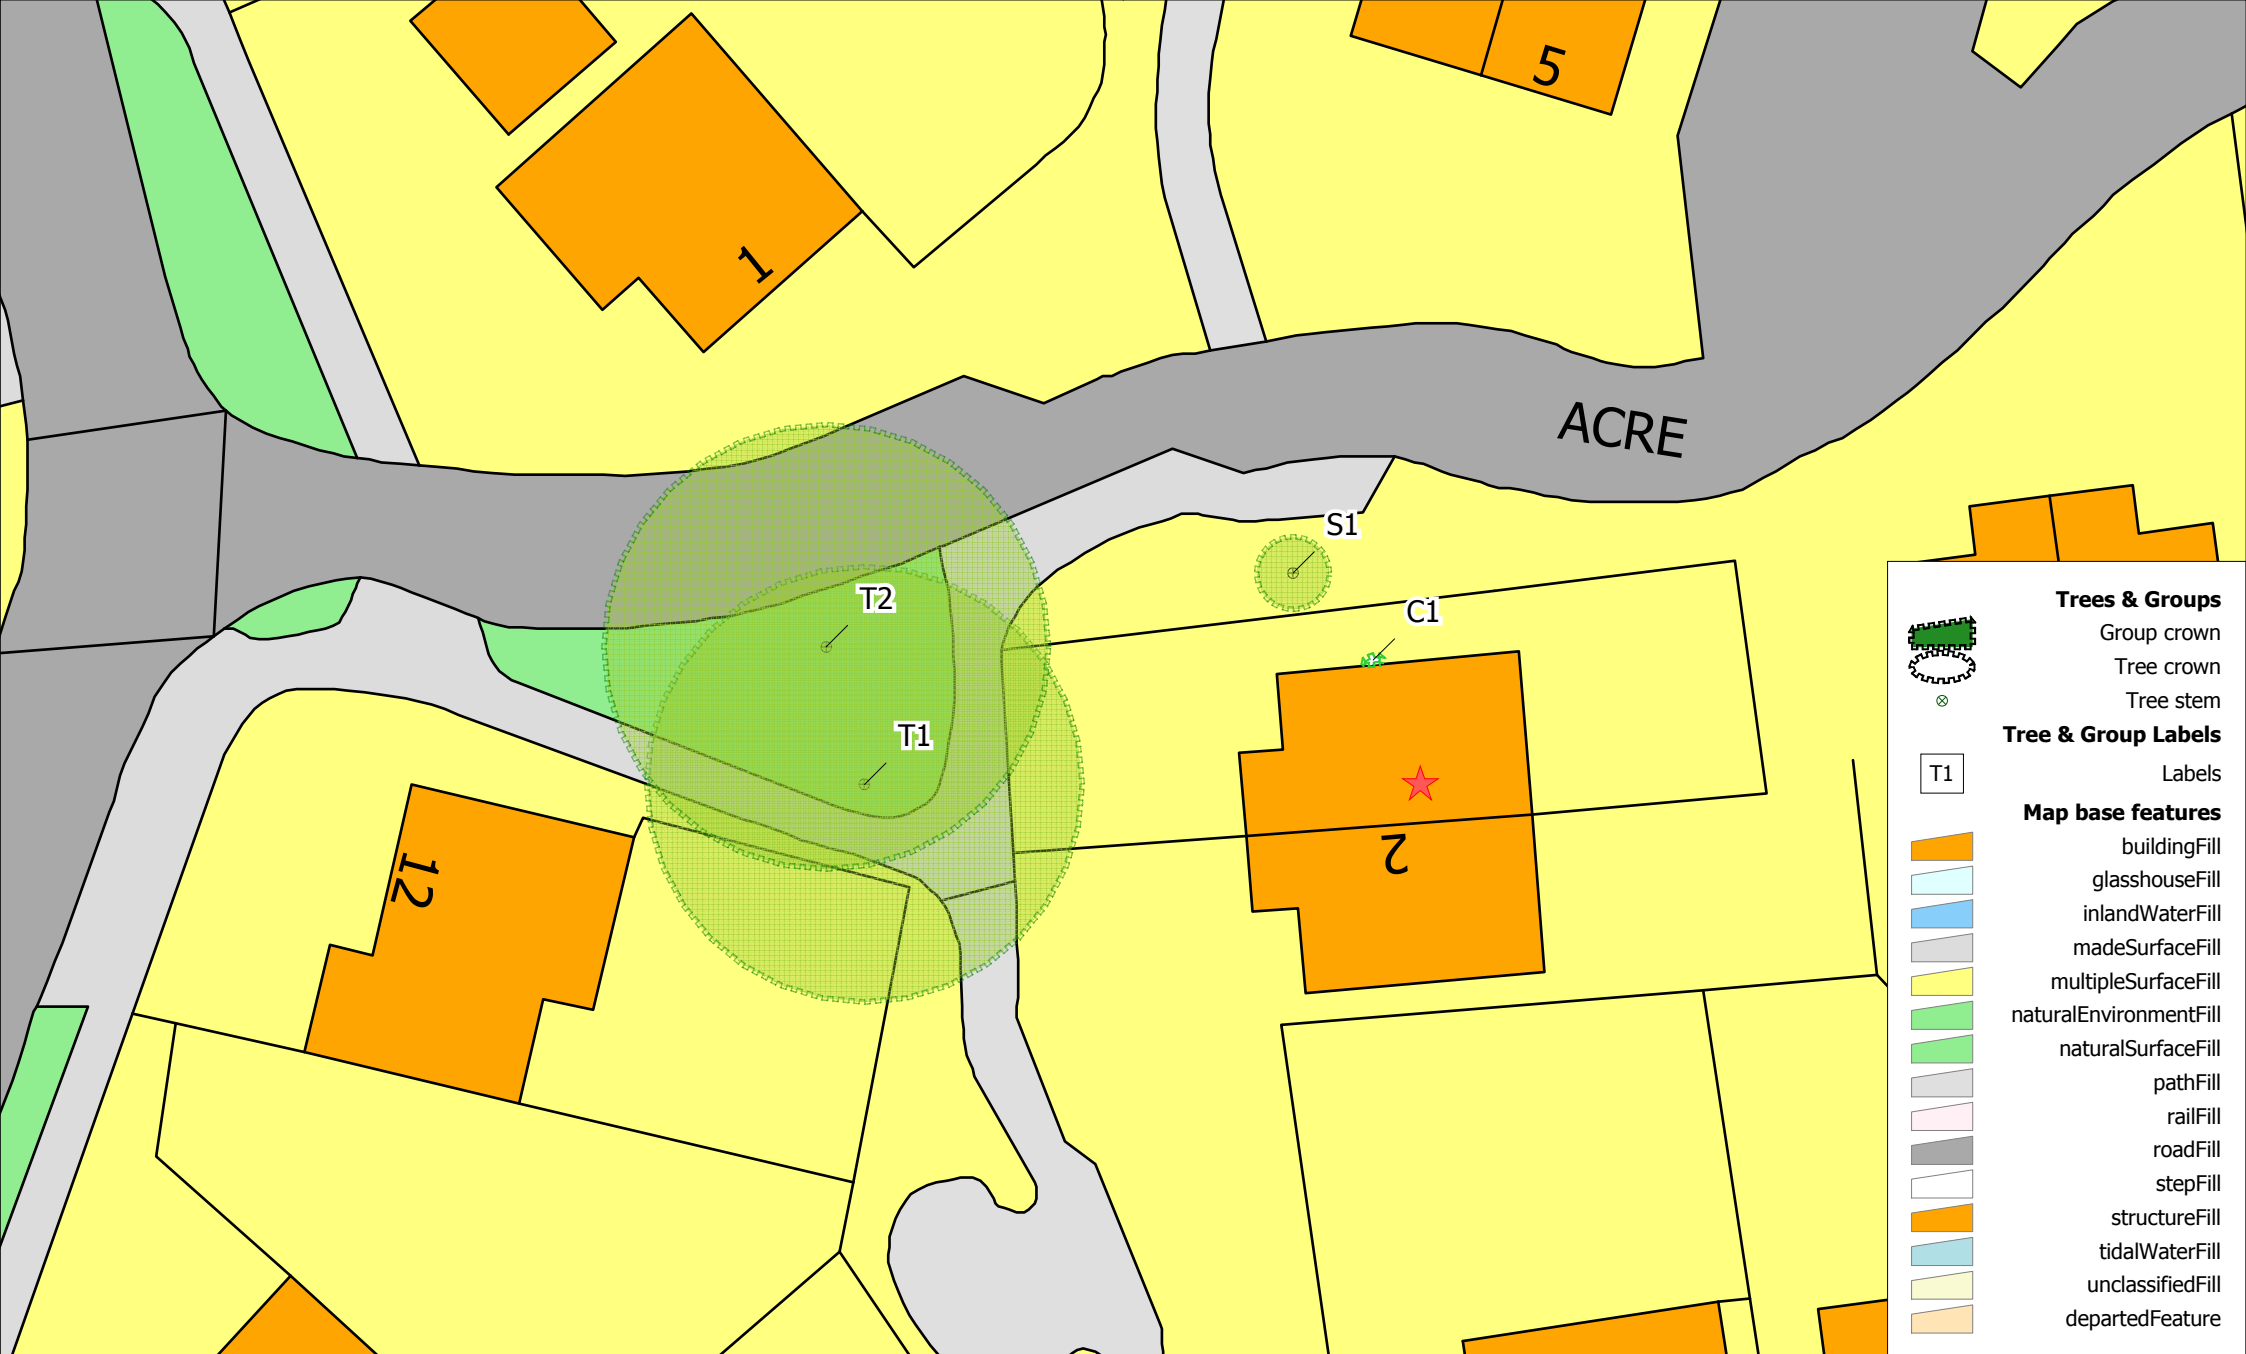
Location: 4 ACRE LANE, WATERLOOVILLE, PO7 8RJ  
Job Ref.: 47560  
Survey Date: 15/04/2011  
Scale: 1:250 @ A4

| Tree No | Common Name | Age Class | Condition | Height (m) | Crown Spread (m) | Stem diam. (mm) | Dist to bldg (m) | Pruning history | Recommendation | Tree work constraints | Notes | Owner |
|---|---|---|---|---|---|---|---|---|---|---|---|---|
| T1 | English Oak | MA | F | 14.6 | 14.4 | 625 | 11.4 | Heavily reduced many years previous, Crown lifted | Fell and grind stump. | | Assymetric crown spread | LA |
| T2 | English Oak | MA | F | 17.1 | 14.7 | 820 | 13.1 | Heavily reduced > 5 years ago | Fell and grind stump. | | | LA |

| Tree No: | Species | Works Required |
|---|---|---|
| T1 | English Oak | Fell to as close to ground level as possible and treat the stump with an appropriate herbicide |
| T2 | English Oak | Fell to as close to ground level as possible and treat the stump with an appropriate herbicide |
