# Tree Condition Assessment

**39 Bridefield Crescent, Waterlooville, PO8 8QY**

Reference: MW.2402.BCW.TCA

Date: 22 February 2024

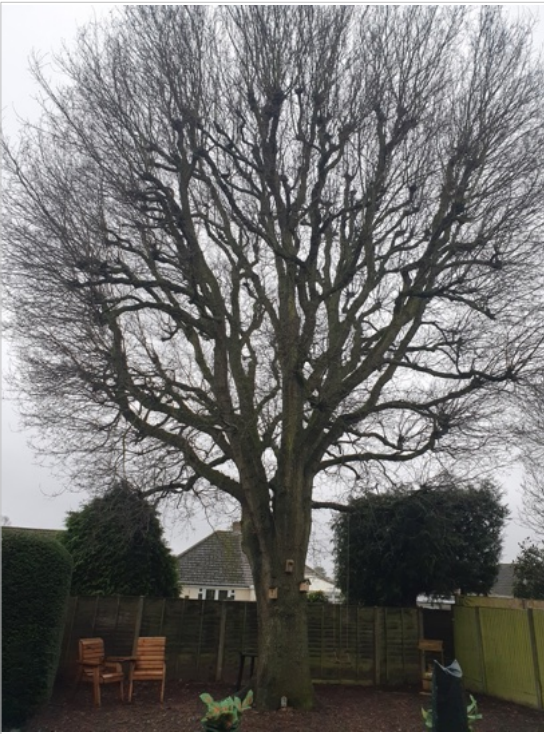
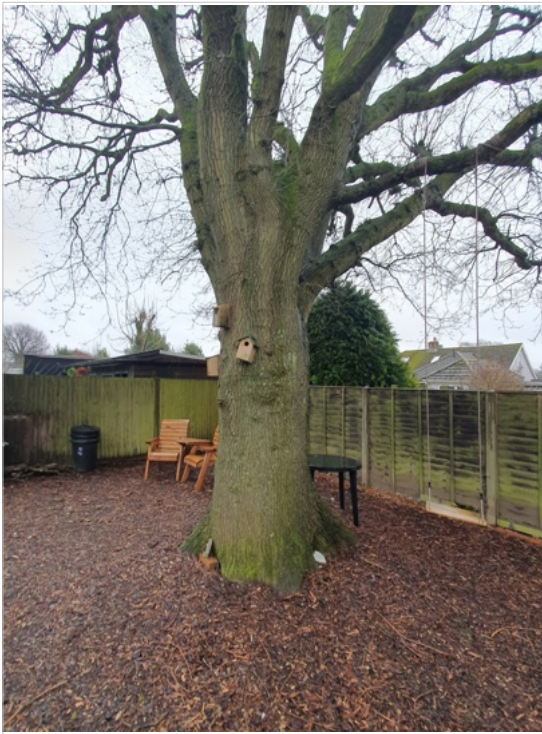
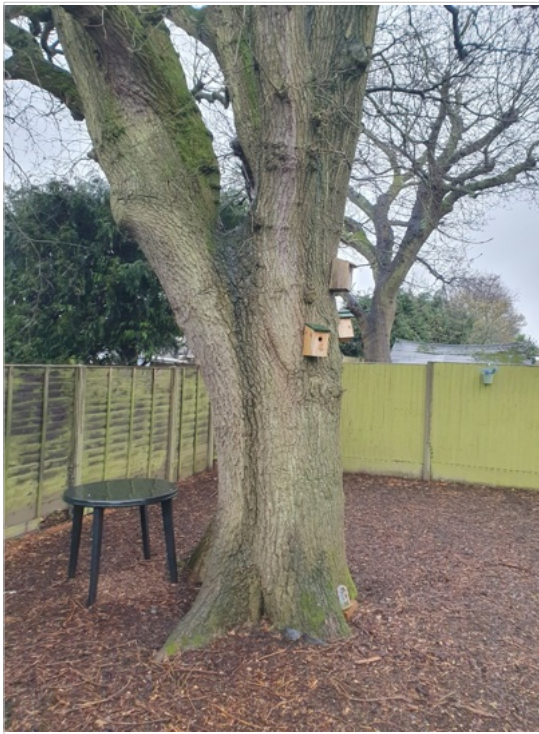
| Ref | Species | Stem Diameter (est cm) | Height (est m) | Survey Notes | Recommendations* | Reassess | Priority |
|---|---|---|---|---|---|---|---|
| 01 | Pedunculate oak ( <i>Quercus robur</i> ) | 90 | 17 | No obvious signs of root plate instability or movement<br>Reasonable root flare and buttressing<br>No obvious fungal fruiting bodies or bark necrosis visible around stem base.<br>Surrounding ground is covered with mulch.<br>Lower stem appears sound when tapped with nylon mallet<br>Very little deadwood present.<br>Crown regularly reduced and now forming typical knuckles at regrowth points.<br>Regrowth appears very healthy. Bud distribution and fine branch reiteration are as expected.<br>No obvious risk features or issues. | None at this time. Repeat reduction to be carried out in 2-3 years | 2.5 years | |

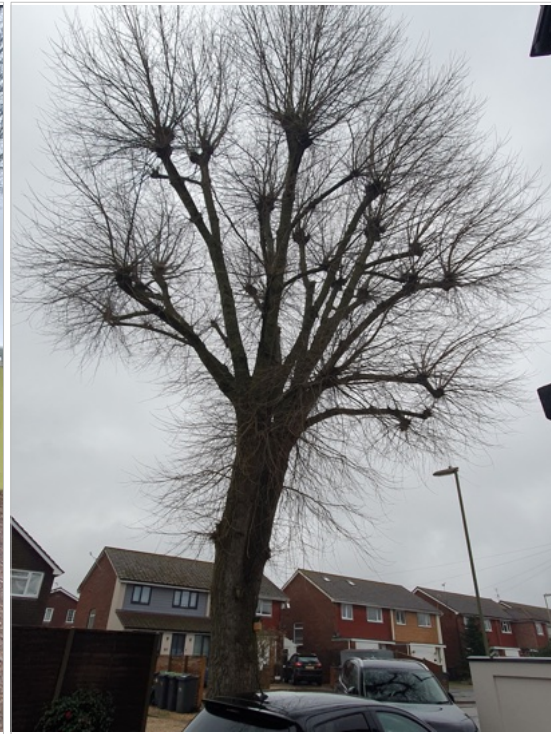
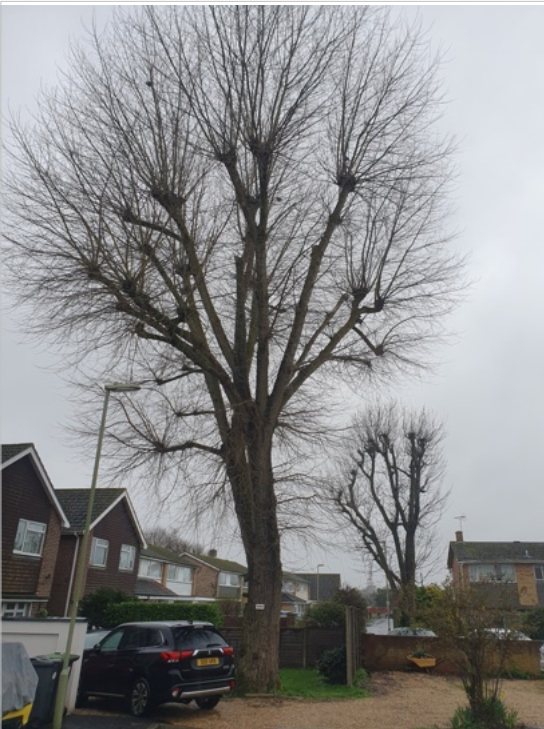
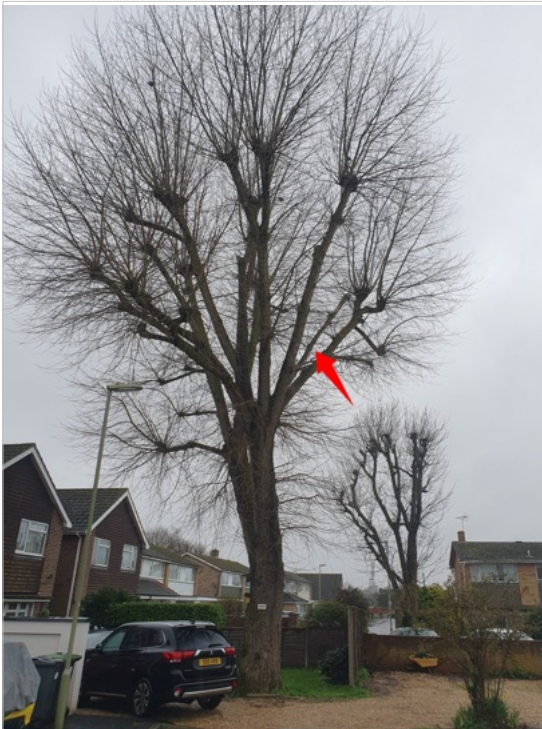
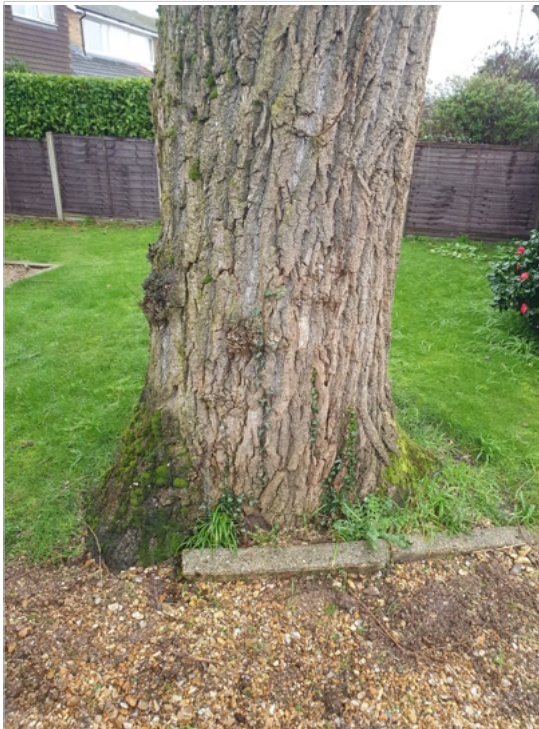
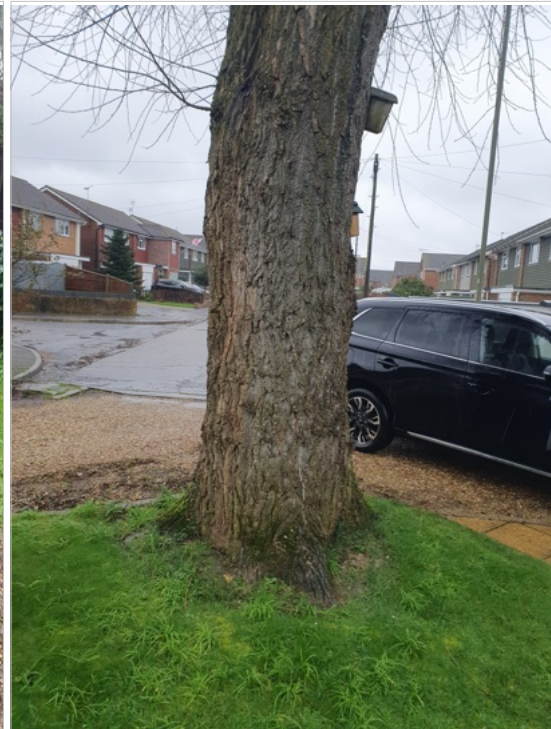
| Ref | Species | Stem Diameter (est cm) | Height (est m) | Survey Notes | Recommendations* | Reassess | Priority |
|---|---|---|---|---|---|---|---|
| 02 | Poplar ( <i>Populus sp.</i> ) | 90 | 22 | Tree growing in driveway overhanging adjacent driveways<br>Historically crown reduced, now regrown. Developing substantial knuckles at pruning points.<br>No obvious signs of root plate instability or movement<br>Reasonable root flare and buttressing.<br>Kerbing is somewhat displaced by roots but displacement is currently minor.<br>No obvious fungal fruiting bodies or bark necrosis visible around stem base.<br>Lower stem appears sound when tapped with nylon mallet.<br>Bifurcation at 2.5 m into two main stems which then fall further. One branch growing to north showing bark necrosis/decline in upper crown. Regrowth is becoming very mature and is ready for repeat reduction. Fine branch reiteration and bud distribution are good and indicative of sound physiological health | Remove regrowth since last reduction back to previous pruning points (no cuts into branches greater than 150mm diameter)<br>Remove dead/declining branch to north (see photo) | 2.5 years | Medium |
