## Arboricultural Impact Assessment

Widening of Footpath 51 to three  
metres, along with appropriate  
lighting, guard railing and other  
features to enable use by cyclists

Langstone Technology Park  
2B Langstone Road  
Havant  
PO9 1SA

Survey Dates: 7<sup>th</sup> June 2021 &  
12<sup>th</sup> November 2021  
Report Date: 12<sup>th</sup> September 2024  
Project no: 1746

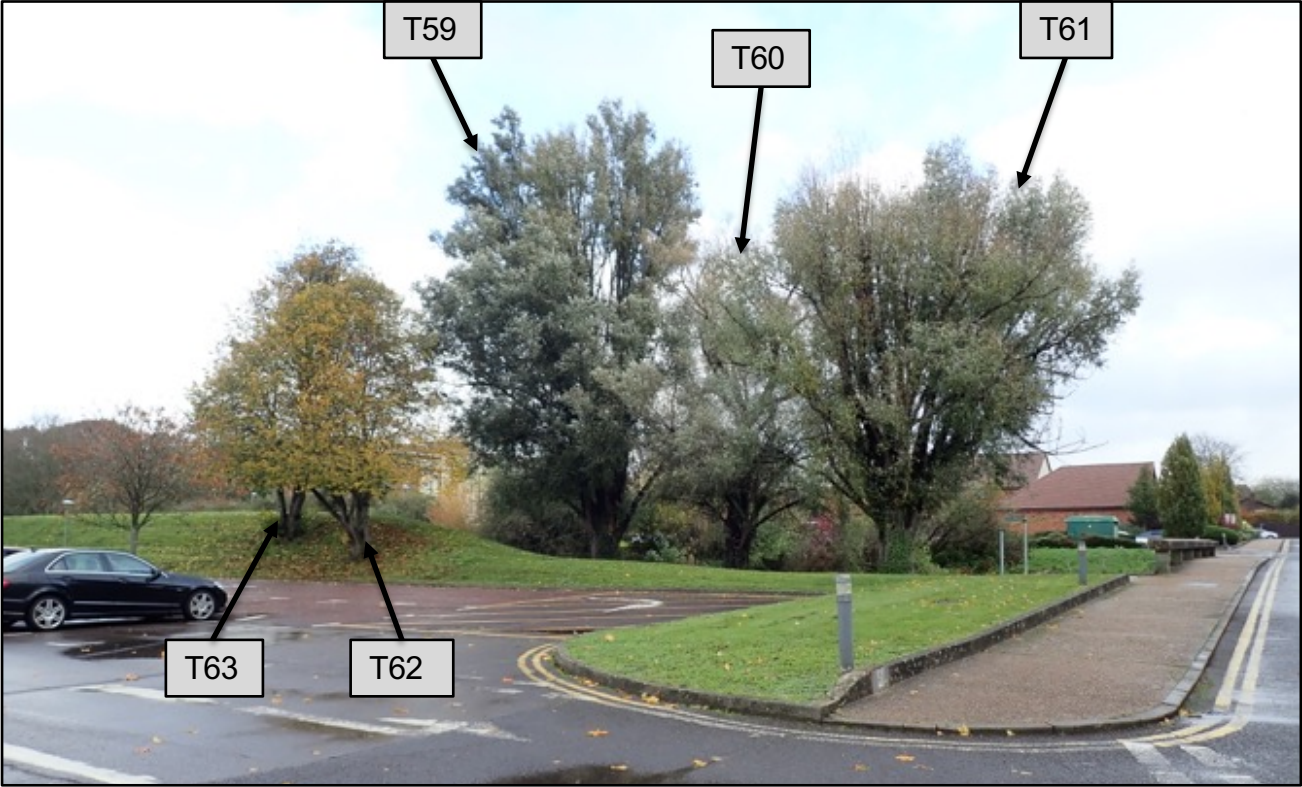
T59, T60 and T61 proposed for removal to allow widening of footpath.

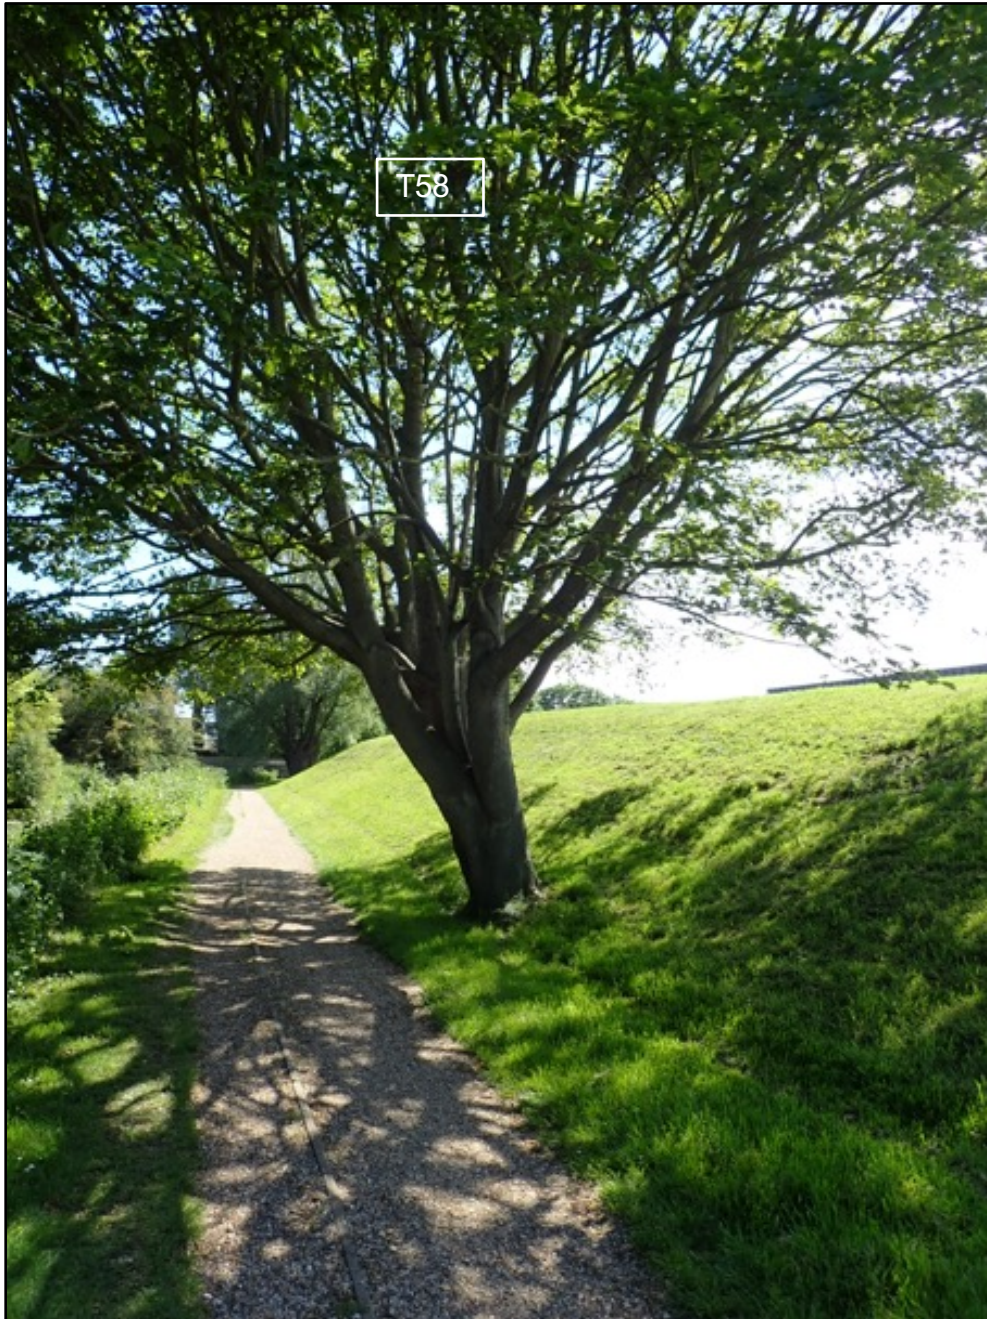
T58 proposed for removal to allow widening of footpath and the associated re-profiling of the grass covered bund.

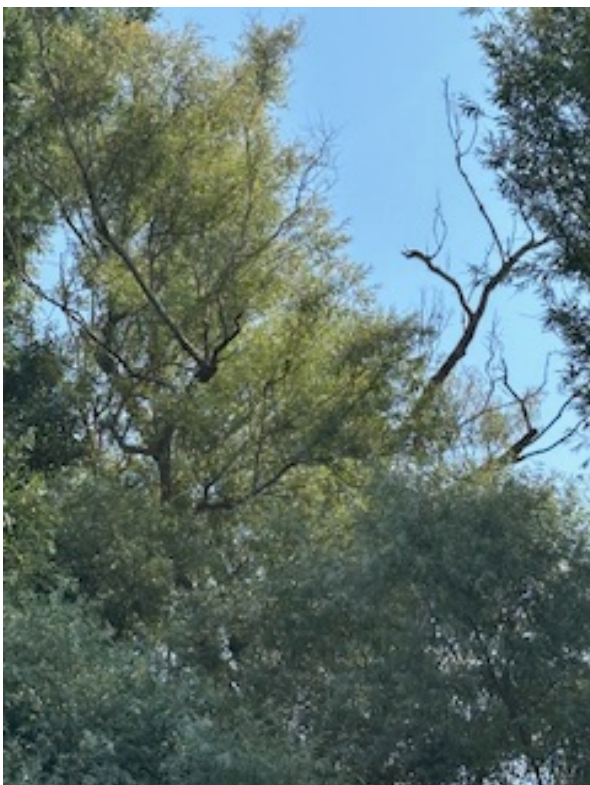
Picture 2

This tree is the middle of 3 willow trees on the southern boundary of the Technology Park. A footpath is 1m east and the Lang Brook 4m east. The tree leans significantly to the east. On the stem and up into the crown there is dense ivy. Lots of limbs have been removed from the stem and into the crown leaving stubs. Some heartwood has been exposed where the bark is coming away, mainly to the east. The crown looks poor with significant die back dead limbs and major (over 75mm diameter) dead wood (Picture 2).

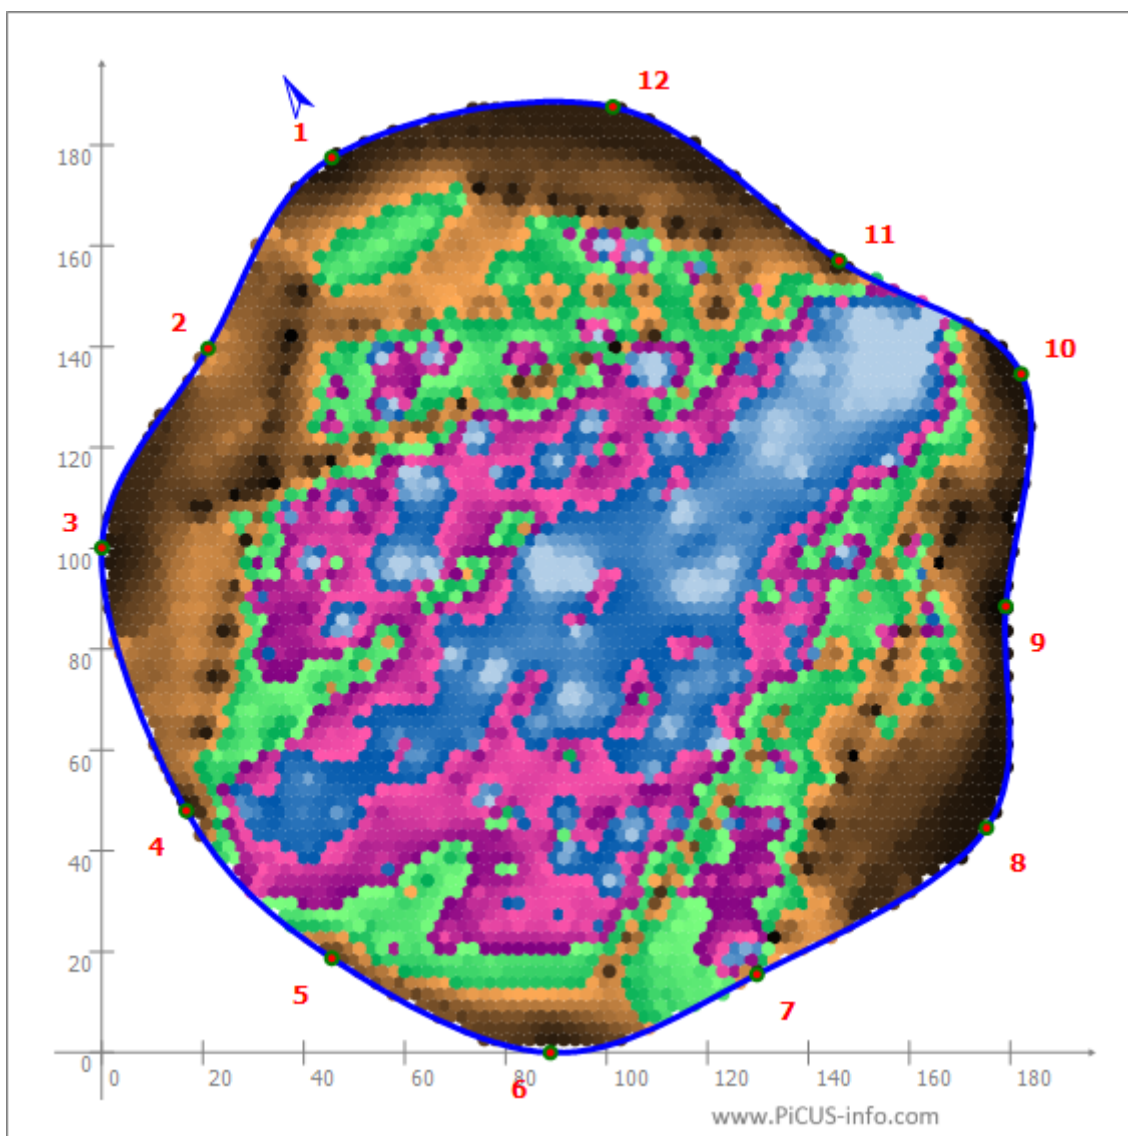
Reading taken at 20cm above ground level (agl).

The Picus Tomograph shows that some of the centre of the stem is cavity coloured blue with some advanced decay coloured pink and early decay coloured green. The Resistograph readings were taken at closer to ground level and show an even greater extent of the decay. This level of decay and cavity is sufficient to affect the structural integrity of the tree. The target area should the tree fail is high.

There is enough decay and cavity for me to recommend removal of the tree as the target area is high. This work to be carried as soon as practically possible by a fully qualified and insured tree surgeon to BS3998 (2010), Tree work.

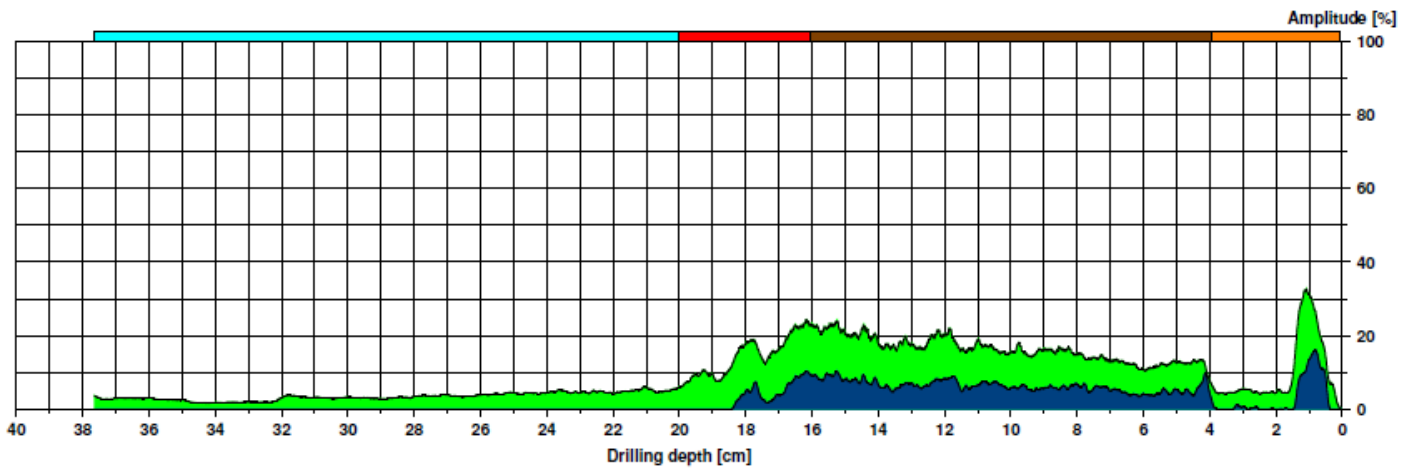
| From | 16,04 cm | to | 20,00 cm | : | Decay |

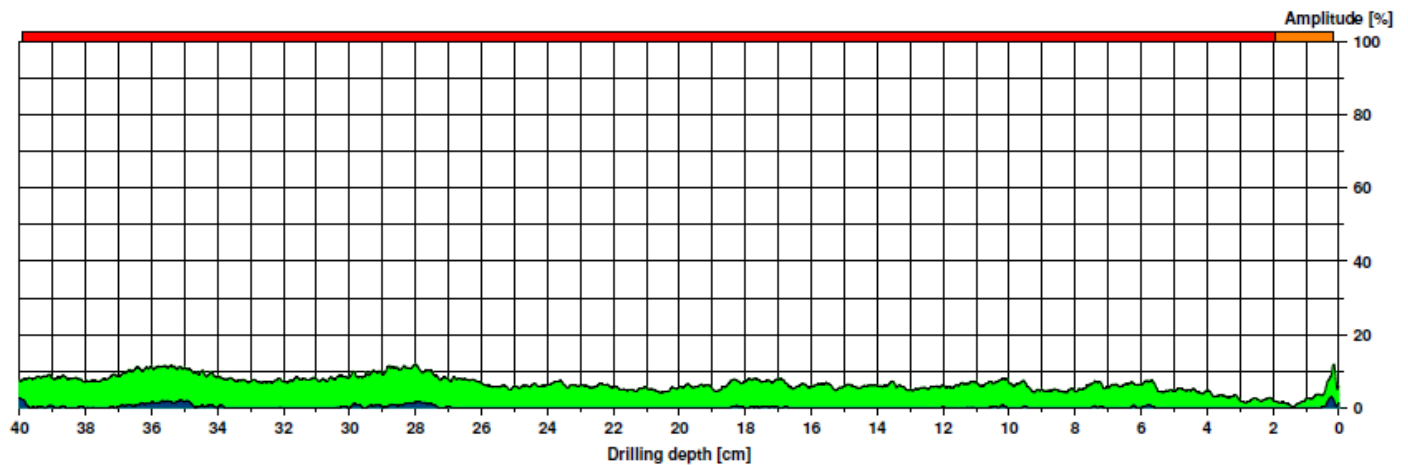
From 0,16 cm to 1,93 cm : Bark  
From 1,93 cm to 39,90 cm : Decay

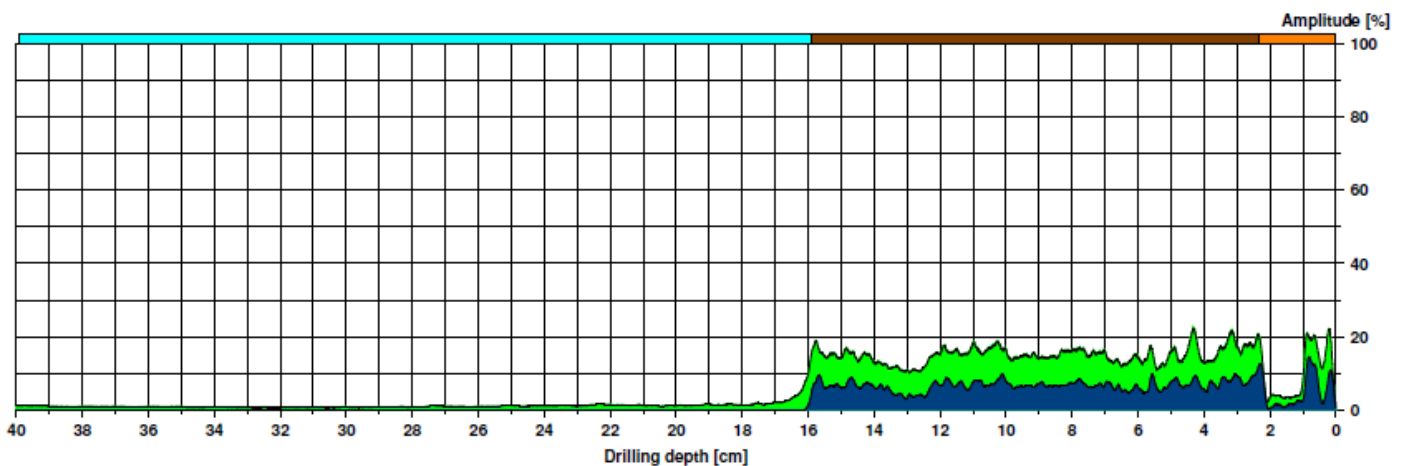
From 0,03 cm to 2,32 cm : Bark  
From 2,32 cm to 15,88 cm : Good Wood  
From 15,88 cm to 39,90 cm : Cavity

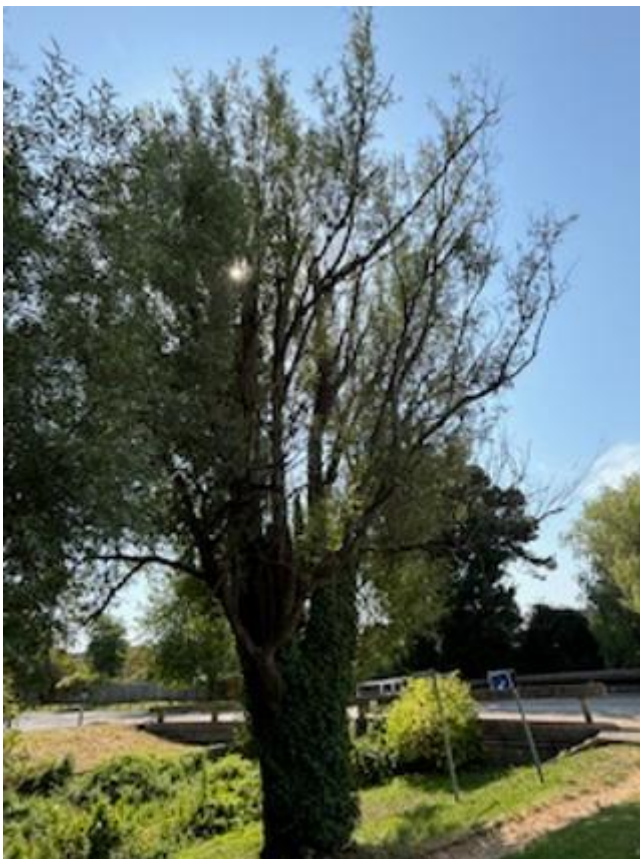
**Tree 2:** White Willow    Height 12m Diameter 1145mm

This tree is 7m south of T1. A footpath is 50cm west, the brook 5m east, Langstone Road and bridge are 6m south of this tree. Around the base from south to northwest are extensive brackets of the fungus *Ganoderma applanatum/adspersum* (Picture 4). The stem is covered in dense ivy. The crown breaks at 3m above ground level. To the east from 20cm agl to the crown break is a crack with exposed, decayed heart wood. A large branch has been removed at 2m agl. The crown has been pollarded and there is extensive die back and major dead wood.

There is enough decay and cavity for me to recommend removal of the tree as the target area is high. This work to be carried as soon as practically possible by a fully qualified and insured tree surgeon to BS3998 (2010), Tree work.

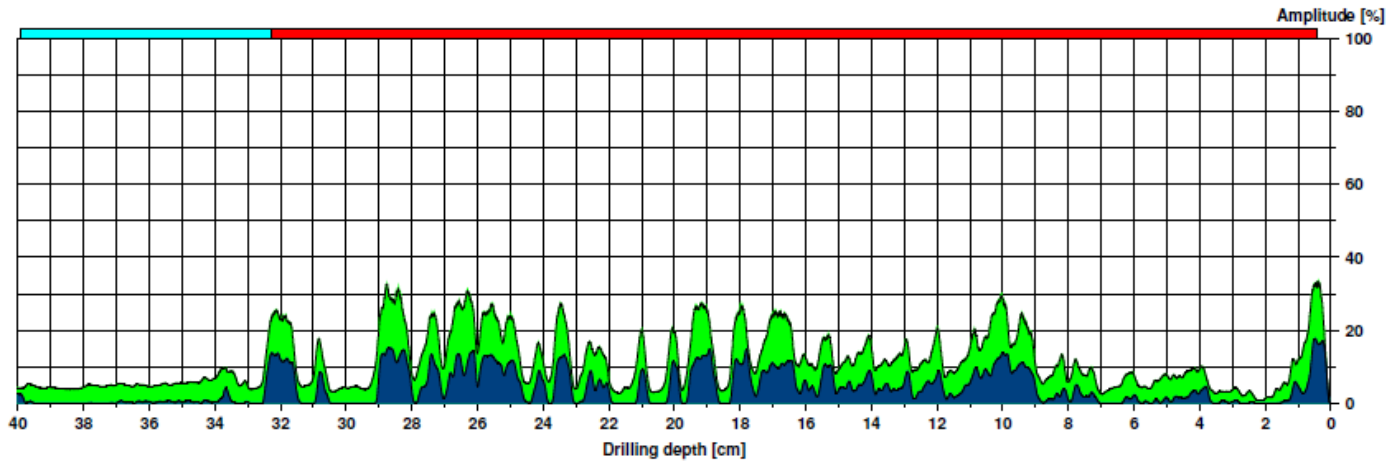
From 0,42 cm to 32,27 cm : Decay  
From 32,27 cm to 39,90 cm : Cavity

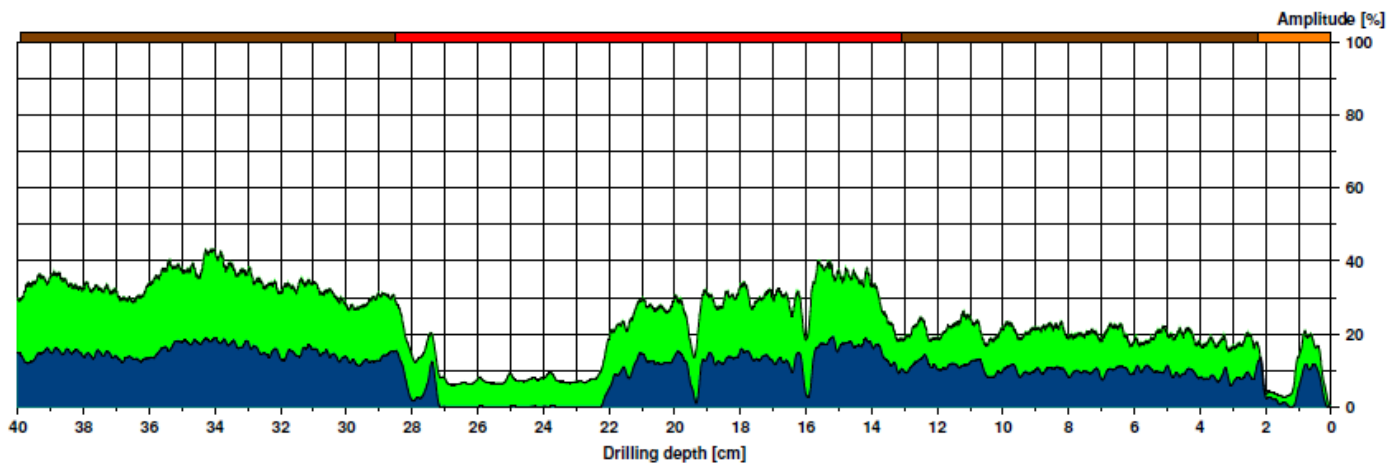
From 0,03 cm to 2,22 cm : Bark  
From 2,22 cm to 13,08 cm : Good Wood  
From 13,08 cm to 28,50 cm : Decay  
From 28,50 cm to 39,94 cm : Good Wood

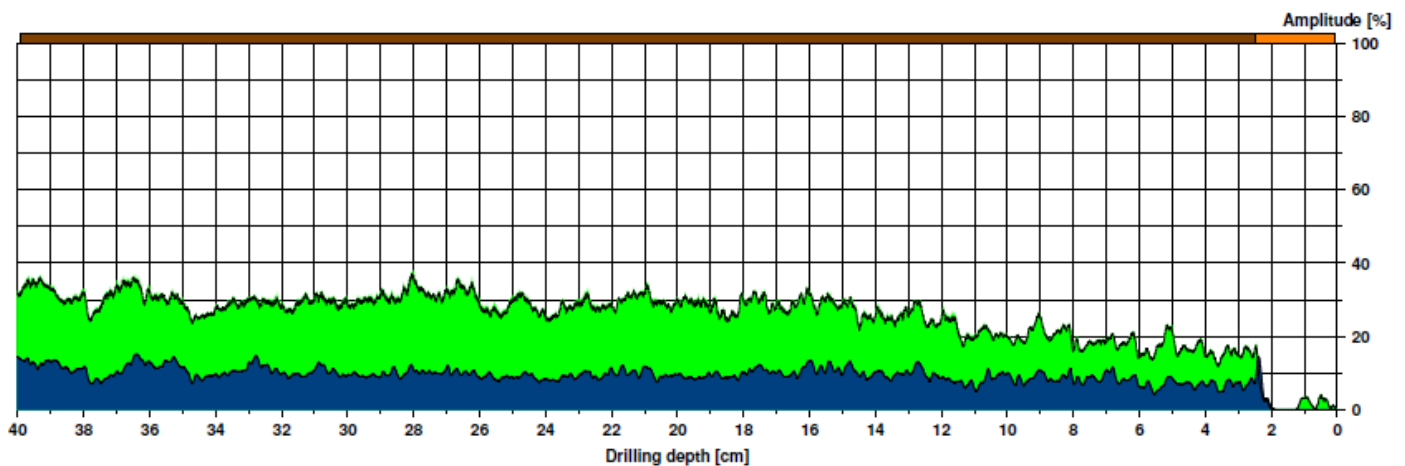
From 0,10 cm to 2,48 cm : Bark  
From 2,48 cm to 39,90 cm : Good Wood

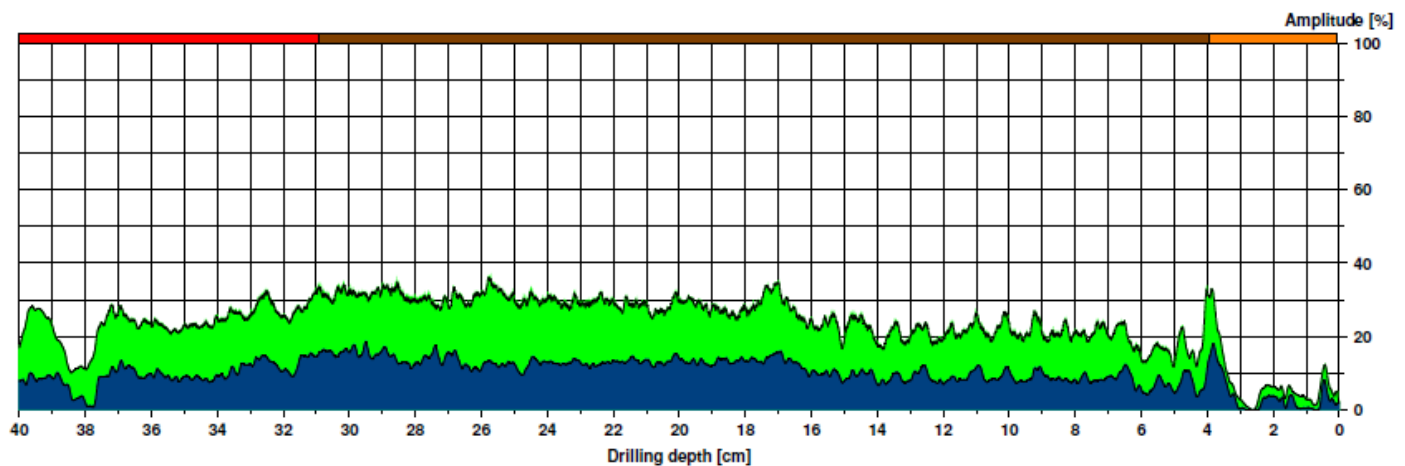
From 0,10 cm to 3,96 cm : Bark  
From 3,96 cm to 30,92 cm : Good Wood  
From 30,92 cm to 40,00 cm : Decay

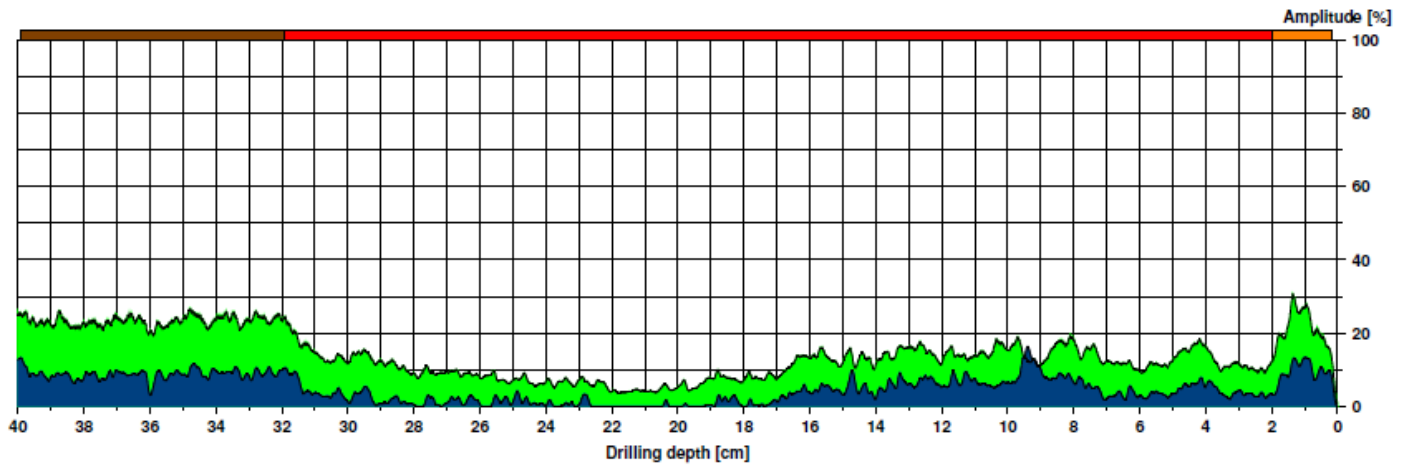
| From 2,00 cm to 31,92 cm : | Decay |

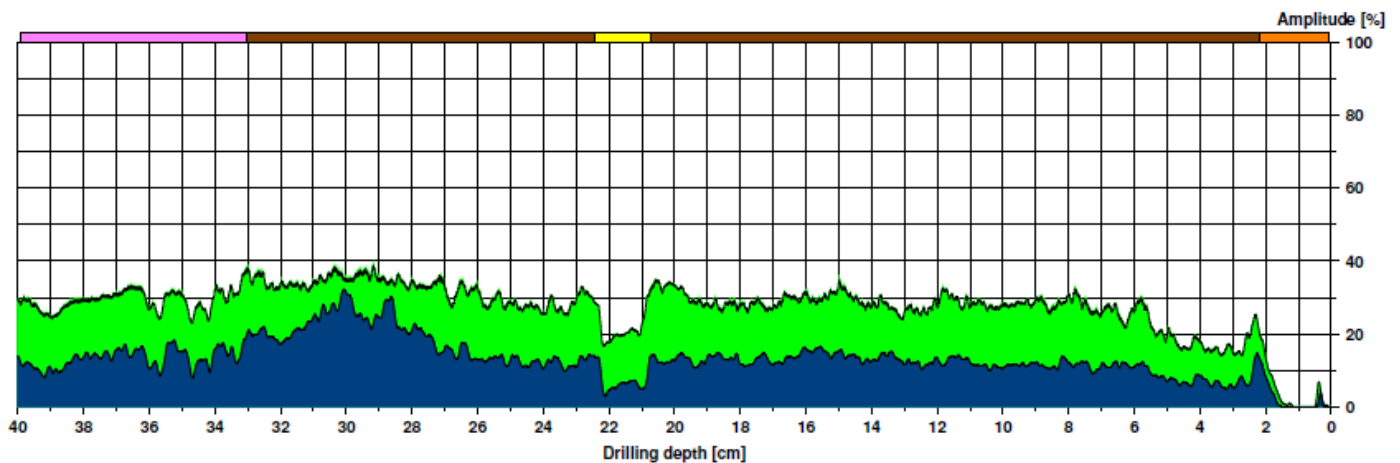
| From 20,71 cm to 22,42 cm : | Crack |
| From 33,04 cm to 39,94 cm : | Early decay |

Resistograph readings were taken at the base of the tree and either side of the crack and exposed heart wood. The readings at the base show extensive decay to the south and west, The readings at 110cm, either side of the crack show decay also. The fungus brackets are around 50% of the base. The heavy die back ad dead wood in the crown indicate that the roots are affected by decay, being next to the busy footpath adjacent to the brook makes the target area high should the tree fail. Willows are renowned for catastrophic failure.
