## Engineer's Report

**Risk Address** 28 Damask  
Gardens  
Waterlooville  
PO7 8QZ

**360 Reference** LIV-SN-23-006703  
**Insurer**  
**Reference** 800-16-008022  
**Policy Holder** Mrs. Hayley Psaila

**Date Notified** 20/04/2023  
**Date Instructed** 20/04/2023  
**Report Date** 17/05/2023

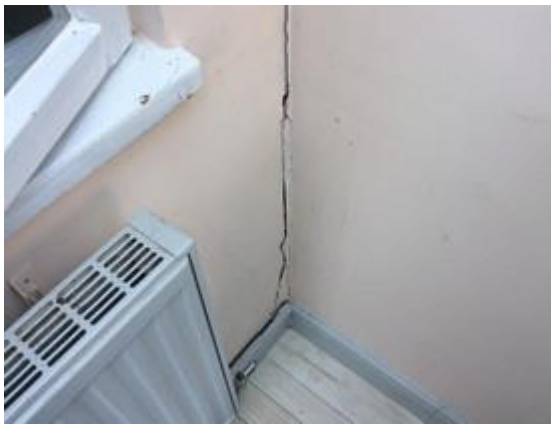
To the left-hand side abutment of the conservatory with the main house wall, arising from ground level up to ceiling height is a vertical gap of 10mm in width.

Picture 1: Internal cracking to conservatory

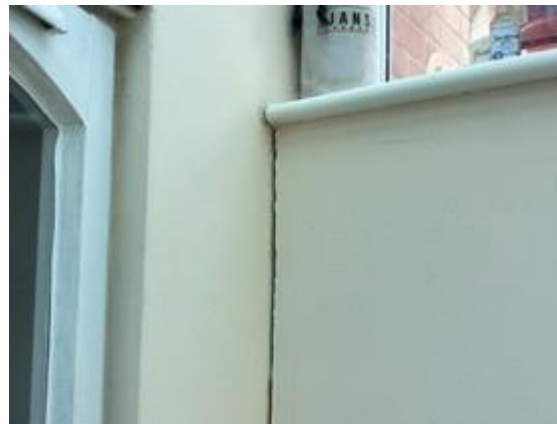
Picture 2: Internal cracking to conservatory

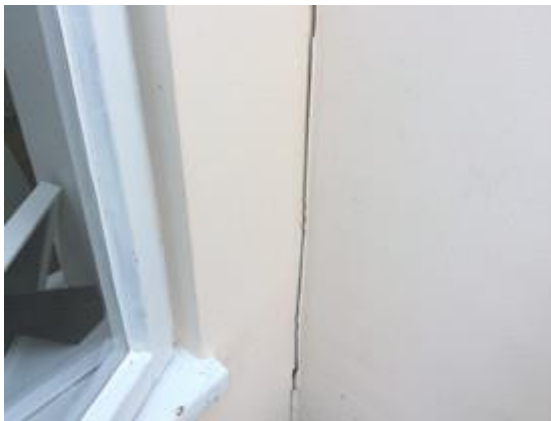
Picture 3: Internal cracking to conservatory

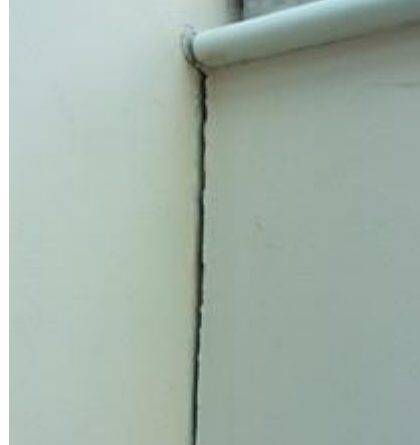
Picture 4: Internal cracking to conservatory
