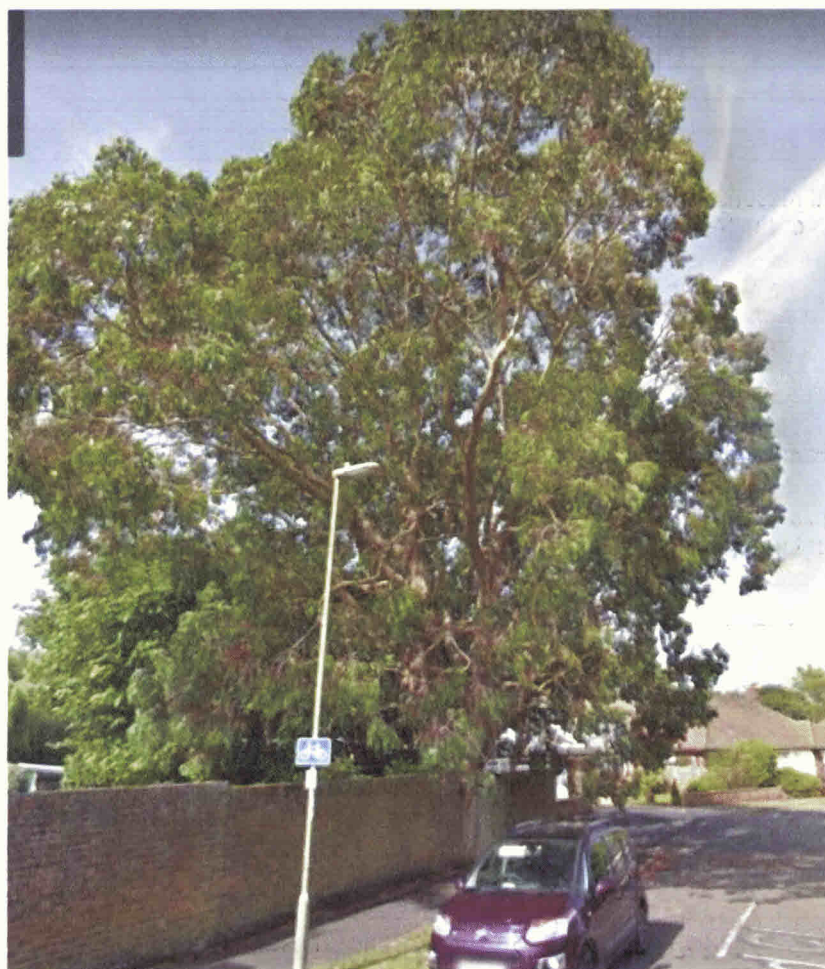
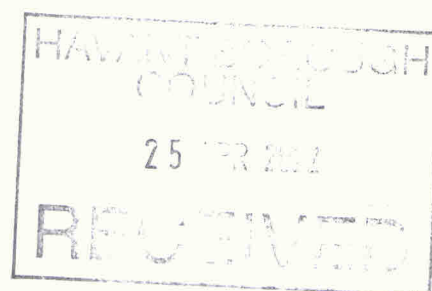
The tree in question is a mature eucalyptus in good health, however has had little maintenance carried out over the years. The tree at the base has pushed the wall over and is causing root issues along the pavement the owners of the tree very much like the tree but would like to carry out some maintenance to keep the size sensible the proposed works would be a height reduction of 3.5 metres and a lateral canopy spread reduction of 2.5 metres all work will be carried out in accordance with British standards.
