**Fallen&Found Arboriculture Ltd**

## **Aerial Tree Inspection**

Q0333\Cox\CIR\_2023

1.1.1. I have been instructed by you (Mr John Cox) to conduct an aerial inspection of a stem cavity located within the main stem of a single Common Oak tree (*Quercus robur*) growing within woodland adjacent to your property located at 53, Oaktree Drive, Emsworth, Hampshire PO10 7UJ.

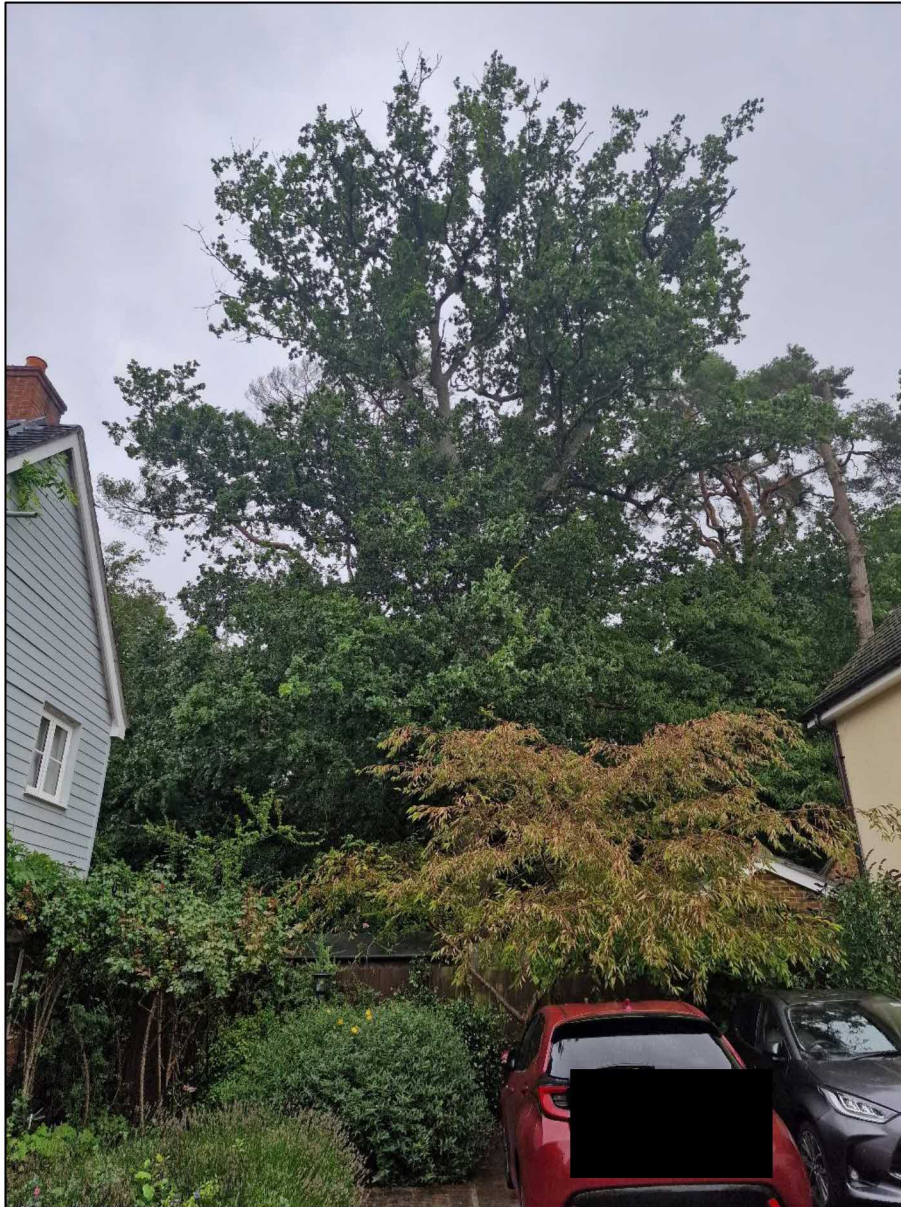
Figure 1

3.2.1. The subject tree is large sized with a canopy which does not appear to have been subjected to historic pruning. Obvious apical dieback within the tree's upper canopy can be observed from ground level<sup>1</sup>. The tree has a single stem which is straight and does not significantly lean. The tree is located within striking distance of numerous above ground targets and areas of moderate, static occupancy from property owners.

The subject tree has apical dieback and a sparse canopy. A reduction in vitality and thinning canopy has likely been caused by the development of the residential estate and associated ground works approximately 8yrs ago.

You have made me aware of the failure of a comparably sized Oak tree which fell into your garden during adverse weather within the last two years. This tree likely failed due to a change in hydrology brought about by excavations, compaction and alterations in soil heights. My concern is that the subject tree may also have been or is being affected by the same conditions. Apical dieback and foliar thinning are evident throughout the trees uppermost canopy which is characteristic of these detrimental factors.

The canopy of the tree should be reduced by up to, but not exceeding 2.5m. All deadwood and any structurally compromised branches should also be removed during this process. X2 lateral branches extending south over the garden emanating from the main stem at an approximate height of 4.5m should be removed. These branches cause disproportionate shading of the garden. These works are prescribed to reduce the wind force dynamic loading of the trees structure.

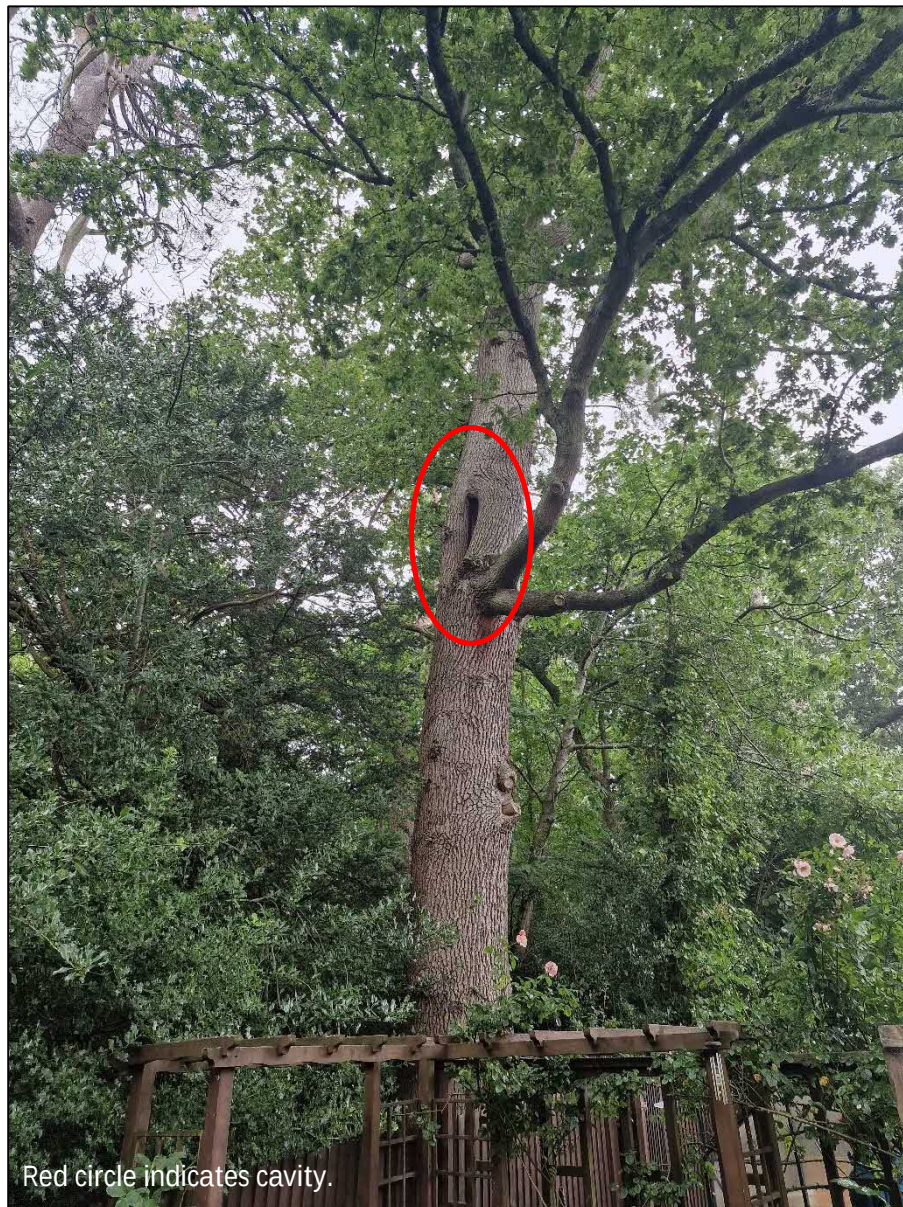
Figure 2

3.4.1. A large cavity can be observed on the western side of the tree's stem at a height of 6.8 meters above ground level<sup>2</sup>.

3.4.2. The trees stem has a diameter of 966mm when measured at the point of the cavity approximately 7m above ground level.

3.4.6. Squirrel damage and signs of historic nesting was observed around the edges and within the cavity.

3.4.7. The cavity is encompassed by significant callus formation and reaction wood.

The Cavity which I inspected has very large reaction wood edges around its opening. These are sometime referred to as gate posts (Claus Mattheck, 1994), they are formed of highly lignified wood referred to as wound wood. Due to their high lignin and other polyphenolic substances, they are harder and more durable than normal wood associated with the tree's stem. The wood associated with this biomechanical feature has the ability to withstand higher tensile and compressive forces which compensates for the strength loss which would otherwise be associated with the cavity. The forces exerted upon the tree are dissipated throughout the trees structure according to the axiom of uniform stress (Claus Mattheck, 1994). Trees self-optmise their structure reinforcing those areas which may become weakened from injury in response to abiotic forces<sup>4</sup>.

Despite the points discussed above, the cavity remains an easily observable biomechanical feature which requires consideration in relation to the trees size, age, biological condition, and the proximity of numerous above ground targets within striking distance of the subject tree. All of these factors increase the risk level associated with the tree.

It is my professional opinion that the cavity which I have assessed during my inspection does not significantly increase the risk of tree failure due to its presence. This opinion is based upon my own experience, training, modern biomechanics and known failure criterion.

The subject tree should be re-inspected in 2yrs time by a fully qualified arboriculturist holding a valid LANTRA Professional Tree Inspection Qualification.

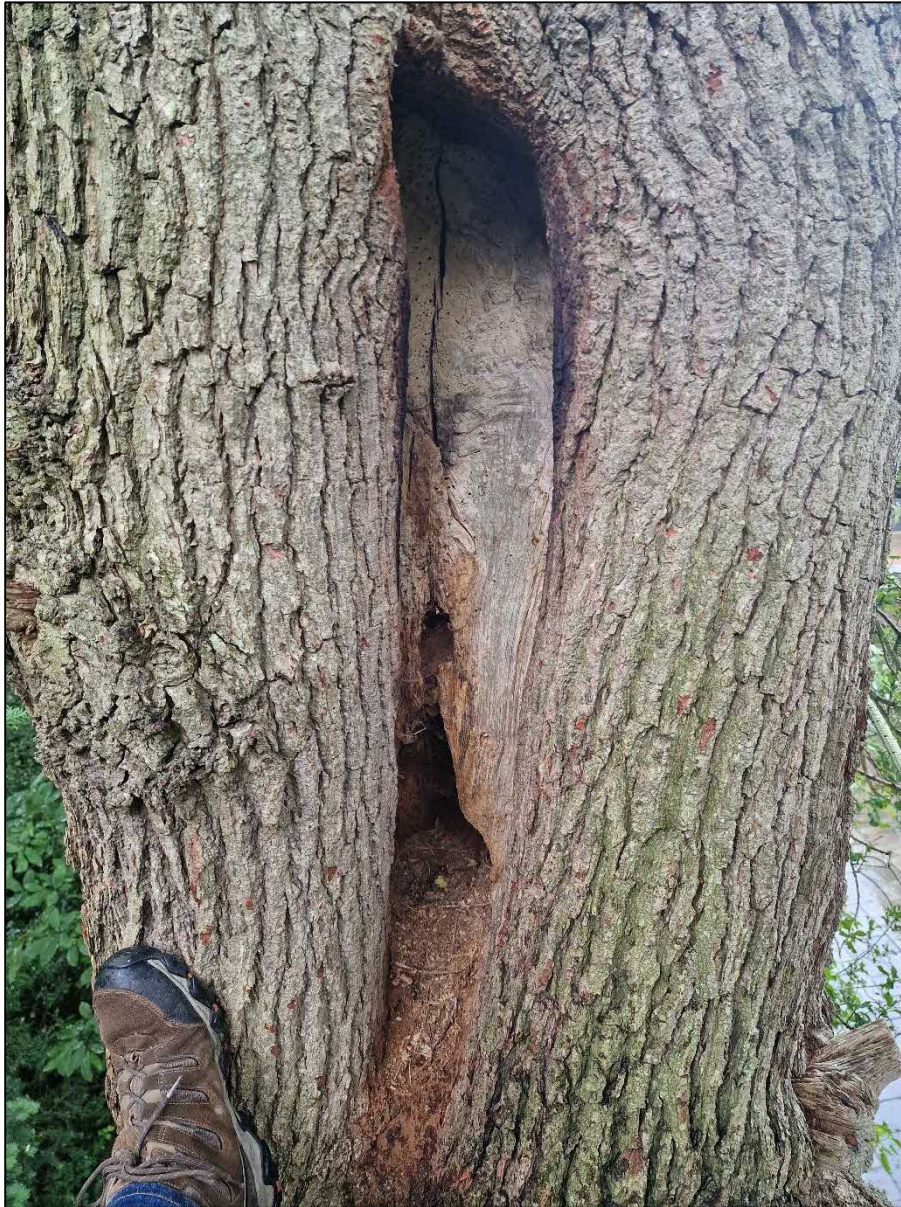
Figure 3

3.4.3. The cavity measures 1500mm in height and has a width of 180mm. When measured with an inspection pin, the deepest point of the cavity extends horizontally into the tree's stem to a depth of 400mm<sup>3</sup>.

3.4.4. Mallet sounding of the tree's stem both above and below the cavity did not produce a resonance characteristic of internal decay or hollowing.

3.4.5. The exposed heartwood within the cavity is dry and hard, with wood boring insect holes. I extracted a small amount of wood fibres during the inspection. This sample crumbled and became dusty when rubbed between finger and thumb.
