## Engineers Report

Risk Address 1a Durley Avenue  
Waterlooville  
PO8 8XA

This document addresses damage notified to insurers in relation to cracking of the detached garage walls. All directions are stated when viewing the property from the front.

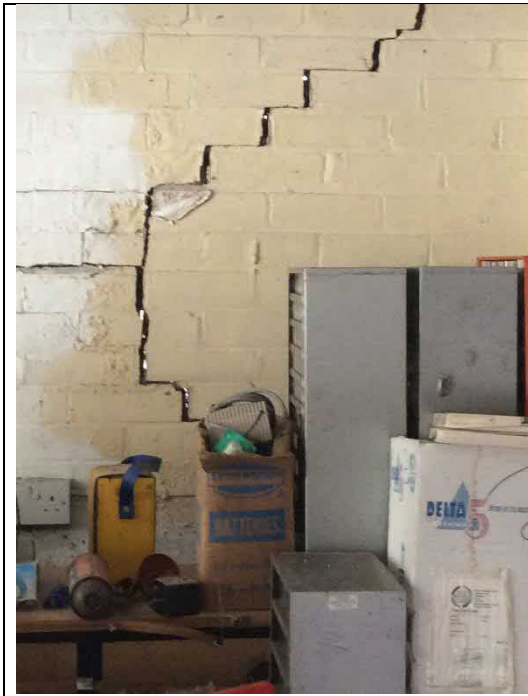
There is stepped cracking to the bed joints of the rear wall and the right hand flank wall. The cracks are between 10mm and 15mm and are visible internally and externally. Several bricks are also cracked.

Cracks to right flank wall

It is common practice to categorise the damage in accordance with B.R.E. Digest 251 "Assessment of Damage in Low-Rise Buildings". In this case, the damage falls into Category 3 "moderate" as there is cracking up to approximately 5-15 mm wide.

The pattern and orientation of damage noted to the property is indicative of localised subsidence of the garage down towards the rear right hand corner.

The cause of the localised subsidence, appears to be clay shrinkage, exacerbated by the water demand of the nearby vegetation.

In order to mitigate further subsidence damage occurring, it will be necessary to remove the cause of the problem, and this may include any implicated vegetation. This should allow the ground to stabilise.

Following completion of the mitigation works described above, and a period to allow the ground to rehydrate, crack repairs and redecoration to the affected areas of the property can proceed. A repair schedule will be drawn up and agreed in due course.

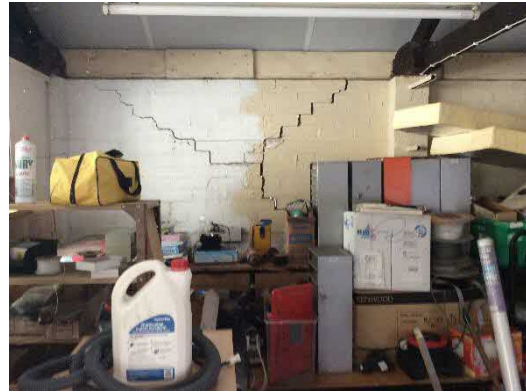
Cracks to right flank wall

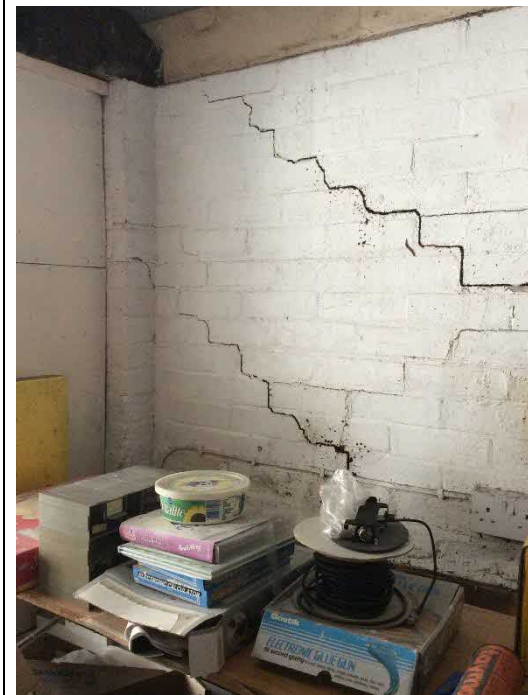
Cracks to right flank wall

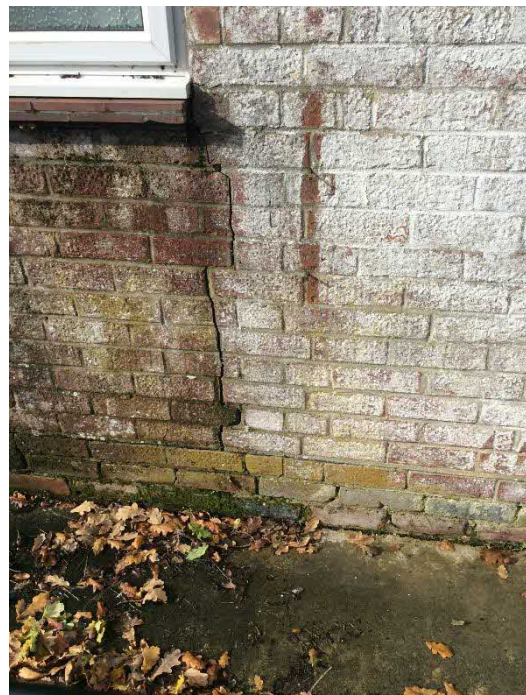
Crack to rear wall
