Our Ref:MH/BeechesTheVillaGardens1/Impct/5873

**TREES AT THE BEECHES, 1 VILLA GARDENS, WATERLOOVILLE, P077RY**

**Brief:** A soakaway and a carparking area has been installed on land adjacent to a pair of Lime Trees which are the subjects of a Tree Preservation Order. Inspect the site and seek to ascertain if the works have had any detrimental impact upon the protected trees.

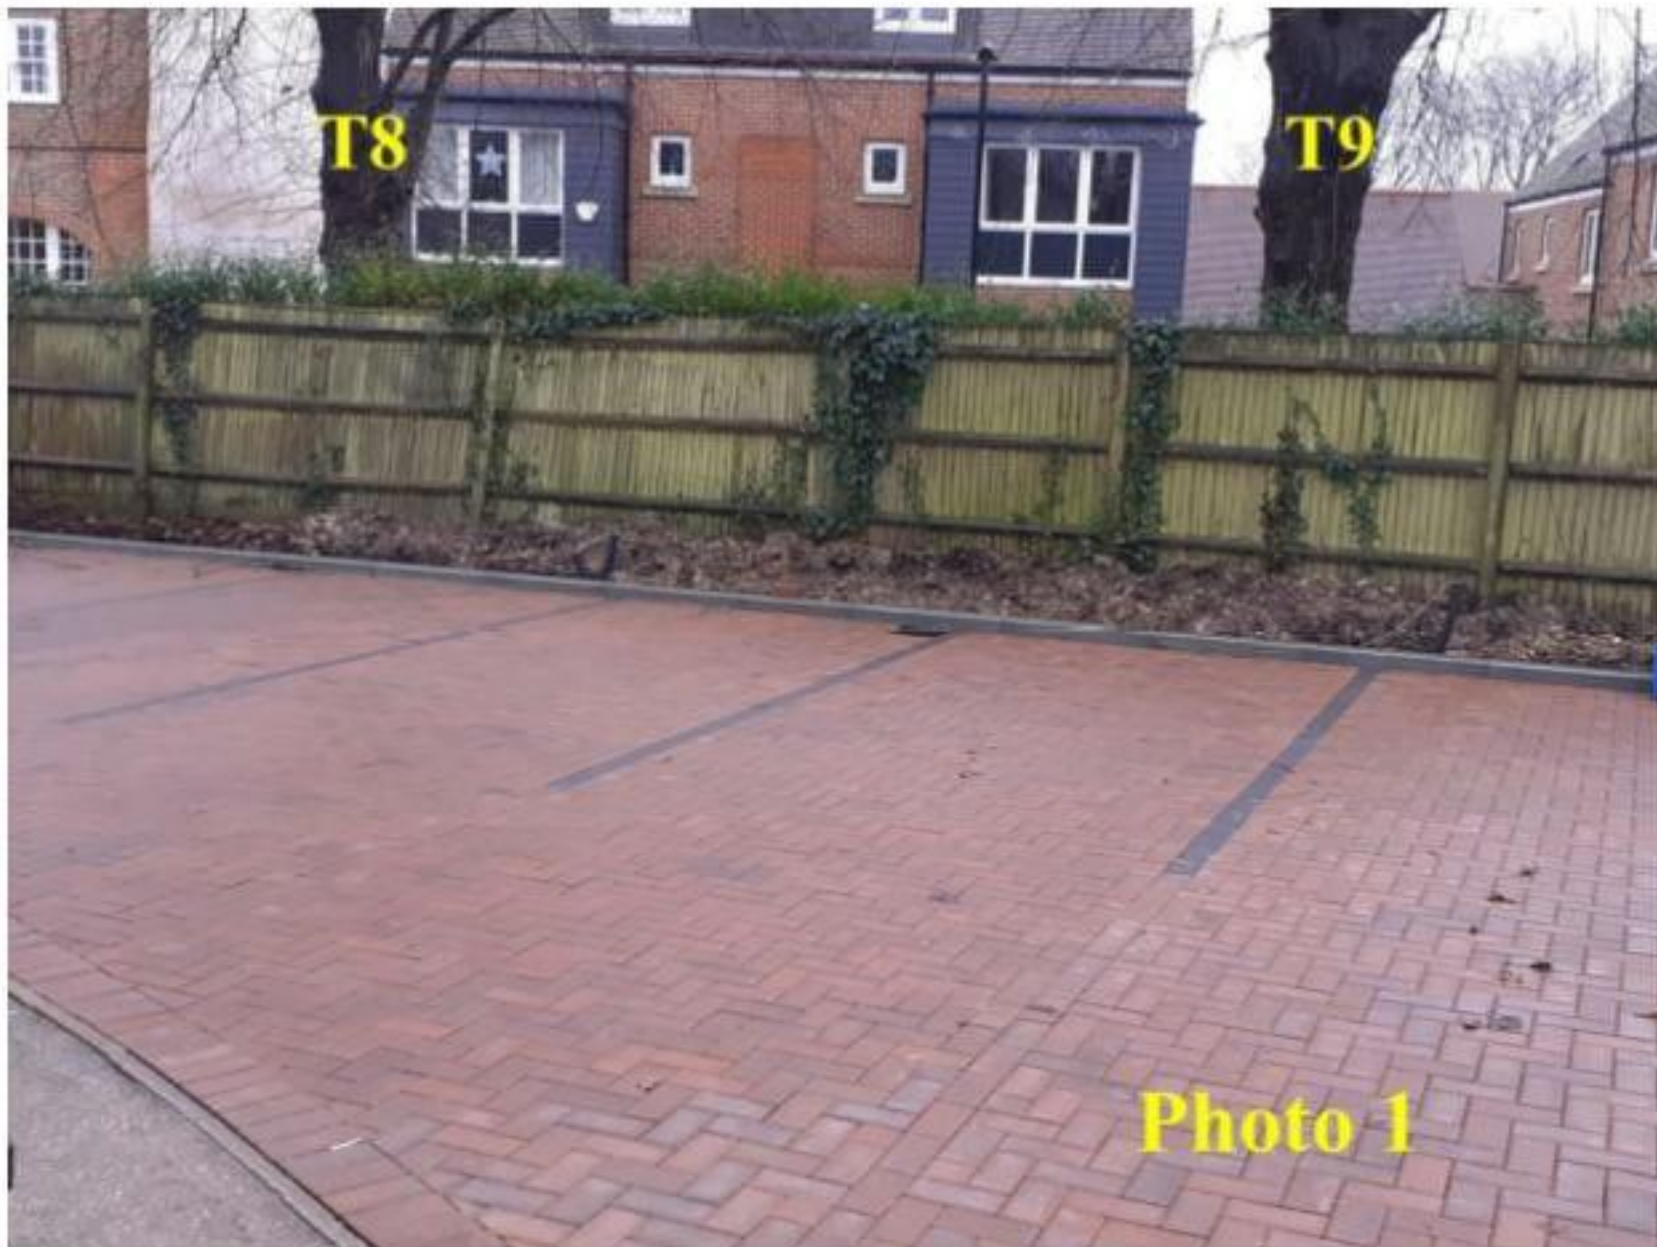
I have been supplied with a photograph of the parking area and the trees which was clearly taken before the trees came into leaf this year (Photo 1). I have added the TPO tree numbers for clarity.

**Findings on site:** There are two Lime Trees as shown in Photo 1 standing on the adjacent property to the carparking area. They have trunk diameters between 500mm and 600mm. This equates to a Root Protection Area radius of a maximum of 7.2m.

On the day of inspection, the trees were in full leaf and appeared to be in a reasonably healthy condition. (Photo 2). I have no reference for the condition of the trees prior to the installation of the carparking.

**Discussion:** I am not a witness to any of the works which preceded my site visit on the 18<sup>th</sup> August 2020. However, taking the given information at face value, it would appear that the installation of the soakaway was performed outside the RPAs of the TPO Lime Trees and will have caused them no harm.

If there has been some disturbance it does not, as yet, appear to be significant.

**Conclusion:** The best thing to do for the Lime Trees is to leave everything exactly as it is and make no further changes to their rooting environment. My expectation is that they will be fine. However, just in case they do develop symptoms of loss of root function, a planning approval for the carpark could have a condition attached requiring a further tree condition survey late next spring when the Limes should be in full leaf. If any signs of distress are recorded discussions regarding suitable remedial measures will have to take place between the site owner and the Local Planning Authority to improve the rooting environment for these trees.

**Recommendation:** Approve the carpark with a follow up survey condition.
