## Crack and Level Monitoring

Provider Name: CET

Address: 2c Padnell Avenue, WATERLOOVILLE, Hampshire, PO8 8DY

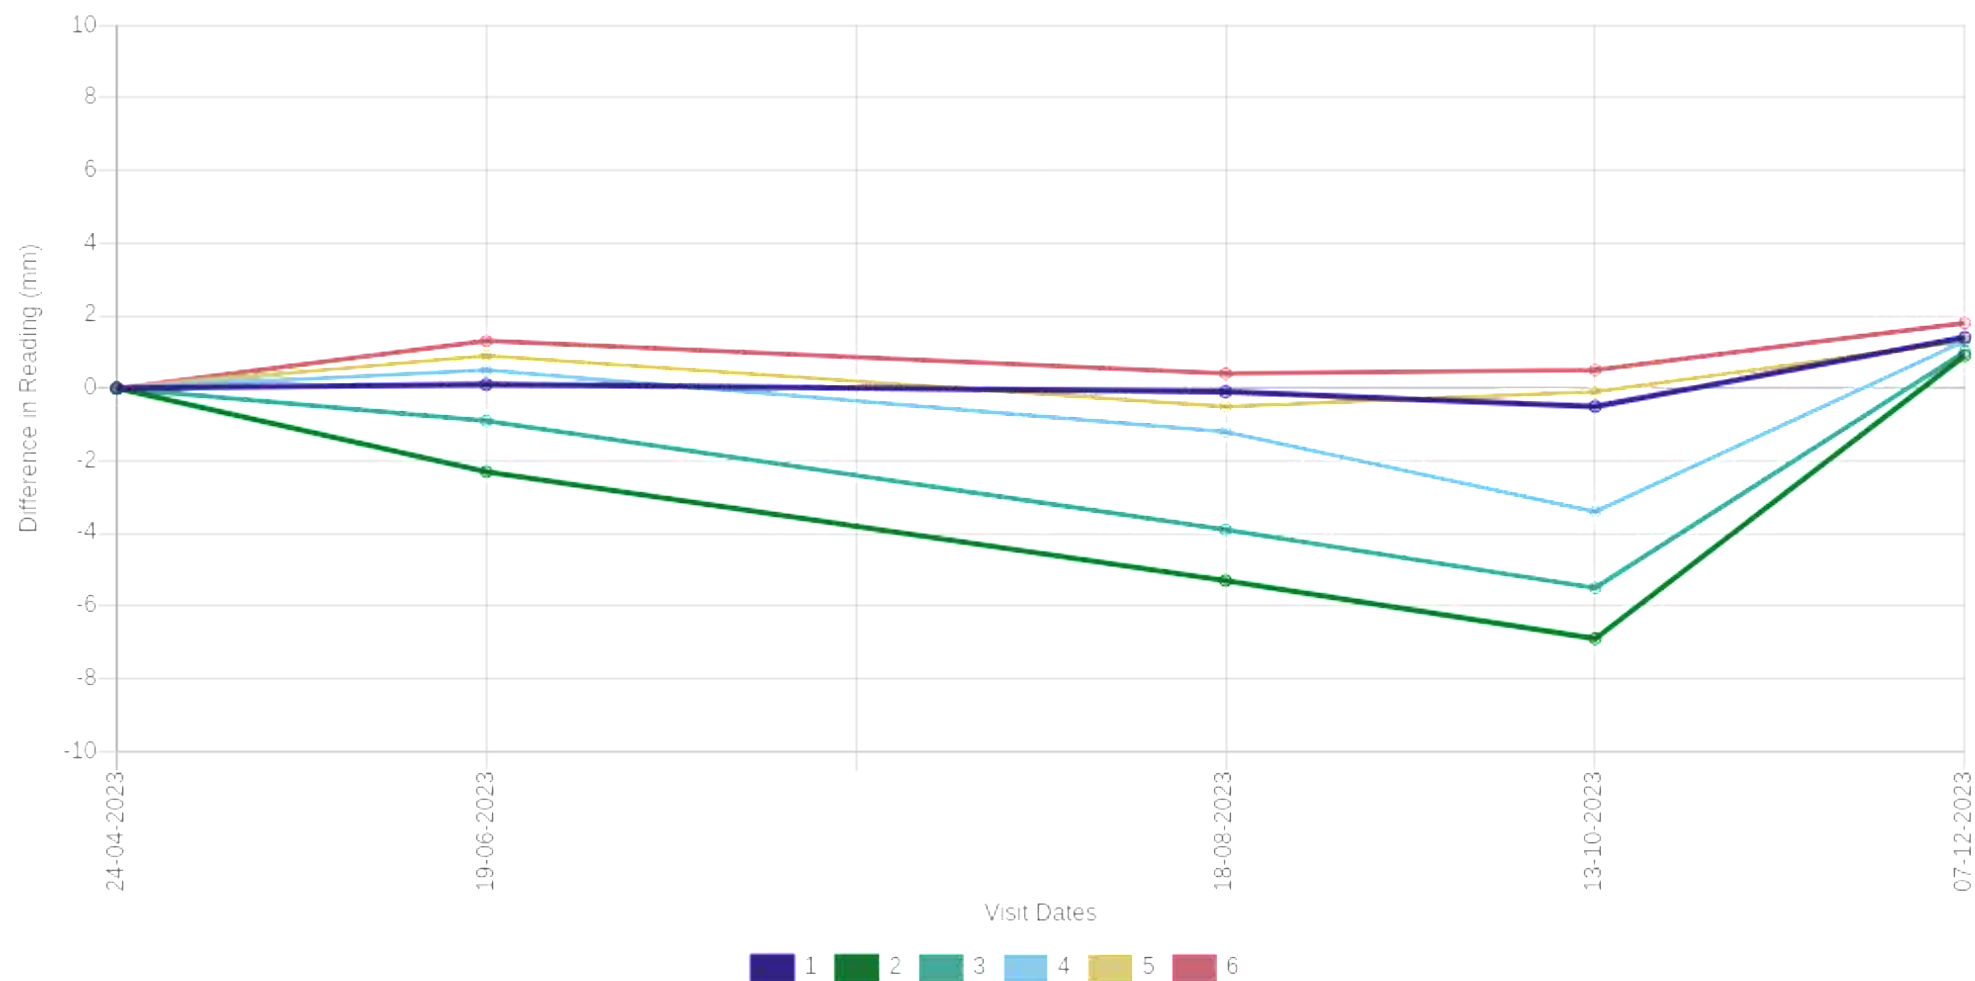
## Level Readings Chart (Points 1 - 6)

| | Visit 1 | Visit 2 | Visit 3 | Visit 4 | Visit 5 | Visit 6 | Visit 7 | Visit 8 | Visit 9 | Visit 10 |
|---|---|---|---|---|---|---|---|---|---|---|
| 1 | 0 | +0.1 | -0.1 | -0.5 | +1.4 | | | | | |
| 2 | 0 | -2.3 | -5.3 | -6.9 | +0.9 | | | | | |
| 3 | 0 | -0.9 | -3.9 | -5.5 | +1 | | | | | |
| 4 | 0 | +0.5 | -1.2 | -3.4 | +1.3 | | | | | |
| 5 | 0 | +0.9 | -0.5 | -0.1 | +1.3 | | | | | |
| 6 | 0 | +1.3 | +0.4 | +0.5 | +1.8 | | | | | |

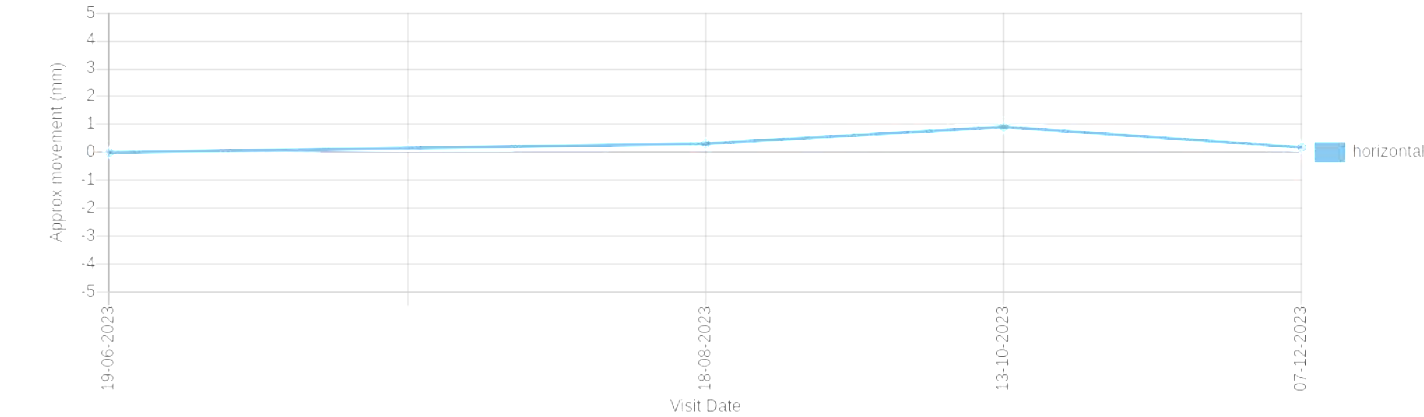
Under window right hand side of front door

| | Visit 1 | Visit 2 | Visit 3 | Visit 4 | Visit 5 | Visit 6 | Visit 7 | Visit 8 | Visit 9 | Visit 10 |
|---|---|---|---|---|---|---|---|---|---|---|
| H | 0 | 0.31 | 0.91 | 0.18 | | | | | | |

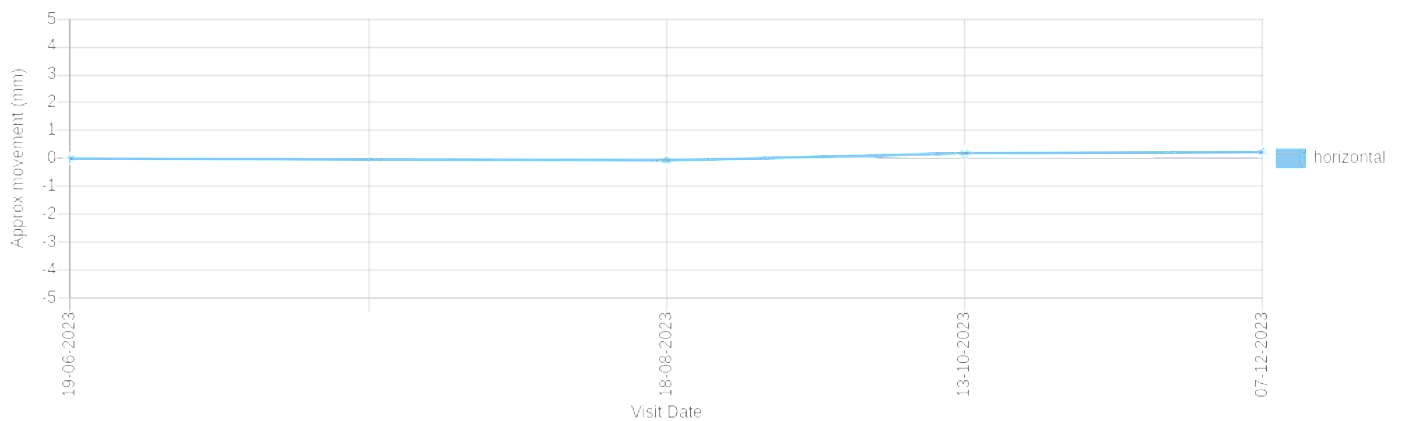
## Rear right hand side of point 6 - Crack Readings Differences (Displayed in Millimetres)

| | Visit 1 | Visit 2 | Visit 3 | Visit 4 | Visit 5 | Visit 6 | Visit 7 | Visit 8 | Visit 9 | Visit 10 |
|---|---|---|---|---|---|---|---|---|---|---|
| H | 0 | -0.08 | 0.19 | 0.22 | | | | | | |

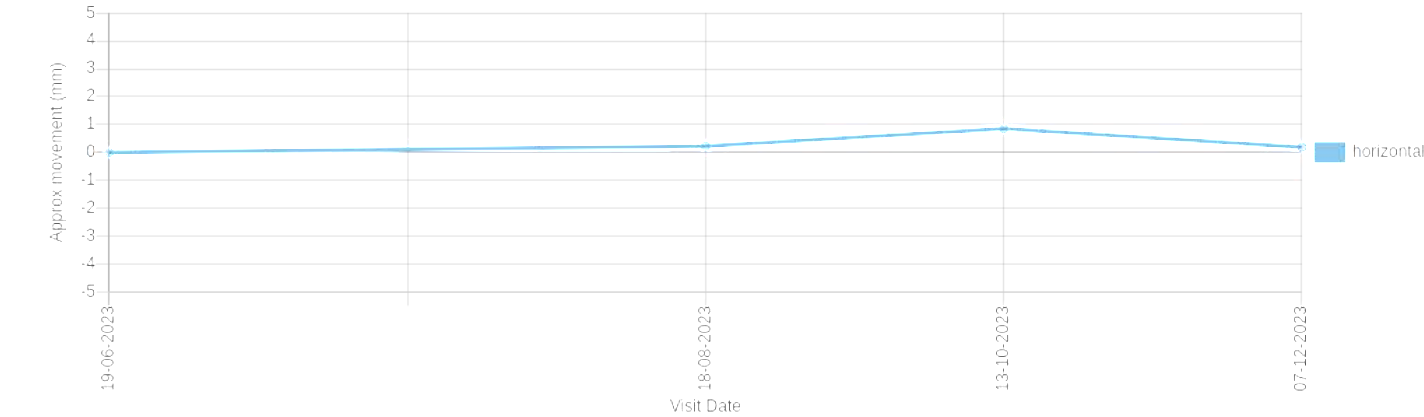
INT right hand side above patio doors - Crack Readings Differences (Displayed in Millimetres)

| | Visit 1 | Visit 2 | Visit 3 | Visit 4 | Visit 5 | Visit 6 | Visit 7 | Visit 8 | Visit 9 | Visit 10 |
|---|---|---|---|---|---|---|---|---|---|---|
| H | 0 | 0.22 | 0.85 | 0.19 | | | | | | |
