**Tree Report**  
**Pine Lodge, 23 Mengham Lane, Hayling Island.**

**1.1 Report date:** 10<sup>th</sup> August 2020 by Mr. Kim Gifford, undertaken in the area of test and at the time of inspection.

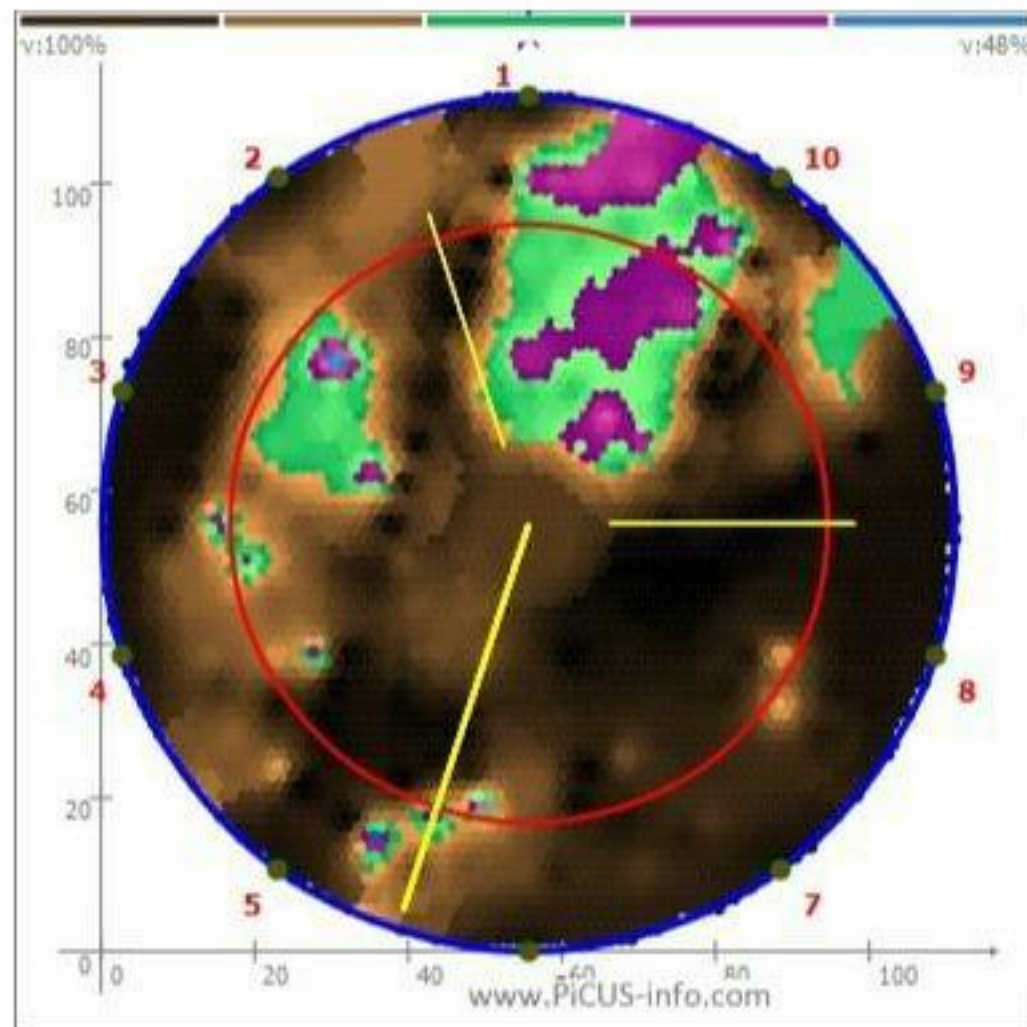
### 1.6 T19 Monterey Pine (Pinus radiata)

Physiological Condition: Dying back in upper crown, low vitality, 5no. major dead branches.

Structural Condition: Exposed buttress roots on bank by main entrance.

Test 1 @ level: 60cms approximately from ground level.

Test point 1 orientation North.

The measuring point readings give evidence of high sound velocities overall in the area of test representation showing as sound timber. The tomographic images shown above has a percentage amount of altered timber. With reference to the 'colour chart see figure 2', the slower sonic speed of sound is represented by three bands of data representation blue/violet/white being the slowest altered/decayed timber, green being faster altered timber, brown being fast sonic-speeds solid timber.

The resulting Picus test is of acceptable limits in relation the altered timber. This ratio called a 'trunk ratio' TR (*reference Claus Mattheck*) has been calculated to be a guideline in terms of stability and rigidity of cylindrical structure. Although a debated theory in arboriculture in general terms the TR of 30% is an average.

Remove all dead branches and continue to monitor on a 2 year cycle.

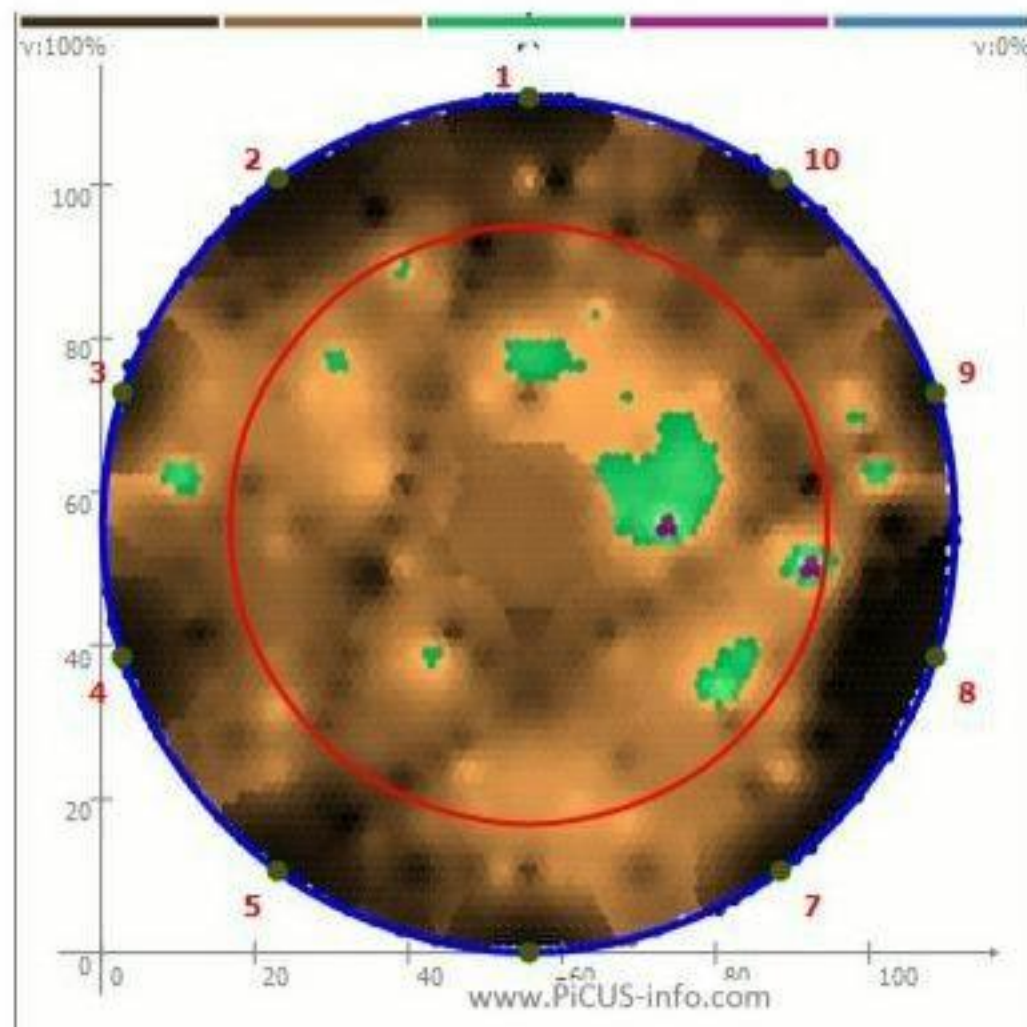
### 1.8 T13 Monterey Pine (Pinus radiata)

Structural Condition: Leaning towards road. Extensive limbs over hanging the road.

Test 1 @ level: 30cms approximately from ground level.

Test point 1 orientation North.

The measuring point readings give evidence of high sound velocities overall in the area of test representation showing as sound timber. The tomographic images shown above has a percentage amount of altered timber. With reference to the 'colour chart see figure 2', the slower sonic speed of sound is represented by three bands of data representation blue/violet/white being the slowest altered/decayed timber, green being faster altered timber, brown being fast sonic-speeds solid timber.

The resulting Picus test is of acceptable limits in relation the altered timber. This ratio called a 'trunk ratio' TR (*reference Claus Mattheck*) has been calculated to be a guideline in terms of stability and rigidity of cylindrical structure. Although a debated theory in arboriculture in general terms the TR of 30% is an average.

Remove dead branches, reduce over extended branches on roadside by 2m-3m and continue to monitor on a 2 year cycle.
